**TITLE: A83 KENNACRAIG TO CAMPBELTOWN - ROAD CONDITION**

## APPENDIX A

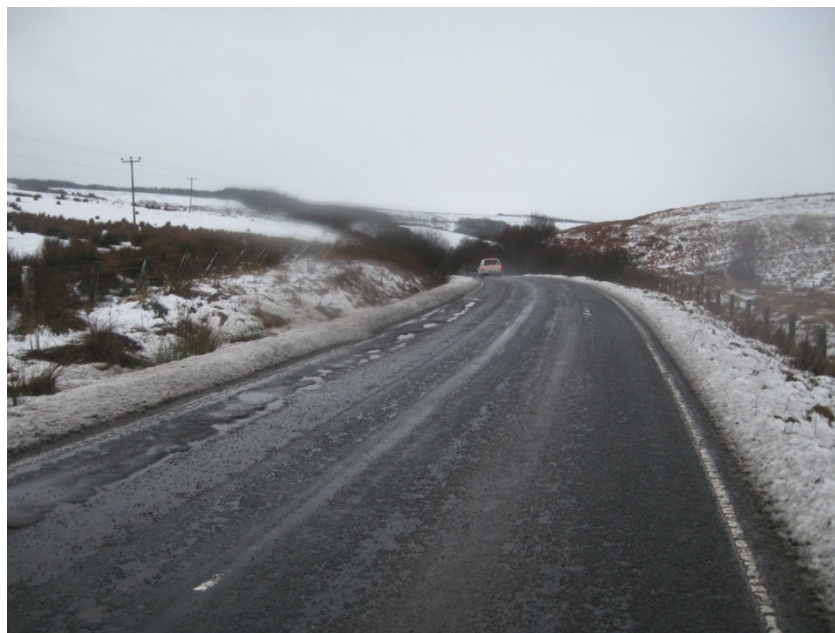
A83 North of Clachan

This section lies mainly to the north of Clachan.

- The existing carriageway surface at this location comprises of old surface dressing over an oxidised bituminous surface. This surface is both potholing & wearing through to the lower layer. This deterioration will continue if left untreated.
- A 280m long critical section will be resurfaced from the 'frost-heave budget' this financial year – highlighted in red on the attached plan in Appendix A. This is approximately 10% of the overall area requiring treatment; the budget for this work is £25,000. The most critical section to be treated lies on the hill north of Clachan. Gradients and bends on this section increases stress on the surface and this has

accelerated surface deterioration. The area of proposed overlay cannot be patched as a permanent solution as the surface is too weak to tie into.

- The remaining 2,900m long section which requires treatment is highlighted in yellow on the plan in Appendix A.
- The remainder of the hill will be reassessed for inclusion in the 2010/11 capital programme. Approximate costs are expected to be in the region of £80,000
- The level sections to the north & south of Clachan hill are unlikely to be included in the 2010/11 capital programme without excluding a large proportion of the proposals for the remaining network. Approximate costs are expected to be in the region of £180,000

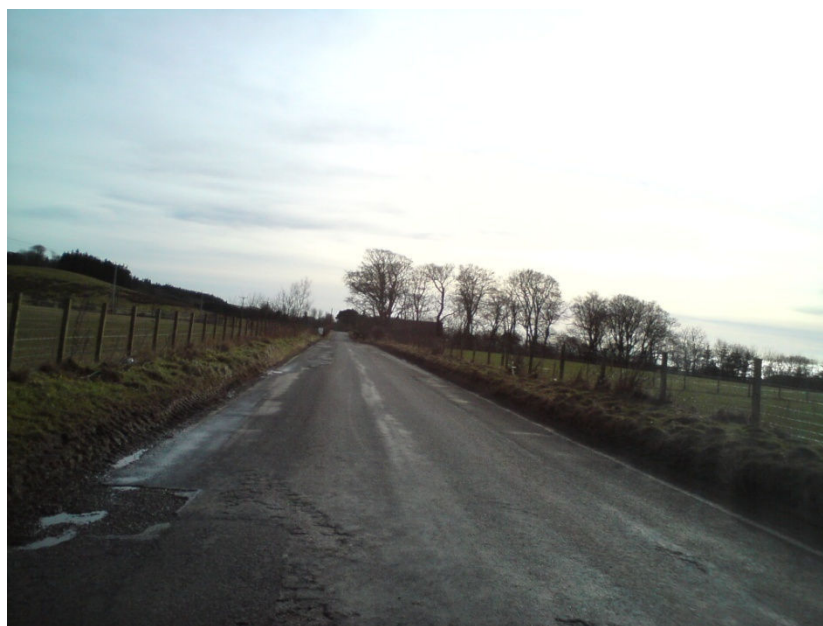
A83 North of Tayinloan

This section has several drainage issues in addition to the poor surface condition.

- The overall section length requiring treatment is 5,200m - highlighted in yellow on the plan in Appendix A.
- The existing surfacing is a mix of old surfacing and permanent and temporary repairs.
- Repairs have been carried out to the drainage along this section with further work required prior to carrying out surfacing work.

- This area has scattered potholes that have been 'screeded', with a few short areas that would warrant overlay. Some areas on the Tayinloan straights will not hold patching as the existing bituminous surfacing is too weak.
- While the straights are in poor condition they can be maintained and will tend to deteriorate at a steady rate.
- Costs for resurfacing are likely to be in the region of £550,000. Some of this funding may be made available from next year's capital budget.

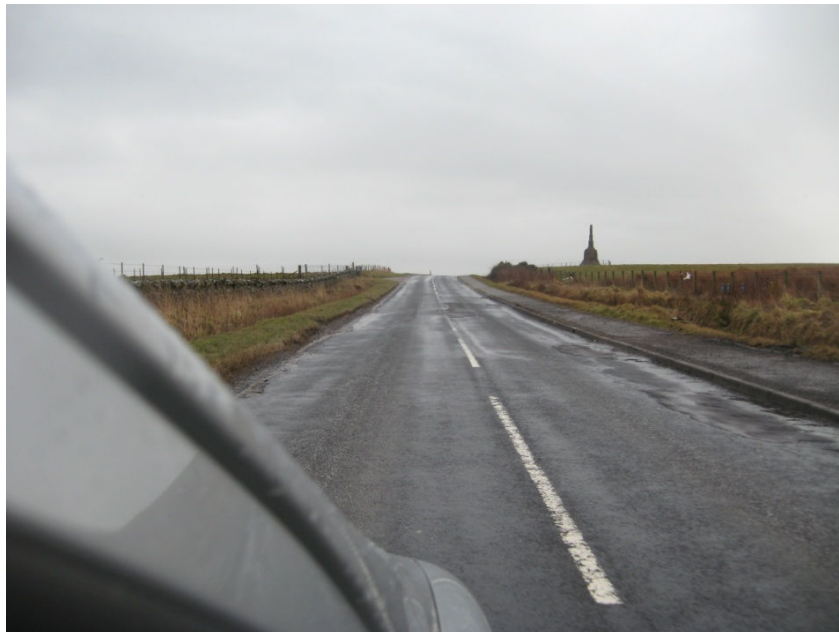
A83 Glenbarr

This section has been surface dressed in recent years although further patching is required.

- This 2,200m long section is highlighted in yellow on the plan – Appendix A.
- The existing surface is generally surface dressing over old surfacing.
- The surface suffers from sporadic potholes with a few localised clusters. One main drainage issue has been highlighted north of the village access - formalised drainage will be installed this coming financial year. There are also longitudinal ruts in the wheel tracks at the south of Glenbarr which carry water down the hill.
- Most of these repairs will suit permanent patching works. This work will be carried out under the revenue maintenance budget. Whilst this section requires limited surfacing work, it remains in a better condition than other sites mentioned in this report.

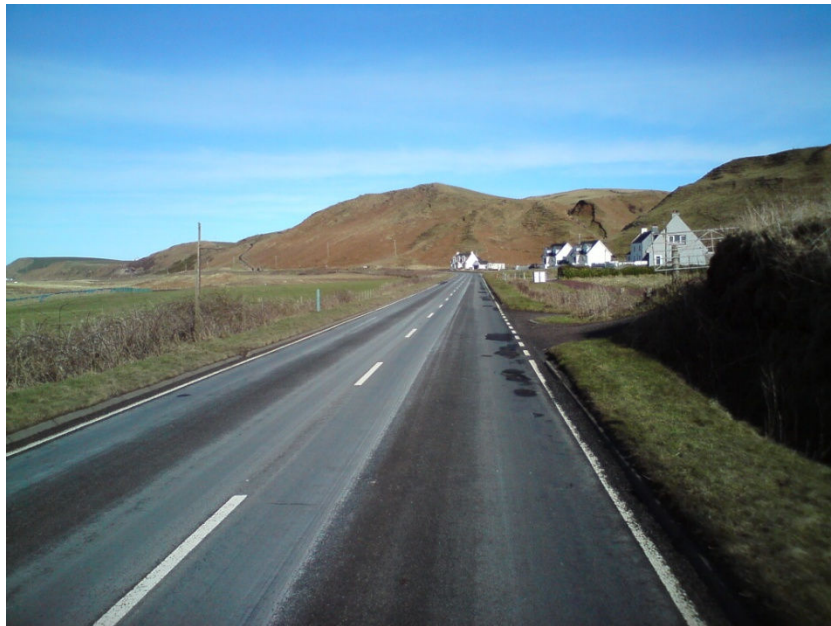
A83 Bellochantuy

This section has developed sections with significant pothole issues along the wheel tracks.

- This 1,100m long section is highlighted in yellow on the plan Appendix A.
- The surface consists of surface dressing over old surfacing.
- Potholes have developed along the wheel tracks at several locations. These will suit repair by overlay or planing out ¼ carriageway & resurfacing with a mini paver.
- Again, as with Glenbarr, this site should remain in a better condition than other sites mentioned in this report. Work here will be carried out under the revenue maintenance budget.

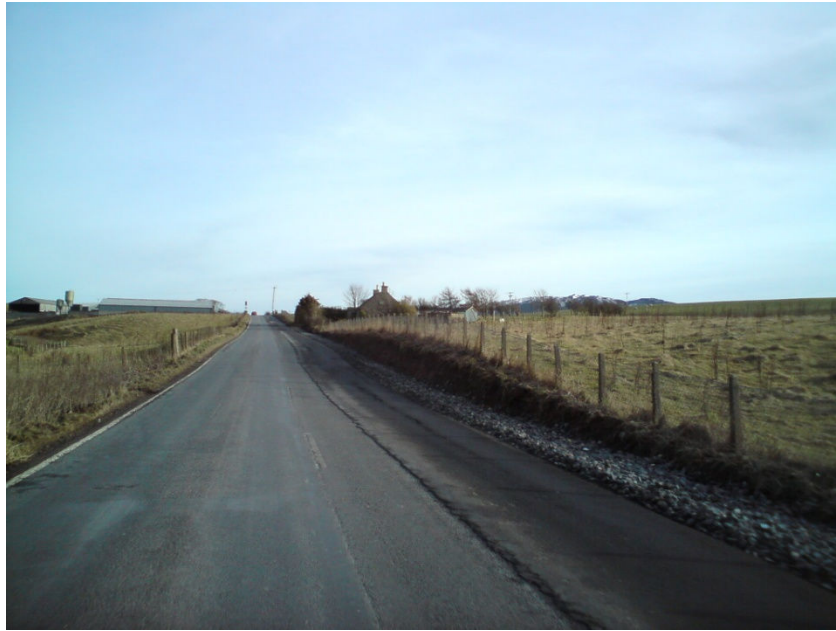
A83 North of Campbeltown

This section has had regulating laid over several areas of major deterioration.

- The 4,900m long section is highlighted in yellow and red on the plan in Appendix A
- Of the overall section, at least 3,200m highlighted in red requires a variety of edge strengthening, regulating & overlay work.
- Most of this section lies on the haul route between Campbeltown and Machrihanish air base and will be subjected to particularly heavy stresses over the coming years.
- Regulating and surfacing works required for this 3,200m section of road, along with regulating and surface dressing for the remaining 1,700m is likely to cost in the region of £500,000.
- This work will have to be planned for future years when a suitable budget is available although it is likely that some works will be carried out from this forthcoming year financial year's capital budget.
