Dunoon Pier Strategy DRAFT

Structural Review

DUNOON PIER TIMBER PILE SURVEY September 2011

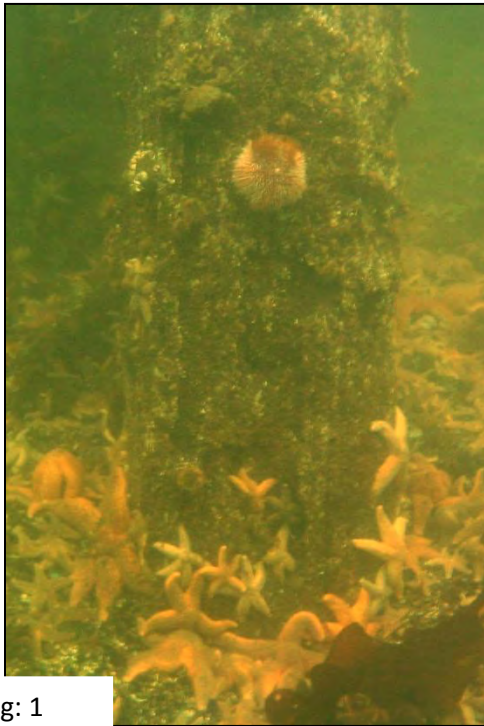
Fig: 1

The following photographic stills (fig: 1 – fig: 6) images represents a general overview of timber pile condition within the scope areas of the inspection. Marine growth is evident in most images.

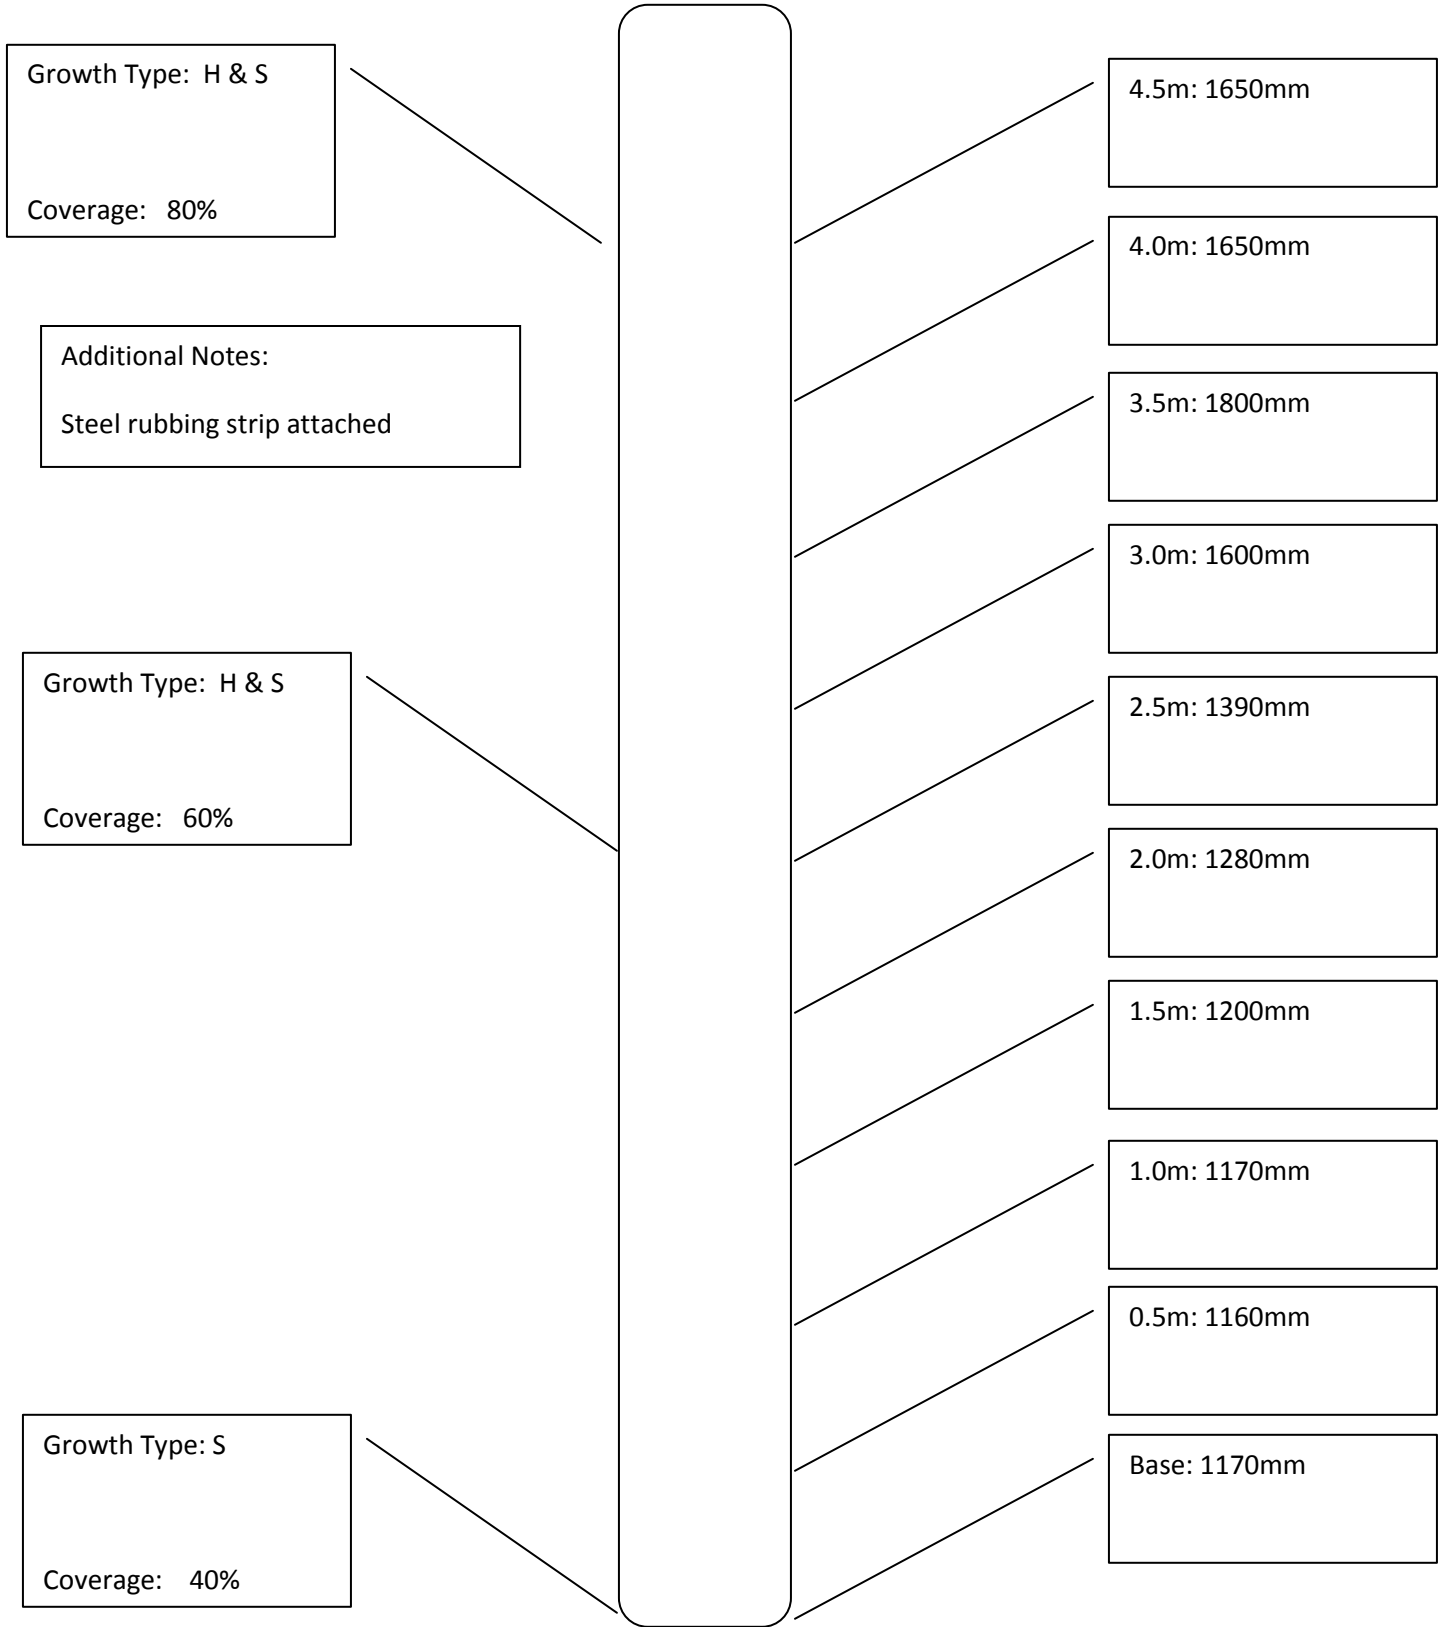
PILE NUMBER: 009

Growth Type: H & S
Coverage: 80%

Additional Notes:
Steel rubbing strip attached
