Dunoon – Wooden Pier: Phase 1 Update

4.1. Dunoon Wooden Pier Phase 1 Refurbishment

4.2. Phase 1A: Structural Repairs to the Timber Pier

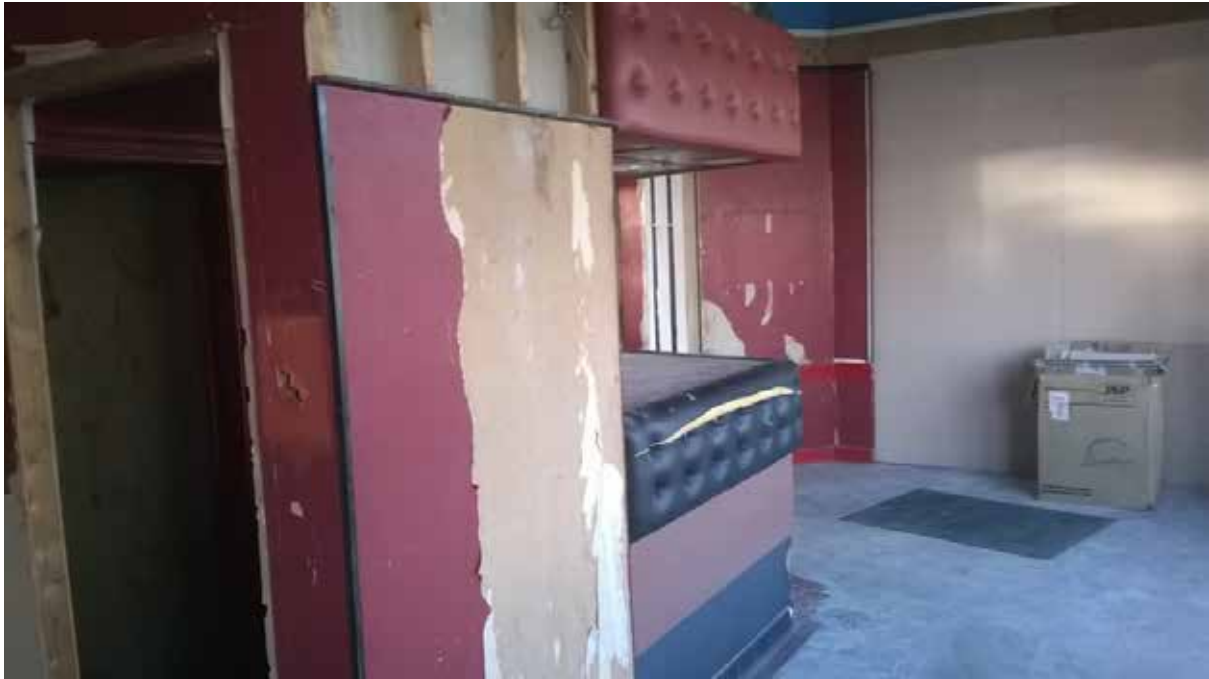
Ground Floor Entrance Lobby – November 2014. Area in the background has been refurbished to provide tea-prep facility and access into the First Class Waiting Room. Area in the foreground has been refurbished to provide ladies and gents toilets and cleaners store/cupboard and access corridor between First Class and Third Class Waiting Rooms

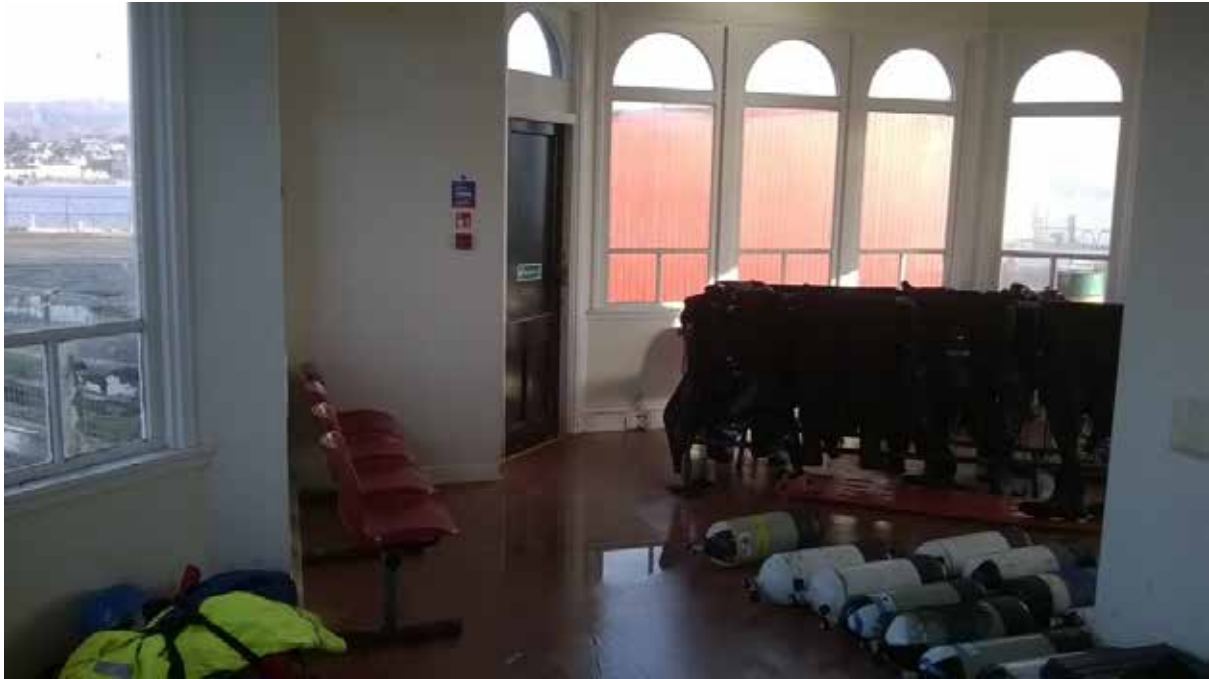
Third Class Waiting Room – November 2014. This room included the ladies and gents toilets

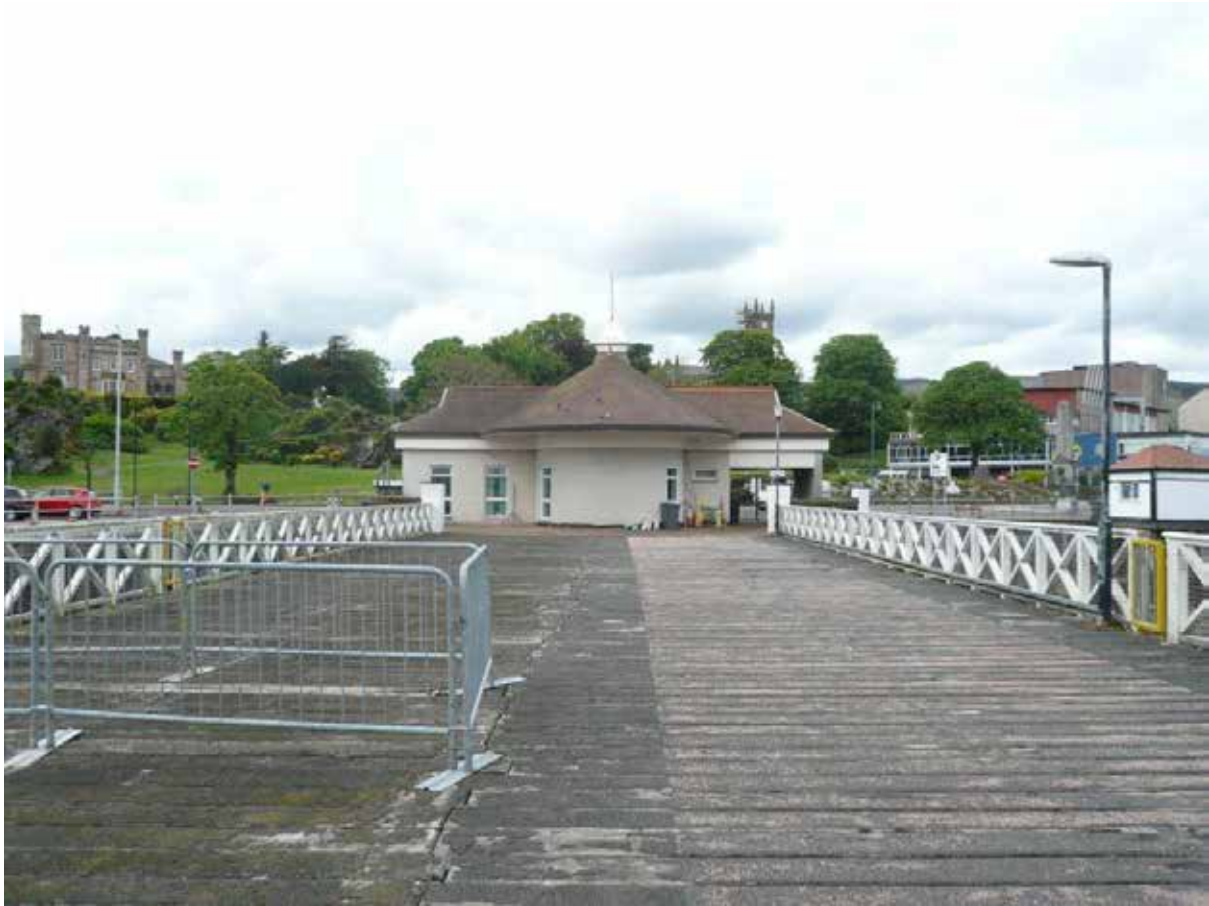
Souther Arm of Pier – May 2014. Note bitumen covering to decking boards, irregular gaps between boards, joints between boards run along the centre and uneven surface.

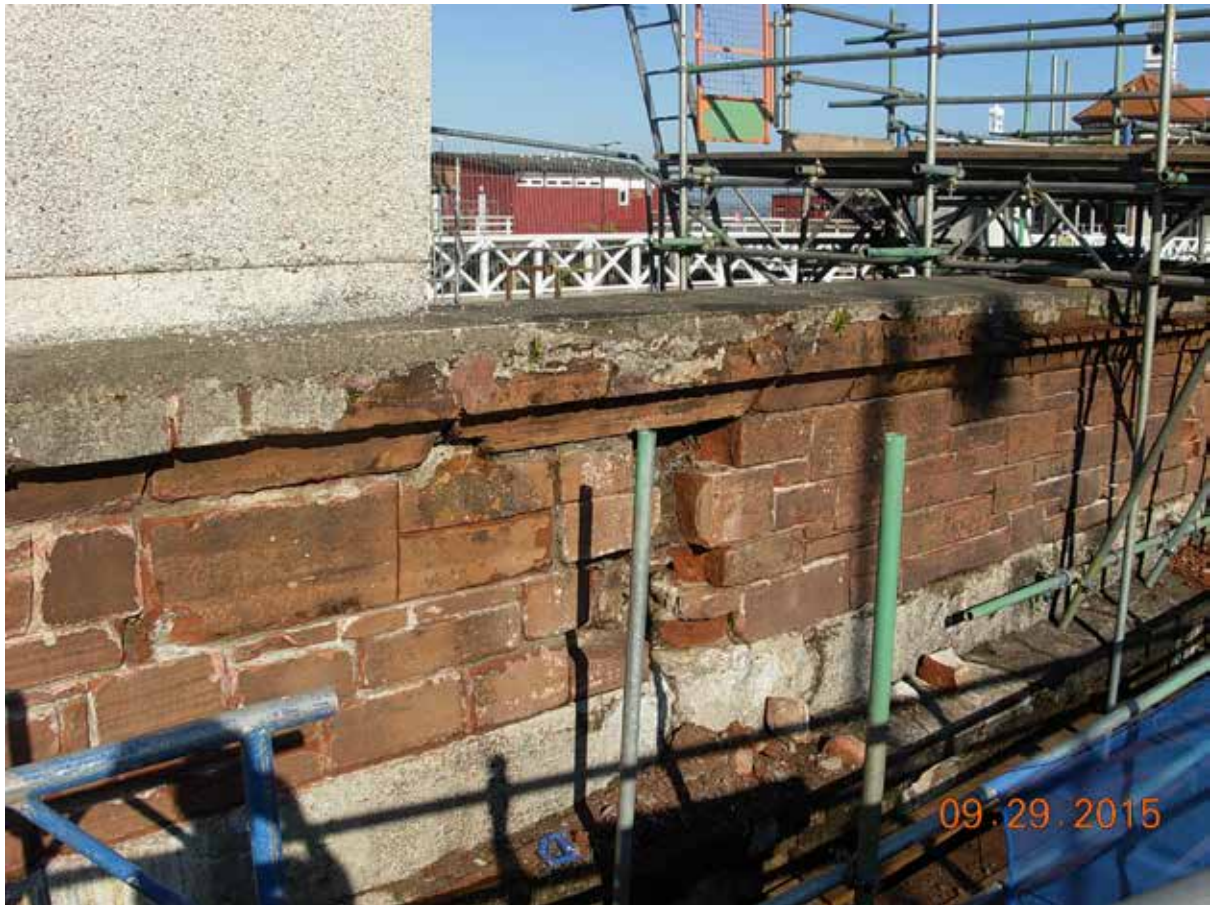
Retaining Wall to Harbourmasters Building – Note condition of stonework and pointing

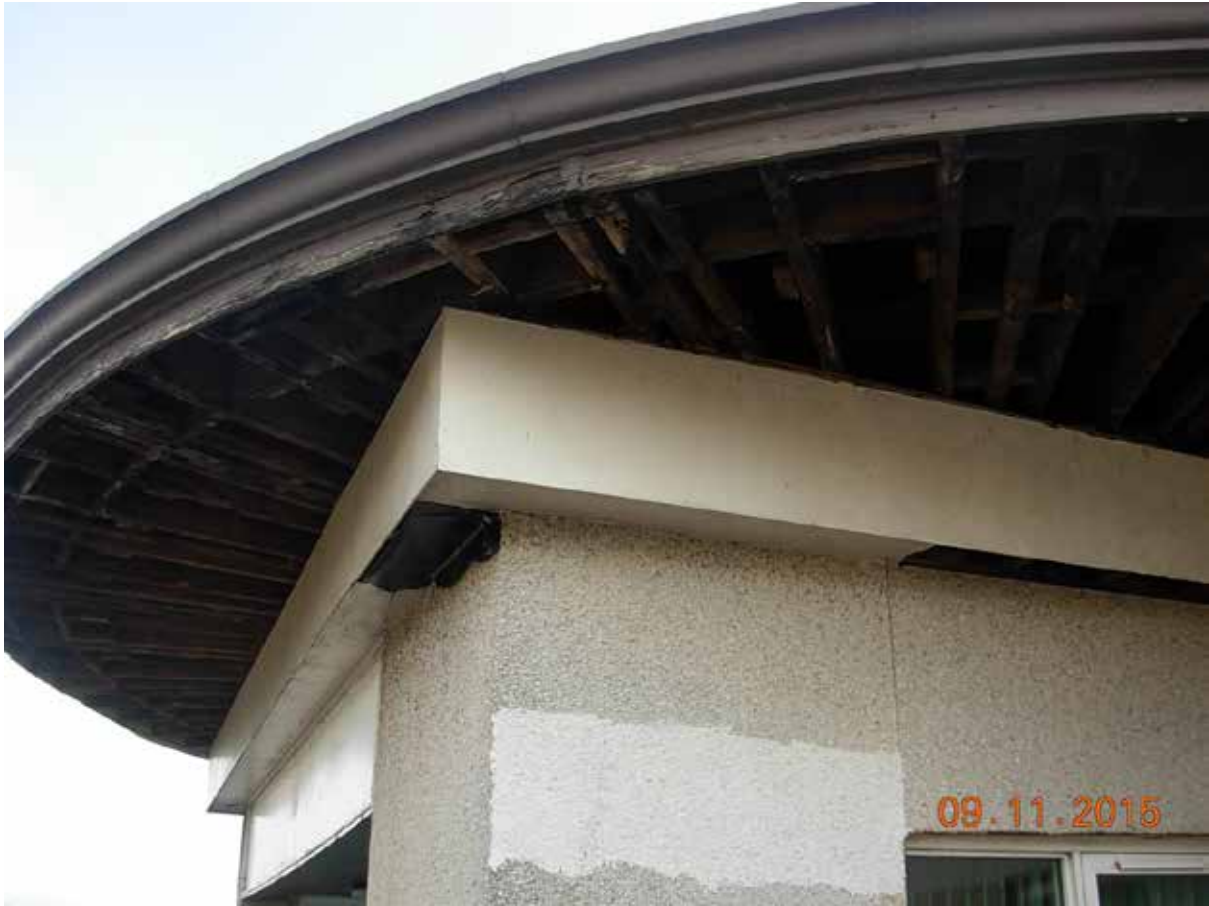
Harbourmasters Roof – Note rotten joists, soffits and fascias which has been caused by internal downpipes leaking and gutters having corroded.

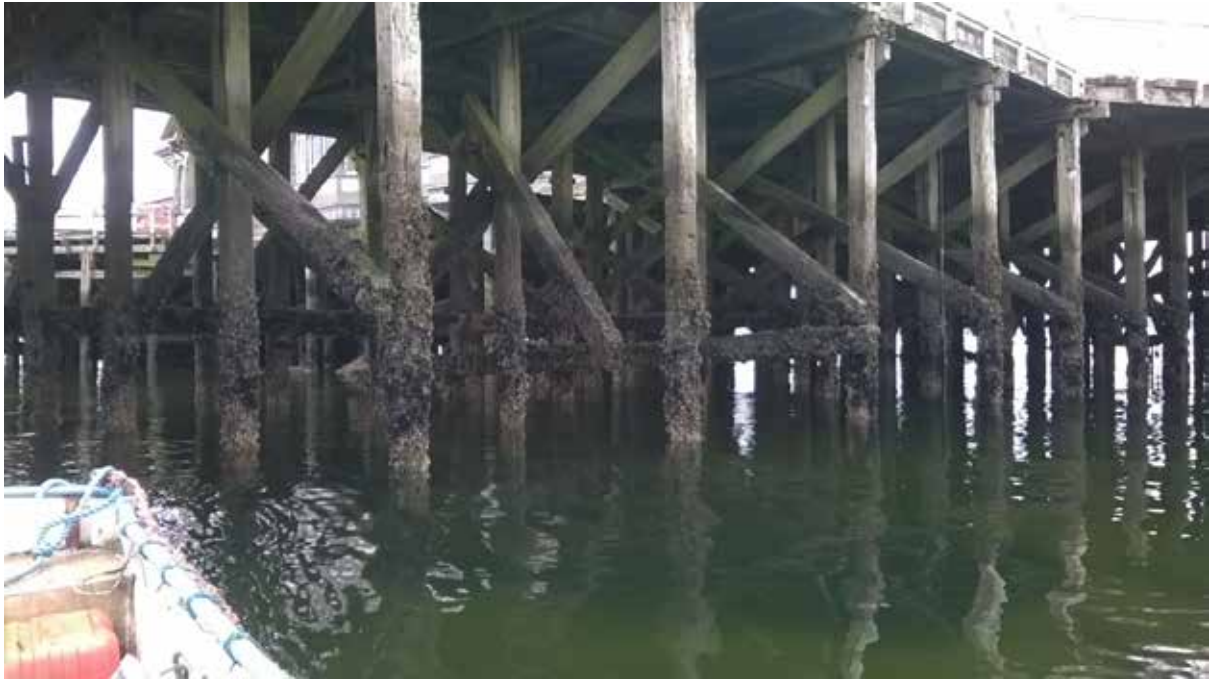
Structure of Pier – May 2014. Note longitudinal timber ties are missing to the foreground, diagonal timber braces are missing or no longer connected to the structure and timber columns are degraded
