Port Marine Safety Code

Audit: Isles of Mull and Iona
(Craignure, Bunessan, Fionnphort, Iona) 2022

November 2022

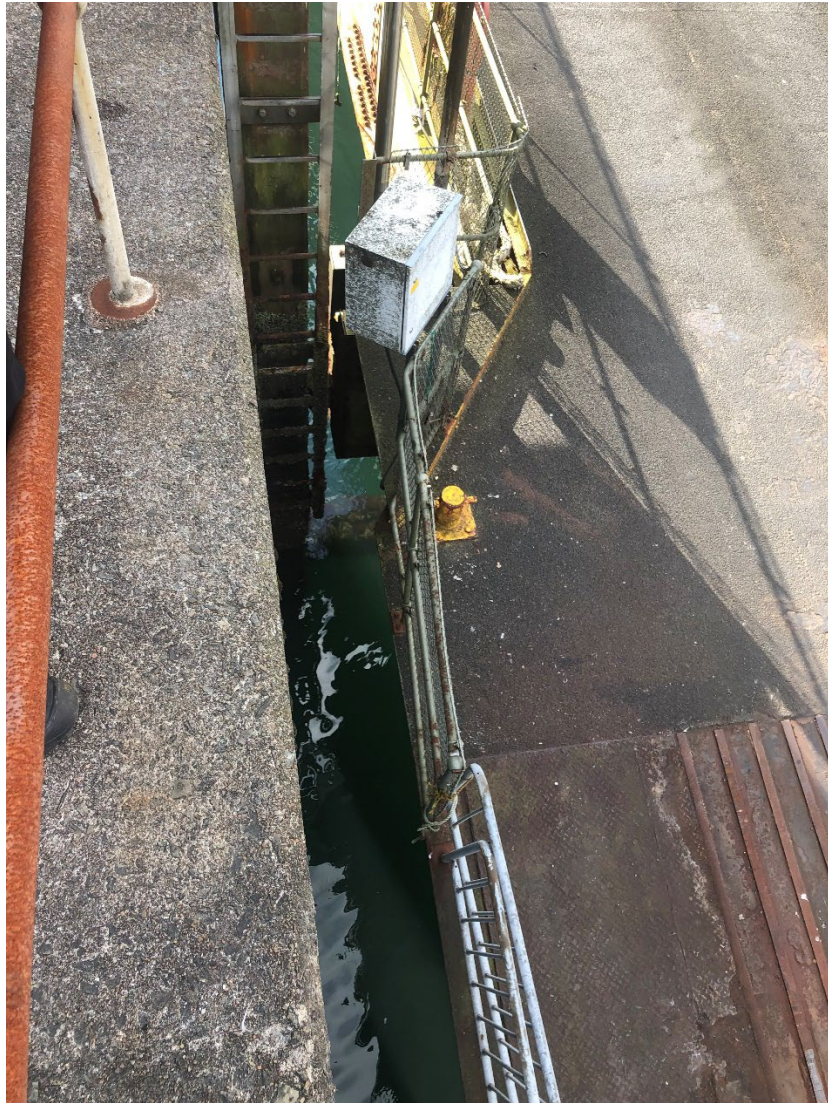
Reference	Subject	Evidence Required For Compliance	Observation	Recommendations	Auditor
PMSC 3.0 GtGP 8.11.19 ACOP 207-208 SIP 014	Access	Is the quayside and its access locations clear of debris and obstructions?	Satisfactory – the Craignure Pier was free from debris and trip hazards. There was good signage for the jetty.		HJA/SRB
		Pedestrian/Disabled access for passengers or leisure users?	Satisfactory – pedestrian walkways were clearly marked.		HJA/SRB
		Is the type and condition of quayside surface appropriate to the operation?	Satisfactory – the pier was in generally good condition and surface is appropriate to its intended use.		HJA/SRB
ACOP 211-223 SIP 014	Rescue and Lifesaving equipment (LSE) at the water's edge	Is there appropriate means of egress from the water?	Satisfactory – access and egress ladders were installed at appropriate distances along the pier.		HJA/SRB
		Is there appropriate LSE at quay edge?	Satisfactory – adequate lifesaving equipment (life rings) were installed along the pier. Observation – some of the ladders do not continue below the waterline. See Image B1. Observation – some ladders located at the pier end were missing handrails and/or grab loops at deck/cope level. See Image B2.	Recommendation – ladders should be replaced with ones that extend to at least 1 m below the low water mark. Recommendation – ladders with missing handrails or grab loops should have these fitted to assist ladder users reach the pier deck.	HJA/SRB

Image B1. Craignure, ladder does not extend below waterline

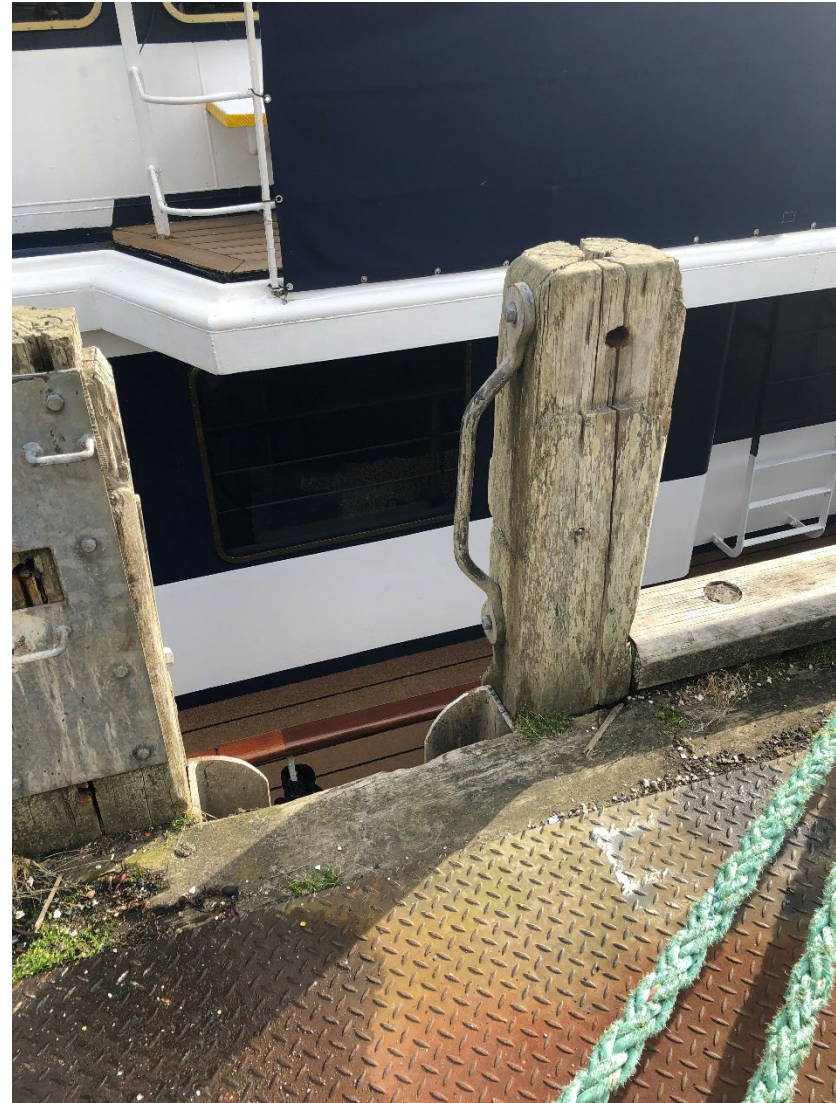
Image B2. Craignure, ladder with missing handrails or grab loops

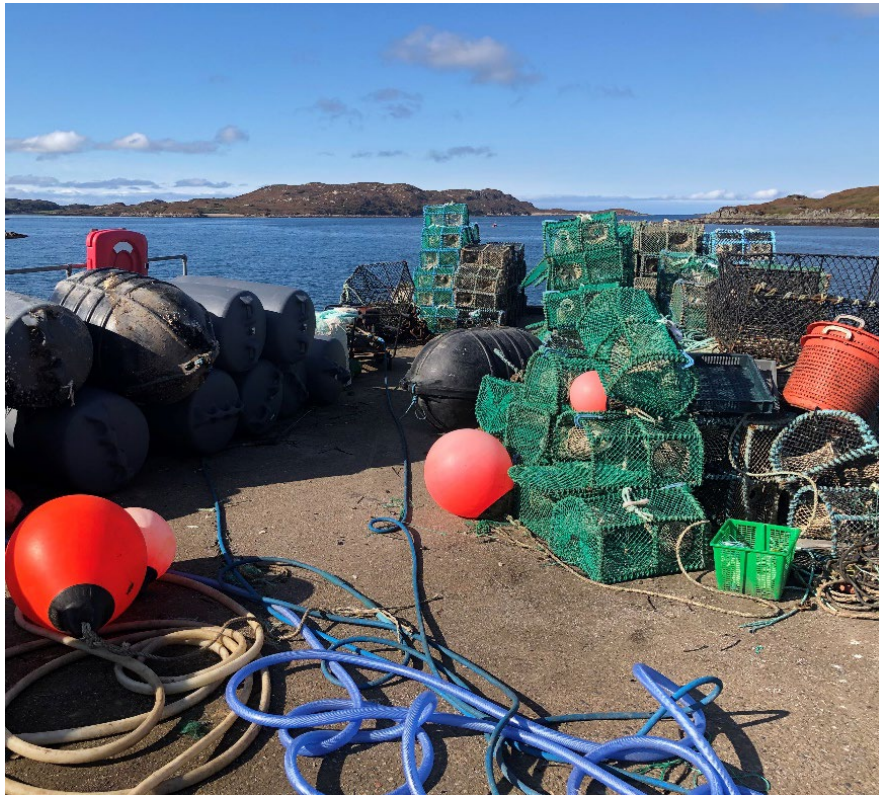
- At Bunessan, housekeeping was noted to be poor with disused ropes hanging off the pier and a substantial amount of stored and/or abandoned fishing equipment. This equipment obstructed access to safety equipment and water egress ladders.

Reference	Subject	Evidence Required For Compliance	Observation	Recommendations	Auditor
PMSC 3.0 GtGP 8.11.19 ACOP 207-208 SIP 014	Access	Is the quayside and its access locations clear of debris and obstructions?	Observation – housekeeping was considered to be poor. There were disused ropes hanging off the pier and there was a substantial amount of stored and/or abandoned fishing equipment, ropes, pots and other fishing items along the pier. See Image B3.	Recommendation – users of the pier and harbour staff should remove unused items, dispose of old fishing gear in a responsible manner and provide housekeeping to ensure the pier can be used free of trip hazards. Any ropes or unwanted fishing gear can become an entrapment hazard for wildlife, pier users and contribute to ghost fishing ¹ .	HJA/SRB
			Observation – obsolete (rusting) metal lifting equipment fixed to the pier presented a trip hazard. See Image B4.	Recommendation – lifting equipment should be removed if no longer in use.

Image B3. Bunessan, trip hazards and obstruction to steps.

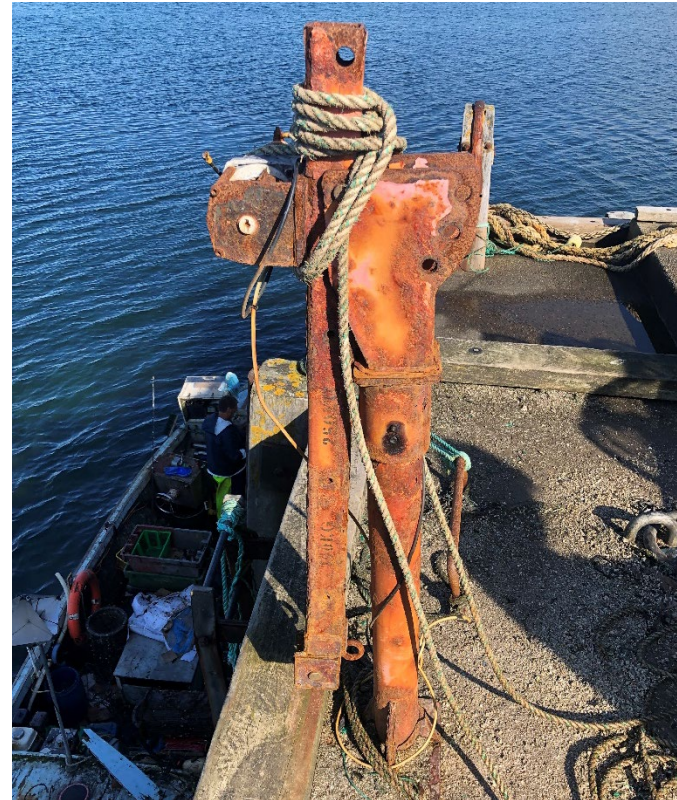
Image B4. Bunessan, obsolete lifting equipment (trip hazard)

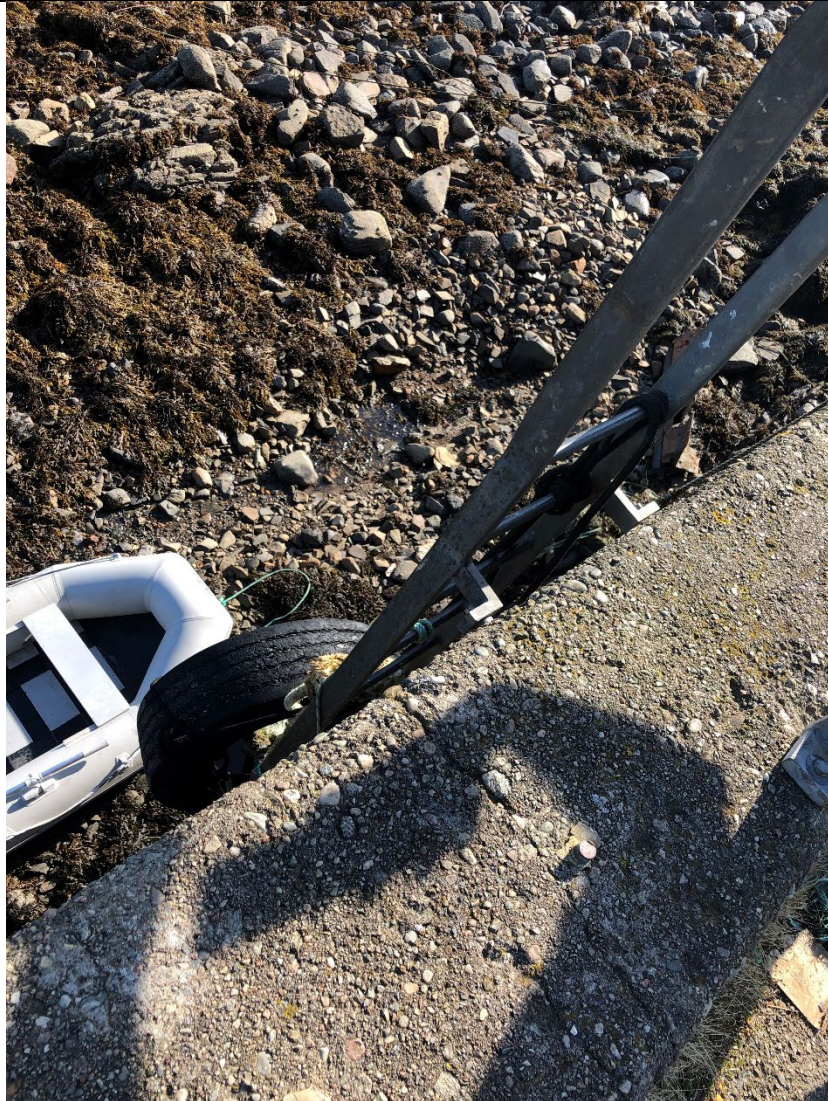
Observation – ropes and tires were tied to ladders impeding use. See Image B5 .	Recommendation – clear all ropes and obstructions from ladders.	
		Is there appropriate LSE at quay edge?	Satisfactory – the pier had adequate numbers of life rings fitted to the handrails.		HJA/SRB
			Observation – one life ring was found to be in a deteriorated state. See Image B6.	Recommendation – inspection and renewal of the life ring and the commencement of a regular inspection regime.

Image B5. Bunessan, tires and ropes affixed to ladders

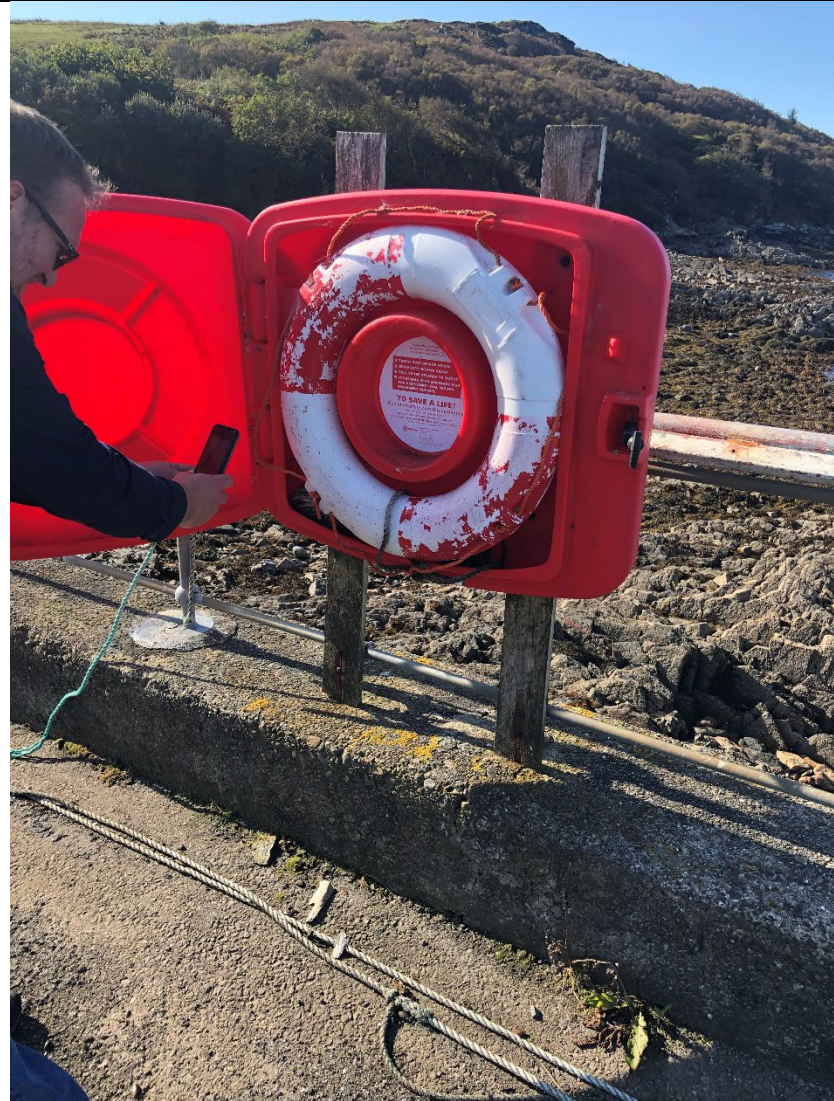
Image B6. Bunessan, life ring

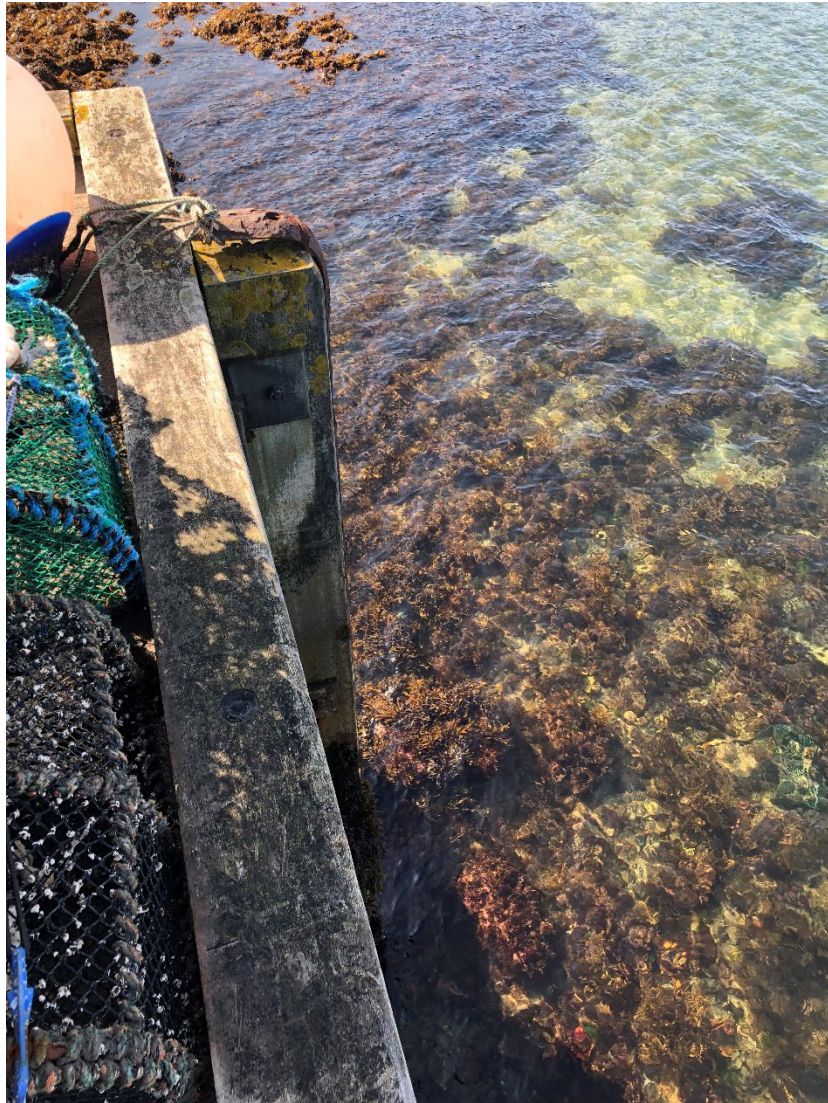
Image B7. Bunessan, wooden fendering in disrepair

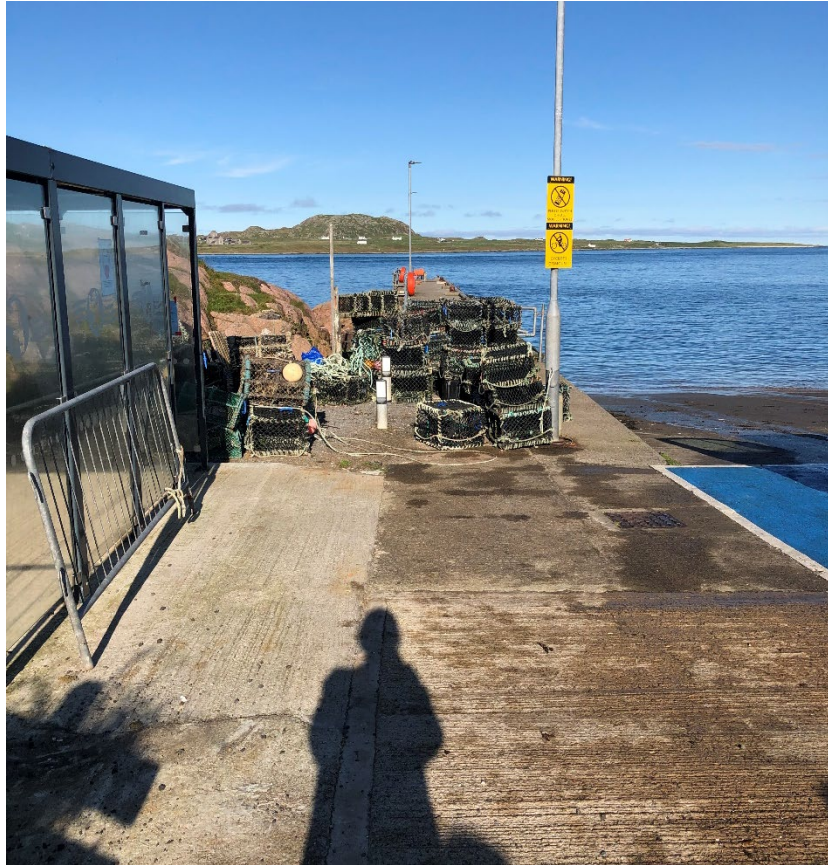
Reference	Subject	Evidence Required For Compliance	Observation	Recommendations	Auditor	
PMSC 3.0 GtGP 8.11.19 ACOP 207-208 SIP 014	Access	Is the quayside and its access locations clear of debris and obstructions?	<p>Satisfactory – the pier and slipway were generally clear of debris and all fishing pots were neatly stacked to the side.</p> <p>Observation – fishing pots were neatly stacked blocking access to the pier presenting a trip hazard. See Image B8.</p> <p>Observation – the gate to the pier was tied shut, and CalMac ferry employees were witnessed jumping around the gate rather than going through it.</p> <p>Observation – there were a couple of raised metal eyelets that presented trip hazards and were not marked with a bright and notable colour.</p>	<p>Recommendation – pier should be easily accessible and fishing pots should be moved.</p> <p>Recommendation – gate should be locked to prevent public access; however gates should be accessible to pier operatives/ferry staff to allow them access to the restricted area.</p> <p>Recommendation – eyelets are either painted or removed if no longer useful.</p>	HJA/SRB

Image B8. Fionnphort, access to pier blocked by fishing pots

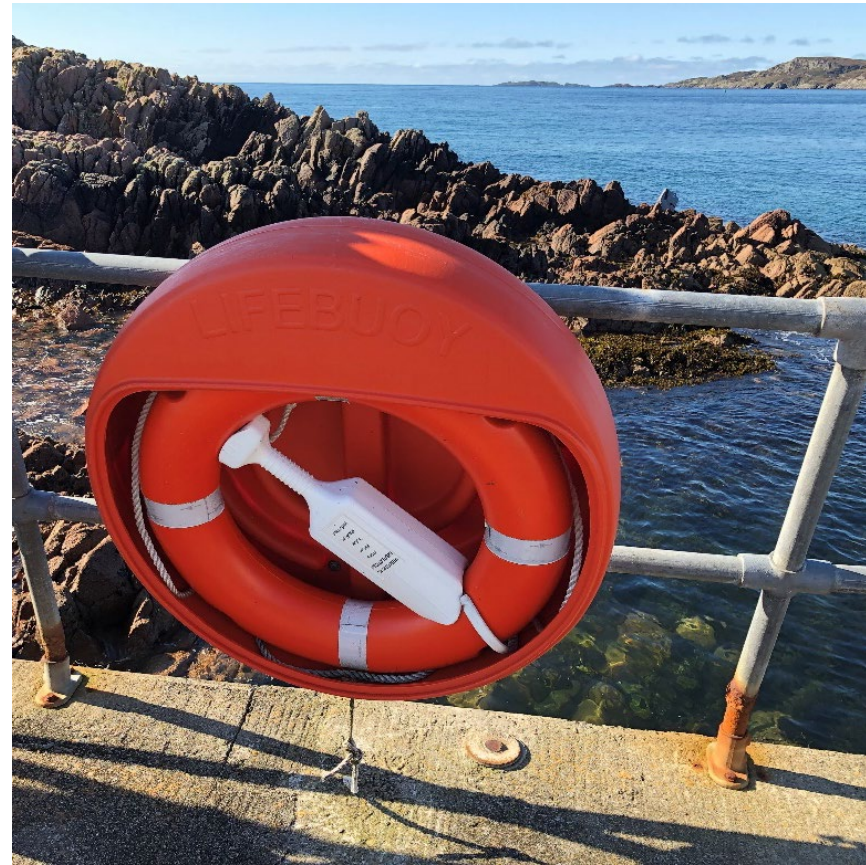
Pedestrian/Disabled access for passengers or leisure users?	Satisfactory – walkways were clearly marked for pedestrians and cars accessing the ferry via the slipway.			HJA/SRB
		Is the type and condition of quayside surface appropriate to the operation?	Satisfactory – the pier and slipway were generally in good condition and free of marine growth. There were a few small potholes.			HJA/SRB
ACOP 211-223 SIP 014	Rescue and Lifesaving equipment (LSE) at the water's edge	Is there appropriate means of egress from the water?	Satisfactory – there were an adequate number of access and egress ladders installed.		HJA/SRB	
		Is there appropriate LSE at quay edge?	<p>Satisfactory – Life saving equipment (life rings) were installed at the appropriate distances along the pier.</p> <p>Observation – one life ring was missing its cover. See Image B9</p>	Recommendation – life ring cover should be replaced.	HJA/SRB

Image B9. Fionnphort, life ring missing cover

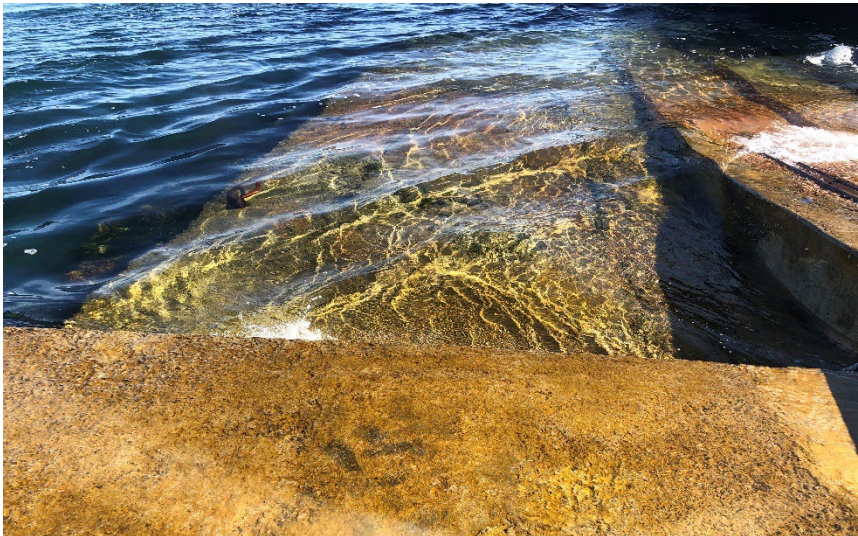
Is the type and condition of quayside surface appropriate to the operation?	Satisfactory – the slipway was generally in good condition and free of marine growth. Observation – the ferry slipway had some obvious potholes and was considered to be in need of surface maintenance. Observation – the surface of the bottom of the small vessel slip was poor and uneven. There was also a reasonable sized step, that was not marked. See Image B10.	Recommendation – ferry slipway surface should be reviewed, and repair arranged if trip hazards are identified. Recommendation – the small vessel slipway surface is repaired, and the step is incorporated into a slope or marked.	HJA/SRB
ACOP 211-223 SIP 014	Rescue and Lifesaving equipment (LSE) at the water's edge	Is there appropriate means of egress from the water?	Satisfactory – there was an access ladder fitted on to the ferry slipway. Observation – a rope is used to help prevent an accidental fall from the top of the ladder. See Image B11	Recommendation – a suitable karabiner and wire (stainless steel) is used to replace the rope, allowing safe access to and from the ladder when required.	HJA/SRB

Image B10. Iona, small vessel slipway step and poor quality surface

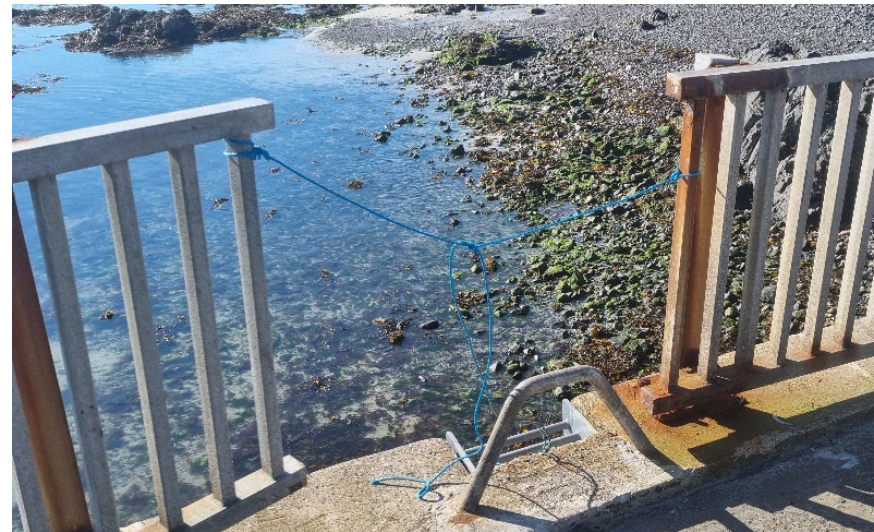
Image B11. Iona, access ladder is blocked by rope
