Port Riddell Condition Report and Initial Option Development

June 2023

Argyll and Bute Council
Kilmory
Lochgilphead
Argyll
PA31 8RT

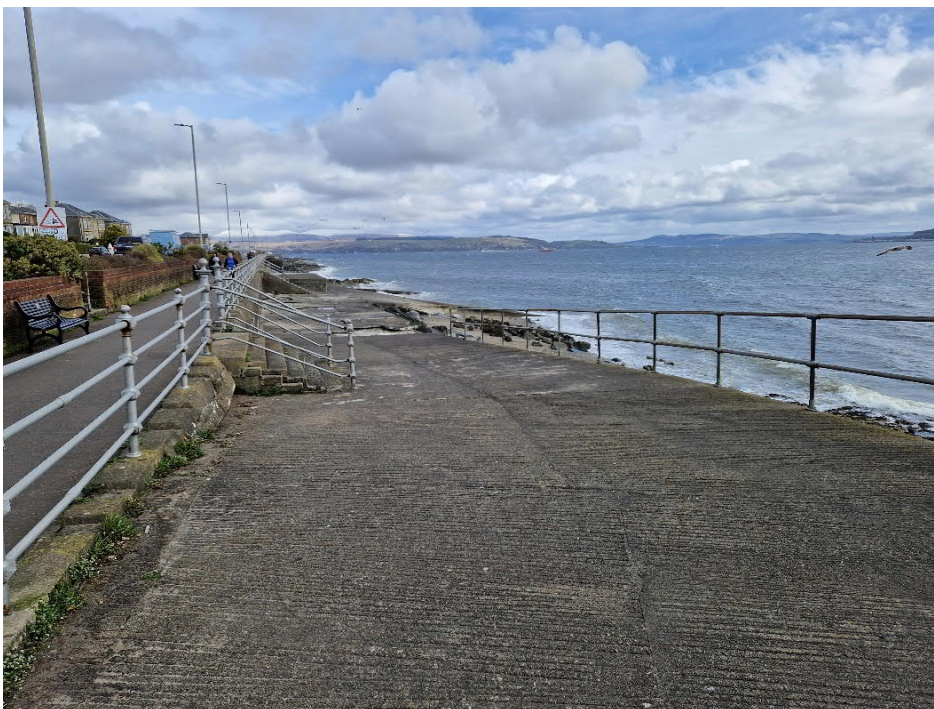
Figure 2: Approach Ramp and Parking Area

There is a small set of steps approximately 10m from the head of the access ramp, with railings either side. These steps narrow the width of the access ramp by approximately 2m and would prohibit two-way traffic on the ramp.

There is handrailing on the seaward side of the access ramp that terminates approximately 2m from of the base of the ramp.

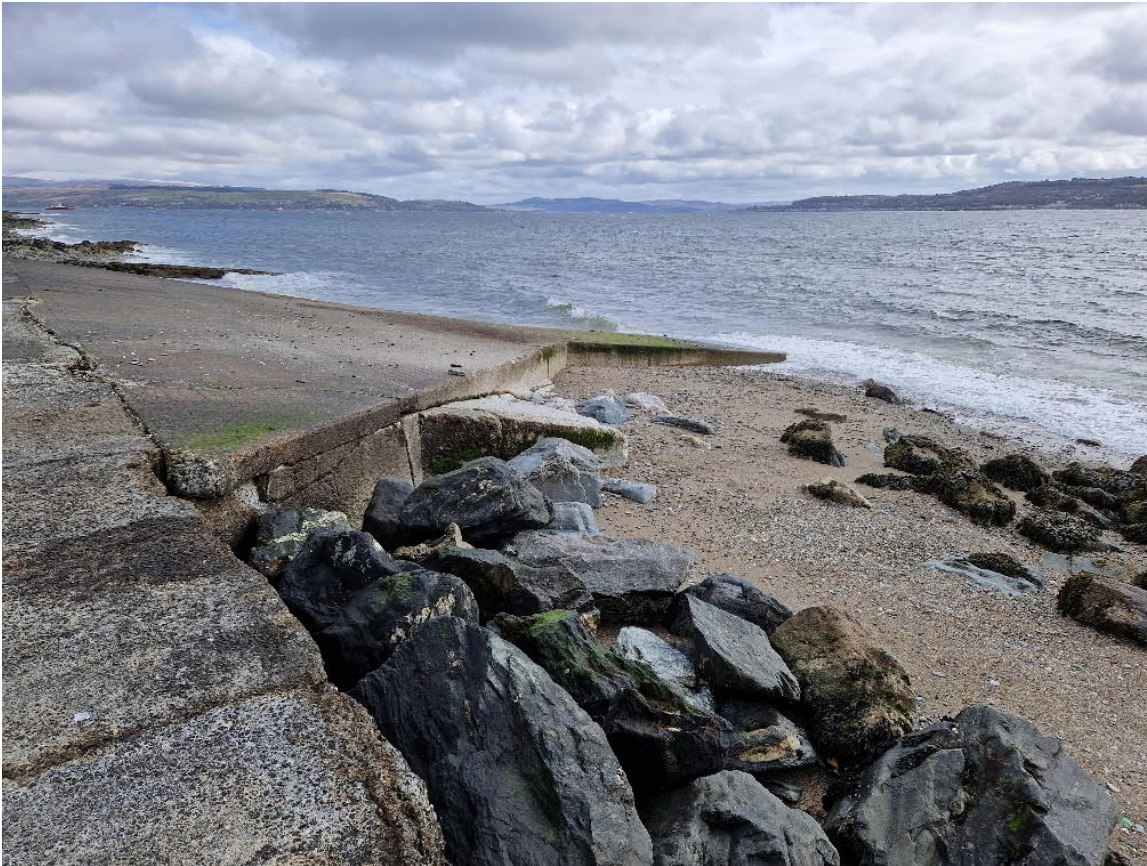
Figure 4: Concrete Slipway

Anecdotally, A&BC advise that the current slipway gradient is acceptable, however the slipway is currently too narrow and abruptly ends, therefore it is considered unsafe to launch/recover small craft.

The slipway appears in fair condition with no undermining of the structure visible on either side of the slipway or the apron during MML's walkover.

- Widen the existing slipway by 1.5m, and
- Extend the existing slipway by 5.0m.

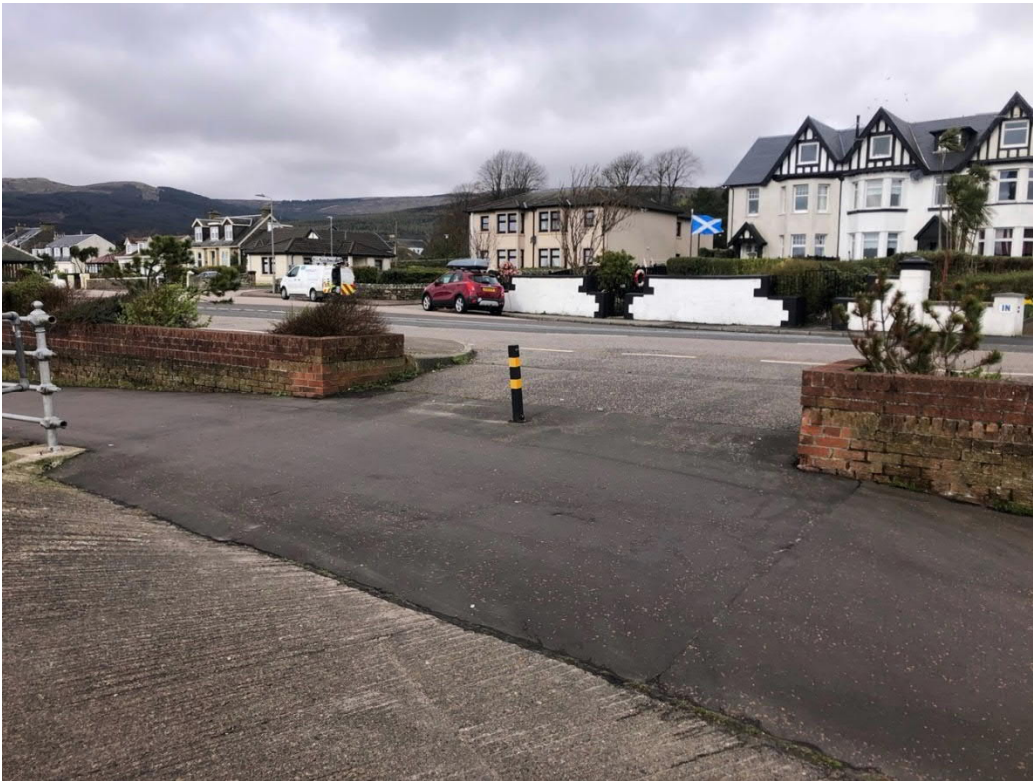
Figure B 1: Entrance from A815

The access ramp is approximately 7.2m wide and 30m long. Vehicular access to the ramp is currently restricted by a traffic bollard and the route passes over the public promenade, as shown in the photograph in Appendix B.1. The entrance to the access ramp from the A815 is narrowed by low-level brick walls, also shown in the photo in Appendix B.1.

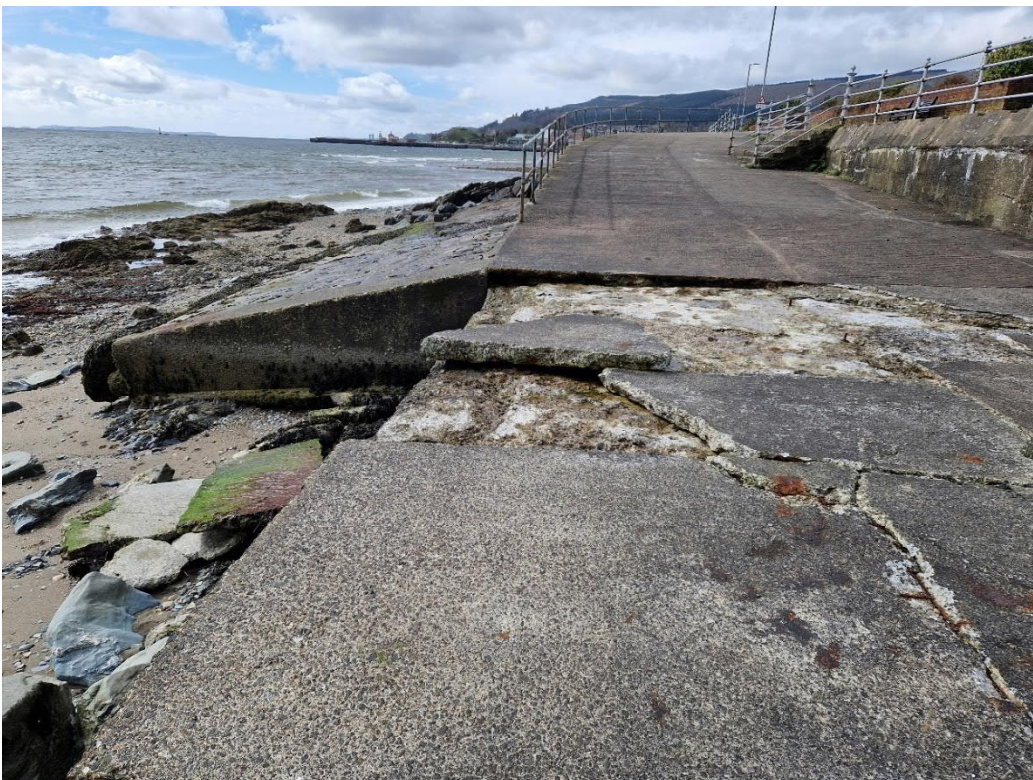
Figure B 2: Paved revetment and access ramp

The vertical wall to the seaward side of the access ramp is protected by rock armour at the toe of the structure, and then by a section of formal revetment with stone pitching at the base of the ramp, as can be seen in the photograph in Appendix B.2. The pitching appears to be in fair condition; however, mortar loss is observed between the paving stones and the toe of the revetment is some distance above the beach level; this may be due to a number of reasons including: seasonal or storm related beach mobility, local scour around the manmade hard structures etc.

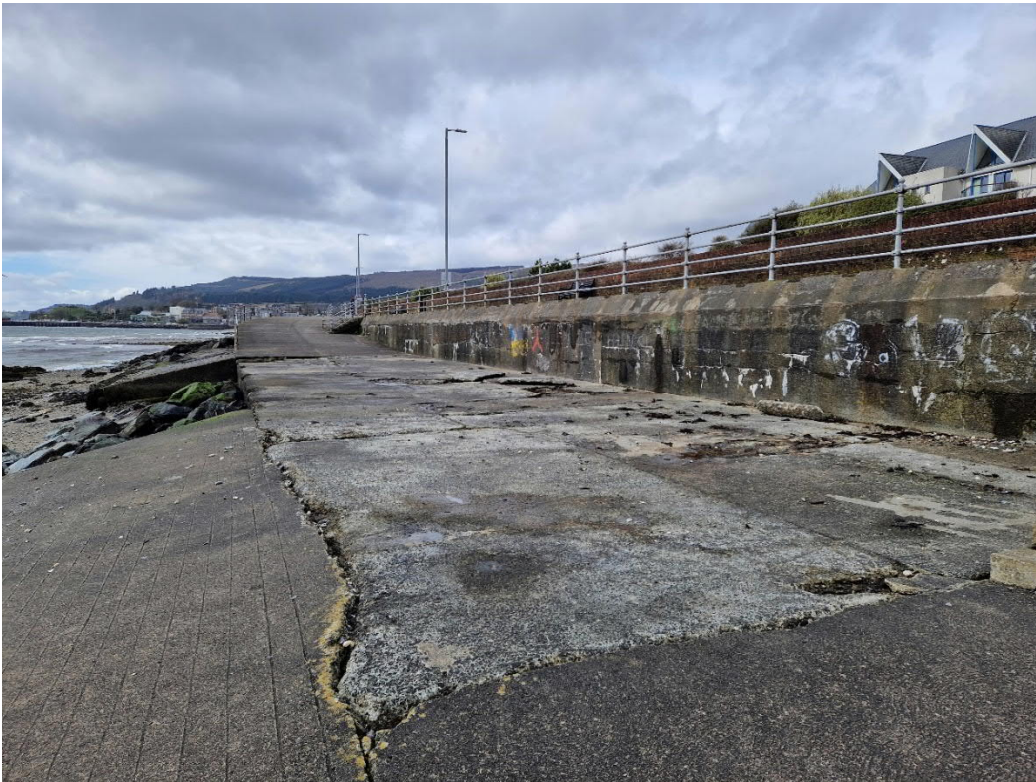
The concrete slab to the parking area is in poor condition with large areas of broken and dislodged concrete, rebar exposed and cracking of the concrete visible. These defects are observed over the majority of the surface and can be seen in Appendices B.2 and B.3.

At the beach, the seaward face of the concrete structure does not appear to be undermined; however, cracks, spalled concrete and voids are observed on the vertical face. The joint between the seaward face of the wall and the concrete slab to the parking area has widened over time, allowing seawater below the slab, potentially worsening the condition of the structure. This can be seen in the photograph in Appendix B.3.

The joint between the slipway apron and the parking area has widened, with voids visible in the wall at the corner of the apron, show in the photograph in Appendix B.3.

Figure B.3: View of broken deck slabs at parking area, joint with head of slipway

- Repair the parking area slab,
- Repair the parking area rear wall,
- Repair the parking area seaward wall,
- Repair the corner of the walkway wall at the beach access steps, and
- Replace the missing blocks at the changing rooms to block them off.

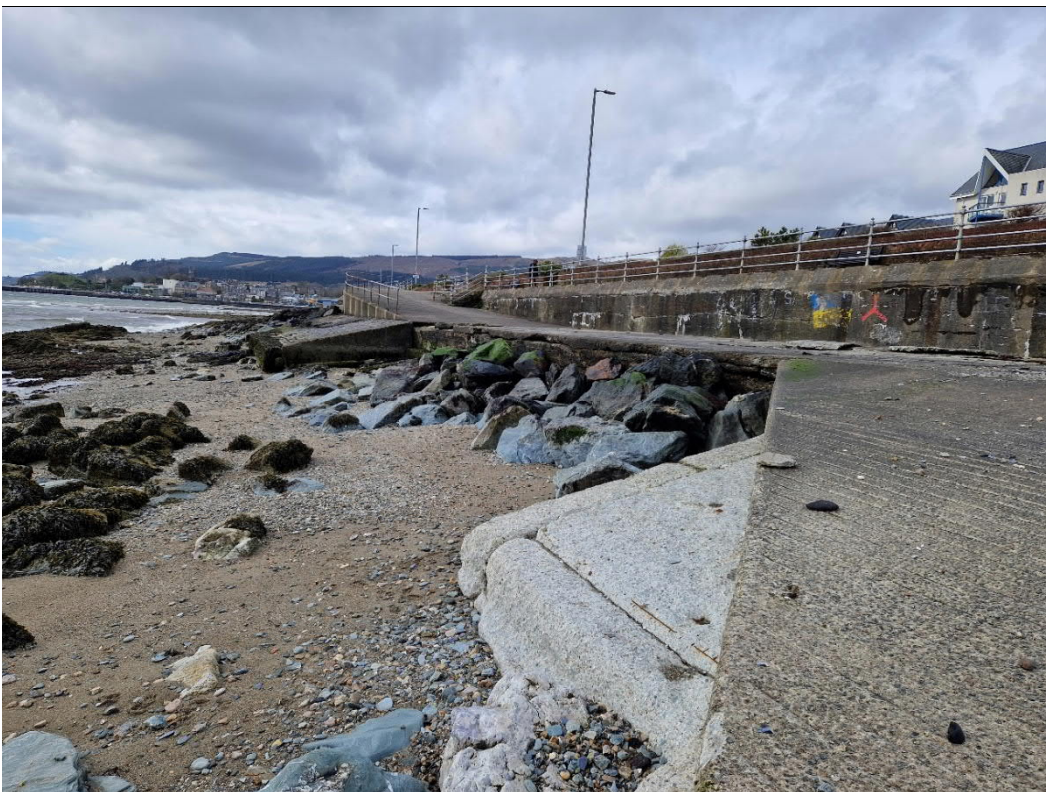
Figure B.4: Rock armour in front of parking area

The parking area at the head of the slipway is approximately 7.2m wide x 30m long and comprises a concrete slab that is raised approximately 1 – 1.5m above the current beach level. There is scattered rock armour placed in front of the parking area, as can be seen below and in the photographs in Appendix B.2 and B.4.

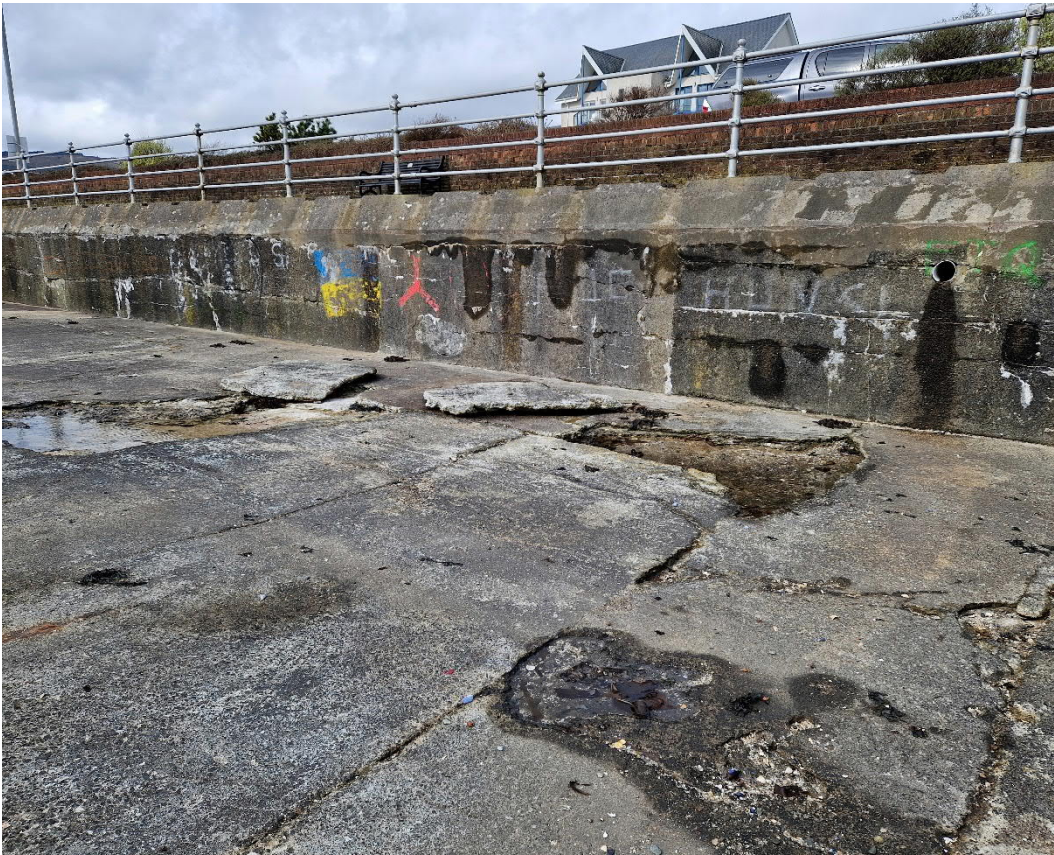
To the rear of the parking area, there is a concrete wall, approximately 2.5 – 3.0m high, which retains the public promenade. This wall has various horizontal cracks along its length, with small areas of concrete spalling around the cracks, this can be seen in the photograph in Appendix B.5. This rear wall is also within the splash zone, with potential corrosion of any reinforcement within the concrete; however, this was not visible during MML's walkover.

There is a drainage pipe, assumed to be a surface drainage pipe from the promenade above, that discharges directly onto the parking area, also shown in the photograph in Appendix B.5.

Figure B.5: Wall to the rear of the parking area

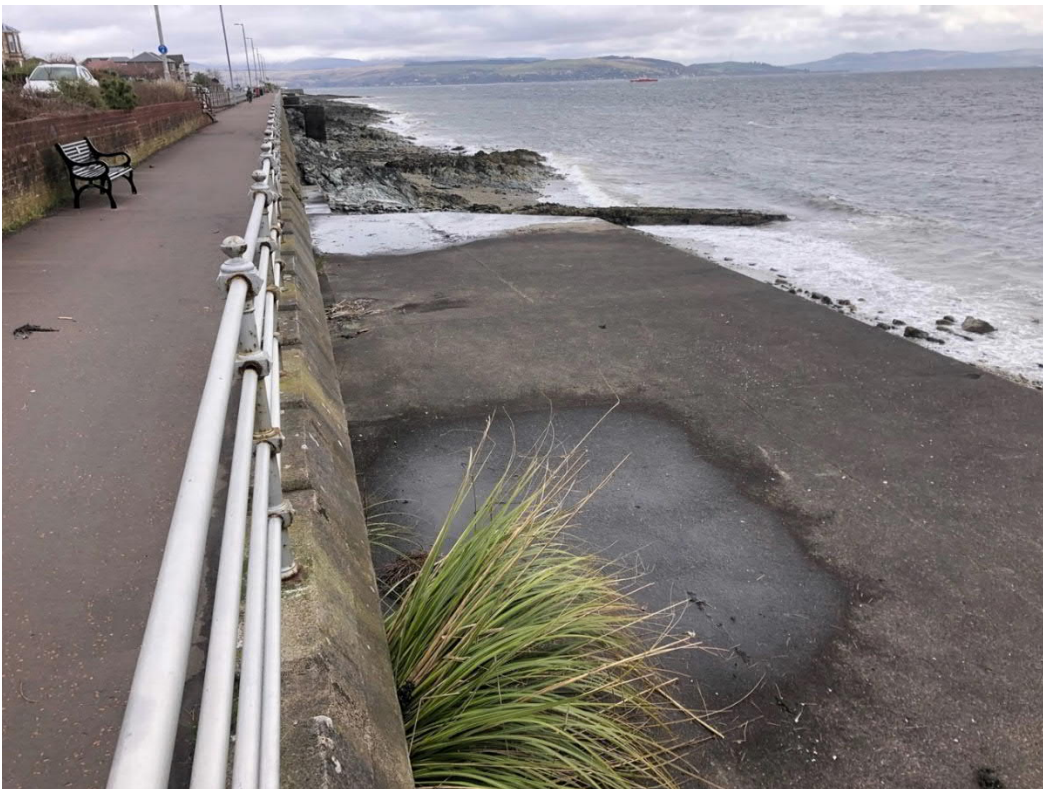
The parking area is bound to the east by the historic concrete bathing area / lido. The bathing area has been capped with a concrete slab, and potentially infilled. This can be seen below and in the photograph in Appendix B.6.

There are cracks present around the bathing area walls, some of which are potentially joints that have widened over time. Similar to the vertical wall at the access ramp, the structural form is unknown and could be masonry with a protective facing – with cracks following the bedding joints. Alternatively, the cracks could be associated with cold joints as concrete was placed in layers.

There are also some gaps in the seaward wall of the bathing area that have been filled with what is assumed to be timber. It is assumed that these were originally associated with water inlets/drainage infrastructure from the bathing area.

There are two drainage outfalls that discharge directly onto the concrete cap of the bathing area. This discharge then flows over the bathing area and down onto the walkway towards the Victorian changing rooms, leading to an accumulation of algae/marine growth at the top of the steps to the beach. This is shown in the photograph in Appendix B.11. This is noted as a health and safety hazard as the algae/marine growth is extremely slippery and makes the steps unsafe for use.

Figure B.6: View of capped bathing area from above

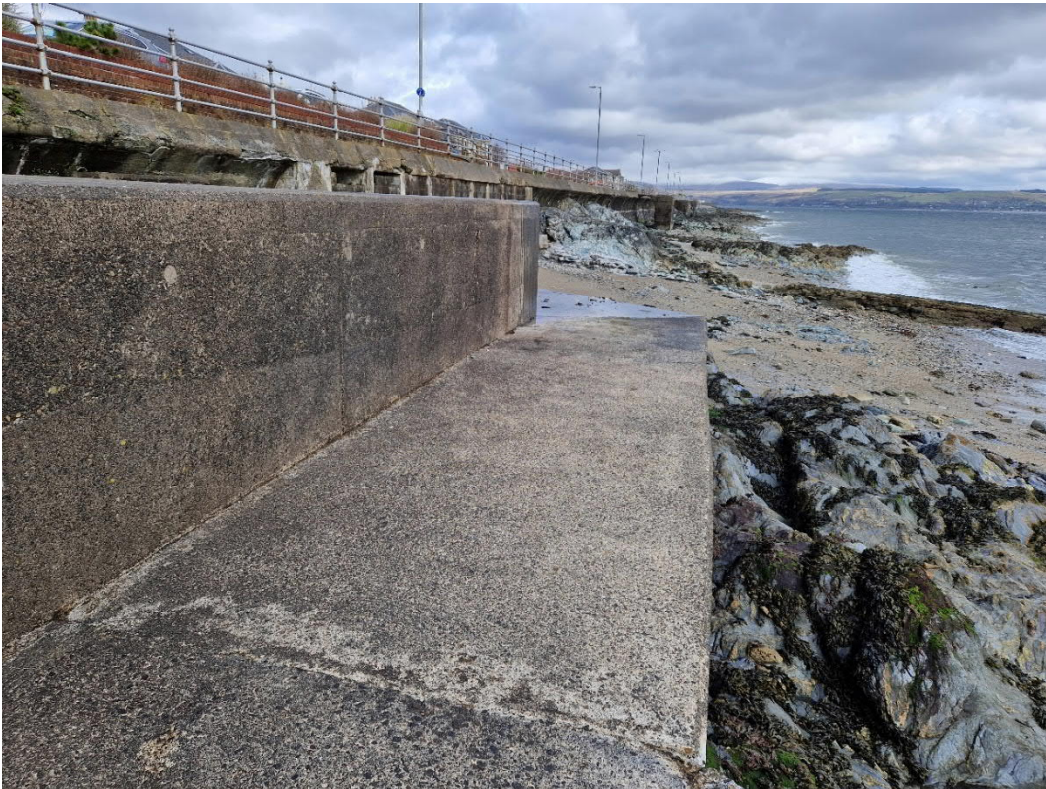
The exposed edge of the concrete roof slab above the changing rooms varies in condition along the length. There are sections with spalling concrete, large cracks and portions missing, as shown in the photograph in Appendix B.10.

The walkway in front of the changing rooms appears in good condition with the exception of the corner nearest the steps down to the beach. This section appears to be undermined where the steps meet the wall and voids are present here. The voids were not measured due to the presence of large amounts of algae and seaweed on the steps making them unsafe. This is shown in the photographs in Appendix B.10 and B.11.

Figure B.10: Walkway in front of Victorian changing rooms
