# **Port Marine Safety Code**

Audit: Isle of Islay (Port Askaig, Bruichladdich, Port Charlotte) 2023

January 2024

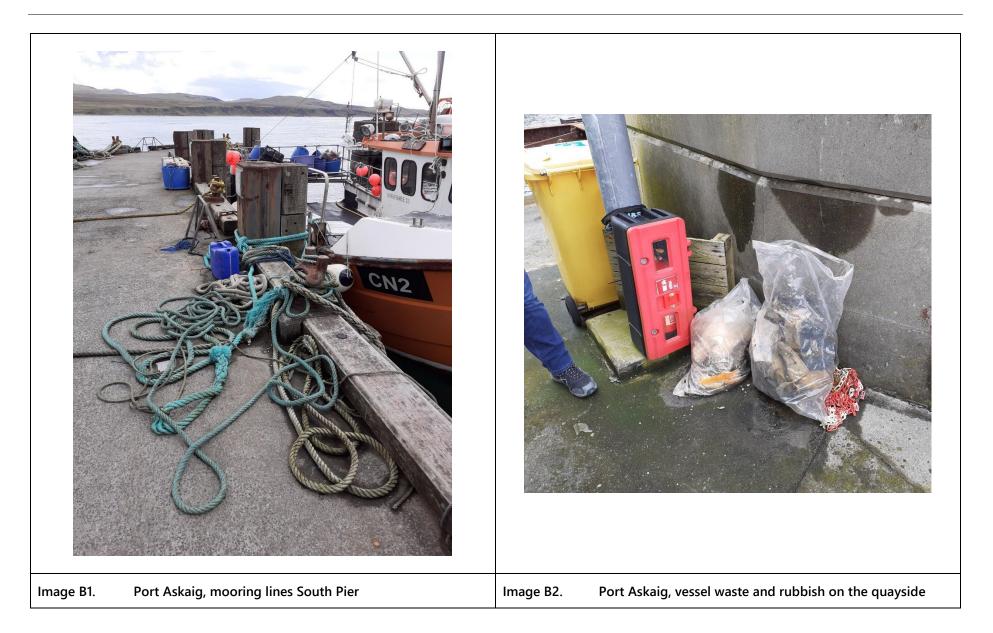
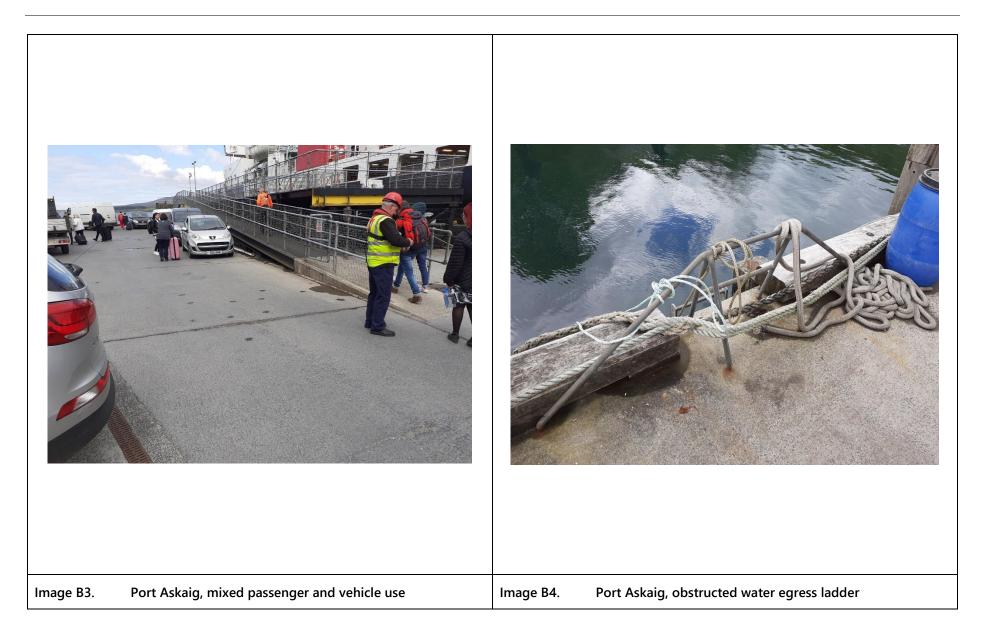
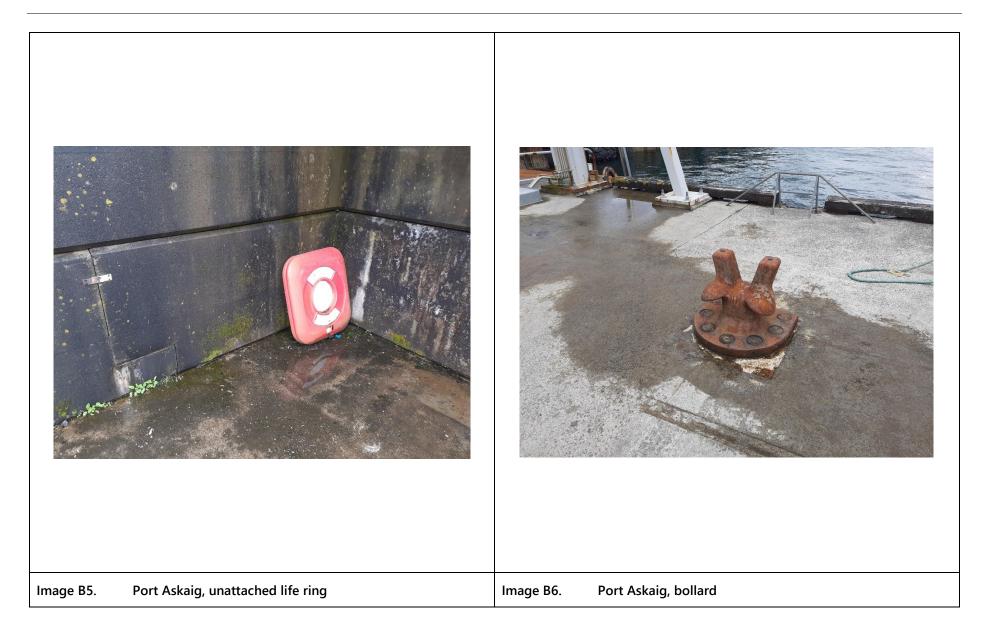
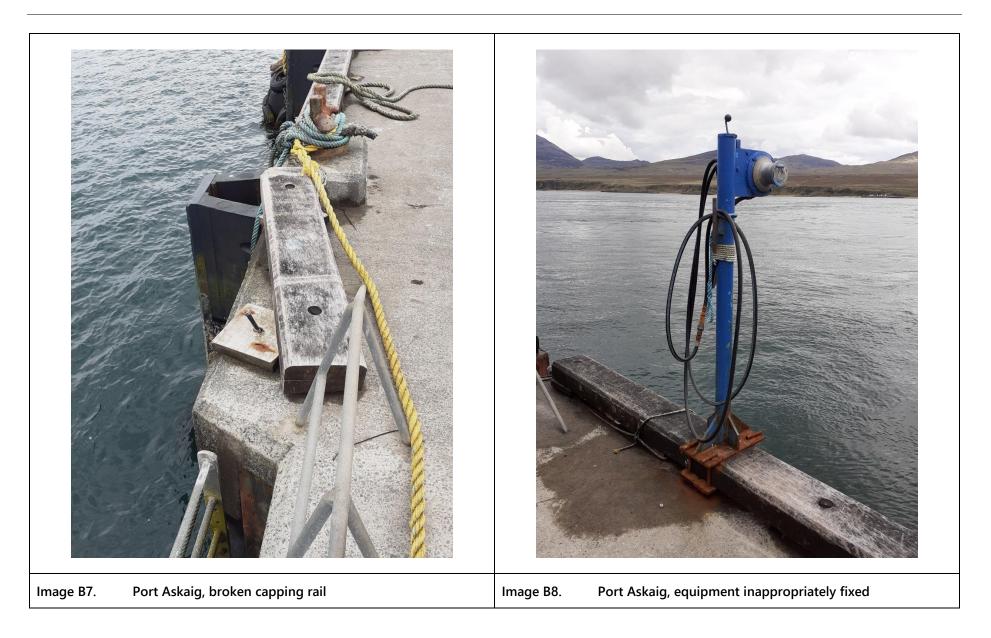
Reference	Subject	Evidence Required For Compliance	Observation	Recommendations	Auditor
PMSC 3.0 Access GtGP 8.11.19 ACOP 207-208 SIP 014	Is the quayside and its access locations clear of debris and obstructions?	<b>Satisfactory</b> – Port Askaig is comprised of a north basin used mainly by fishing vessels, the main (ferry) berth and the Jura Ferry Slipway, with a southern Pier forming the southern basin. The lifeboat berths at a dedicated facility to the south of the port. Generally, the port infrastructure is of good quality with quayside areas appropriate to their use.		MJS	
			Observation – at the time of the quayside checks, there were numerous mooring lines causing obstruction along the southern Pier. In a number of locations, vessel waste and other general rubbish was left on the quayside. See Image B1 and B2.	Recommendation – housekeeping should be improved with vessel Masters required to remove unnecessary lines from quayside areas and waste from vessels removed or disposed of properly.

Pedestrian/Disabled access for passengers or leisure users?	Satisfactory – walkways were generally clear of obstructions with footpaths and vehicle marshalling areas for both the CFL ferry and Jura ferry.		MJS
			Observation – in several locations, due to the amount of available space and port road layout, both pedestrians and vehicles use the same area. This was especially noted when the CFL Ferry passenger embarked and disembarked, with vehicles dropping off or collecting foot passengers passing close to, and around queuing passengers. See Image B3.	Recommendation – the Health and Safety Executive (HSE) publication L148 'Safety in Docks: Approved Code of Practice and Guidance' (ACOP) (HSE, 2014) Section 58 to 72 'Safe site – design and activity' provides the requirements for designing and operating pedestrian and vehicle assess. The layout of Port Askaig should be considered in light of the ACOP with the aim of removing risks to pedestrians from moving vehicles associated with ferry traffic.

Reference	Subject	Evidence Required For Compliance	Observation	Recommendations	Auditor
SIP 014 Life equ	Rescue and Lifesaving equipment (LSE) at the water's edge	Is there appropriate means of egress from the water?	Satisfactory – the Piers and quayside areas had good quality and appropriately spaced water egress ladders, with grab rails fitted at deck level.		MJS
	the mater's cage		Observation – some of the water egress ladders were obstructed by mooring lines, this was noted on the south Pier. See Image B4.	Recommendation – housekeeping should be improved with vessel Masters required to remove mooring lines from water egress ladders.	
		Is there appropriate LSE at quay edge?	Satisfactory – Life saving equipment (life rings) were installed along all Piers and quayside.		MJS
			<mark>Observation</mark> – not all life rings were fixed. See Image B5.	Recommendation – life rings should be checked on a routine basis with any damaged items repaired or replaced.

SIP 005	Bollards and securing equipment	Does the general condition of bollards appear to be in good order?	Satisfactory – the bollards along the Piers are (visually) in good condition.		MJS
			Observation – the quay bollards were not numbered, or Safe Working Loads (SWL) identified. See Image B6.	Recommendation – bollards and bits are inspected, numbered and SWL added.	
SIP 005	Fenders	Is the fendering appropriate to the vessel being handled?	Satisfactory – fendering on the Pier is vertical rubber sections on timber, the condition of which is considered to be good from visual observation. In other areas, the fendering is wood vertical sections with some tyres used for fishing vessels and workboat berths.		MJS
		Is the condition of the fendering in good order?	Satisfactory – fitted fendering was observed to be in serviceable condition.		MJS
		Are chaffing plates used?	Satisfactory – wooden beams/toe rails are used along the Pier edge as protection from lines chaffing on the quay and also double as barriers to prevent items being knocked off the Piers onto vessels moored below.		MJS

Observation – the wooden beams/toe rails along the southern Pier has some sections that had sustained damage. See Image B7. It was also noted that equipment may have been installed at the Pier that was causing damage to wooden sections. See Image B8. The attachment of this item had caused the wooden beam to loosen.	Recommendation – that inspection and maintenance of quayside beams/rails is conducted. Any equipment fitted to the Pier should be fitted in such a way as to prevent damage to infrastructure.

- At the time of the quayside checks, there were numerous mooring lines causing obstruction along the southern Pier. It is recommended that housekeeping is improved with vessel Masters and owners required to remove unnecessary lines from quayside areas.

- In several locations, due to the amount of available space and port road layout, both pedestrians and vehicles use the same area. This was especially noted when the CFL Ferry passenger embarked and disembarked, with vehicles dropping off or collecting foot passengers. It is recommended that a review of the layout around the ferry berth is conducted with reference to the Health and Safety Executive (HSE) publication L148 'Safety in Docks: Approved Code of Practice and Guidance' (HSE, 2014) Section 58 to 72 'Safe site design and activity'.

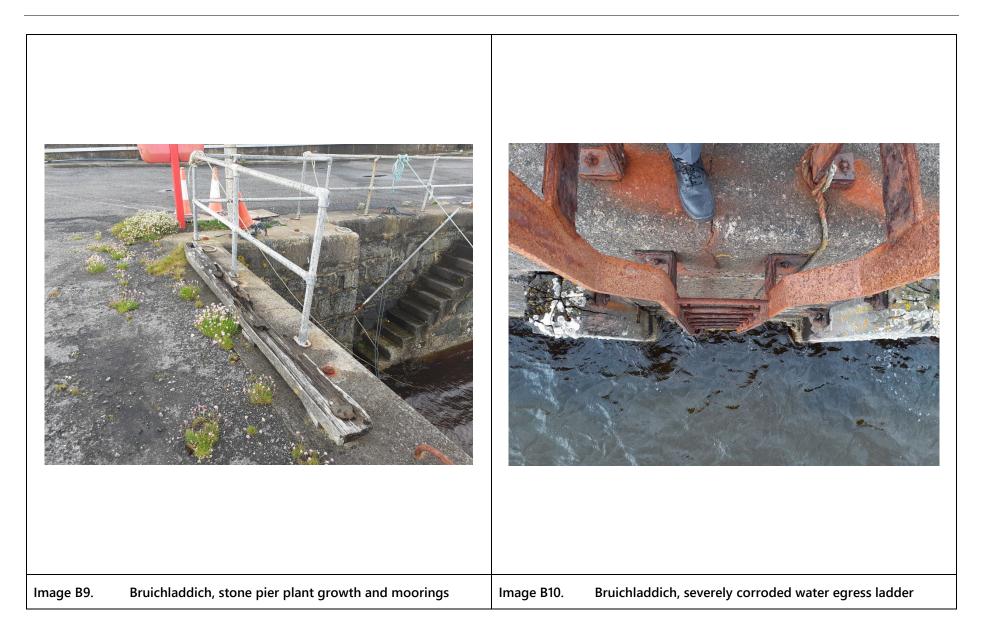
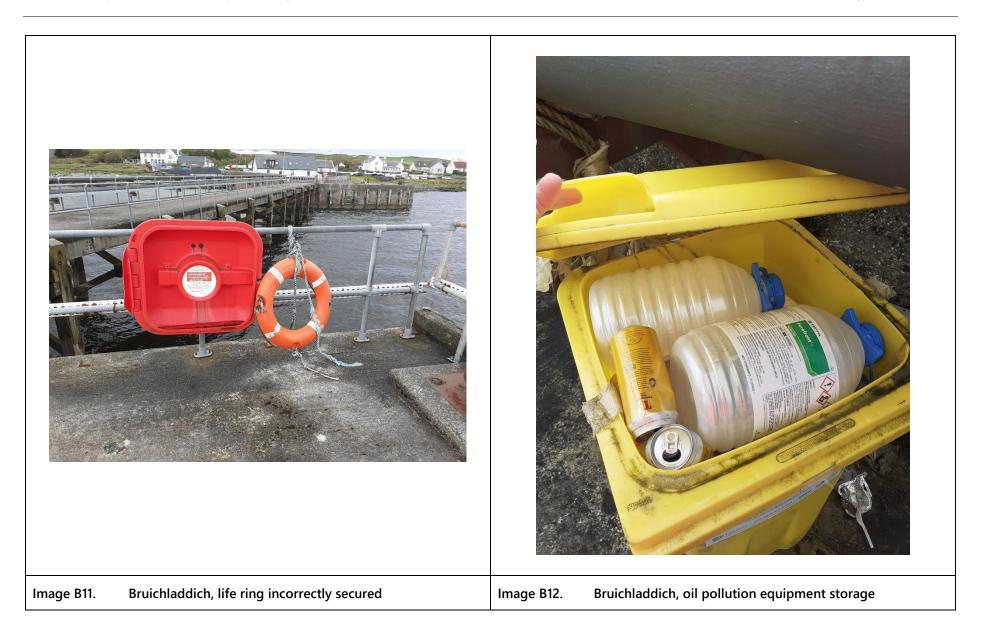
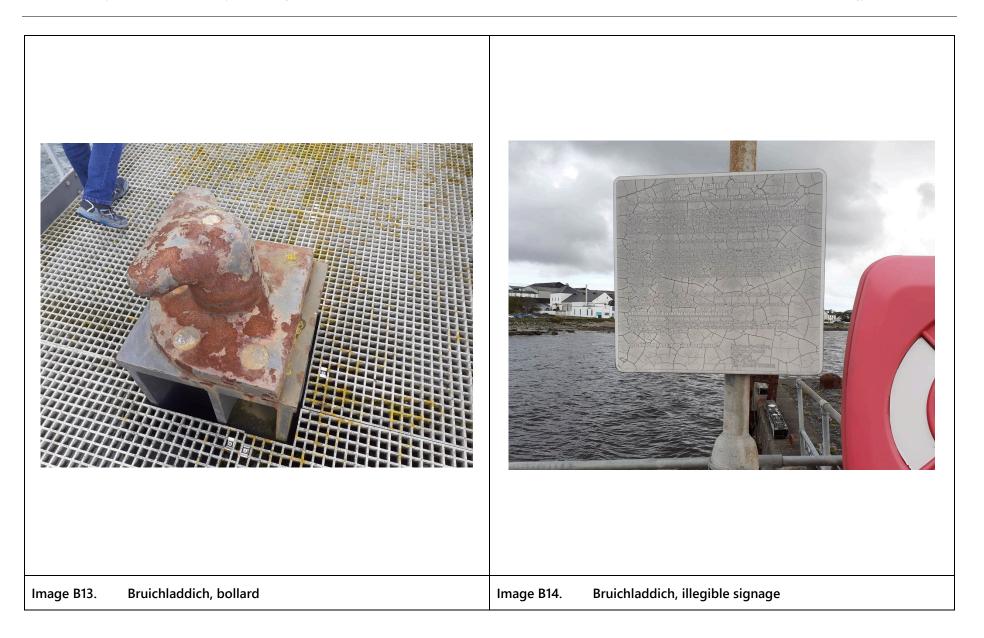
Reference	Subject	Evidence Required For Compliance	Observation	Recommendations	Auditor
PMSC 3.0 Access GtGP 8.11.19 ACOP 207-208 SIP 014	Access	Is the quayside and its access locations clear of debris and obstructions?	Satisfactory – the quayside is comprised of an original stone pier used by the local community and inshore fishing vessels, leading to a new jetty with eight mooring dolphins connected by walkways. The new pier and dolphins are clear of debris and obstructions with access controlled through security gates.		MJS .
			Observation – the common user stone Pier had a number of mooring lines obstructing the stone steps used to access and egress the launch point and water, the quayside also had an amount of plant growth which could present a slip or trip hazard. See Image B9.	Recommendation – housekeeping on the stone pier is improved with redundant mooring lines removed and plant growth removed from the pier surface.

Observation – not all life rings were in a serviceable condition and housed correctly. See Image B11.	Recommendation – life rings should be checked on a routine basis with any damaged items repaired or replaced.	
			Observation – some of the oil pollution response equipment storage bins had been used for waste. See Image B12.	Recommendation – oil pollution response equipment storage should be checked, and any unnecessary items removed.

Are chaffing plates used?	Satisfactory – metal tubular rails are used along the outer edge of the new Pier to allow mooring lines to run over them without fouling or chaffing. Chaffing plates or wooden sections are not used on the original Pier.		MJS
ACOP 232-235 SIP 005 SIP 014	Lighting	Is lighting appropriate and appear to be in compliance with ACOP 'safety in docs' and the PFSP?	Satisfactory – there is ample lighting around all berths at the new Pier and original Pier. (Note, quayside checks carried out in daylight only).		MJS
ACOP 58-60	Layout	Is adequate separation delineated between quayside operations?	Satisfactory – there is adequate delineated between the commercially operated new Pier and the public use original Pier. Security gates are used to restrict access.		MJS
ACOP 82	Signage	Is appropriate signs and markings provided	Satisfactory – the harbour has signage. Observation – a number of Pier signs had weathered and deteriorated to the point of being illegible. See Image B14.	Recommendation – a full check of signage should be conducted with degraded or illegible signed replaced.	MJS

- The common user stone Pier had a number of mooring lines obstructing the stone steps used to access and egress the launch point and water.
- One of the water egress ladders at the original stone Pier was severely corroded with the rungs unusable.
- Not all life rings were in a serviceable condition and housed correctly.
- A number of Pier signs had weathered and deteriorated to the point of being illegible.

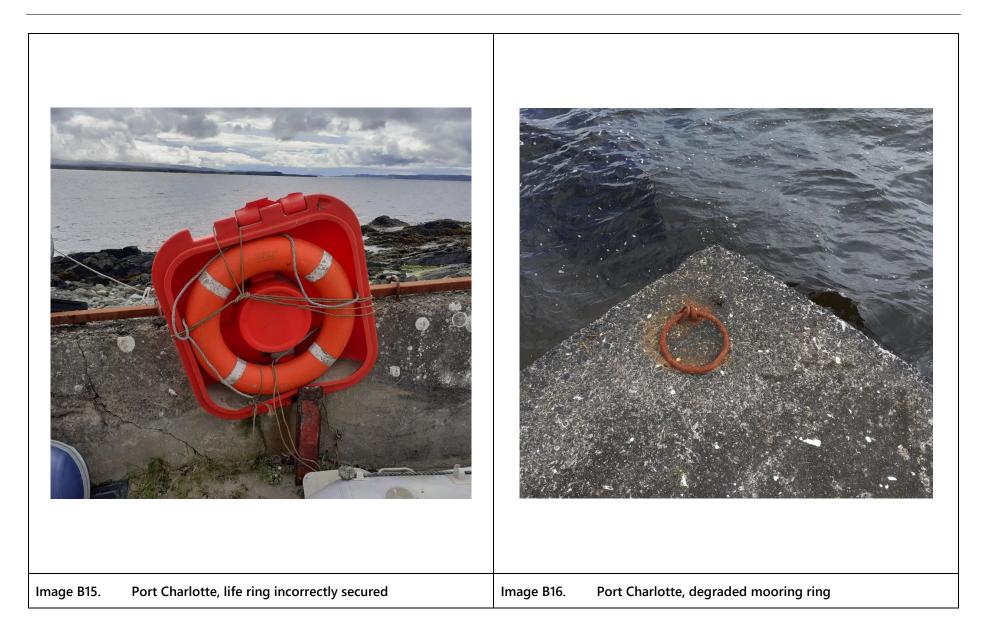
Is there appropriate LSE at quay edge?	Satisfactory – the Pier had one life ring. Observation – the life ring housing was broken and not secured to a support. See Image B15	Recommendation – life rings should be checked on a routine basis with any damaged items repaired or replaced.	MJS
SIP 005	Bollards and securing equipment	Does the general condition of bollards appear to be in good order?	Satisfactory – mooring rings are installed on the Pier. Observation – some of the mooring rings are visually deteriorated and may not provide sufficient restraint capacity. See Image B16.	Recommendation – mooring rings should be inspected and replaced if significantly deteriorated.	MJS
SIP 005	Fenders	Is the fendering appropriate to the vessel being handled?	Satisfactory – fendering on the Pier is vertical rubber sections on timber, the condition of which is considered to be good from visual observation. In other areas, the fendering is wood vertical sections with some tyres used for fishing vessels and workboat berths.		MJS

Is the condition of the fendering in good order?	Satisfactory – fitted fendering was observed to be in serviceable condition.		MJS
		Are chaffing plates used?	Not applicable – chaffing plates and/or wood sections are not used on the Pier.		MJS
ACOP 232-235 SIP 005 SIP 014	Lighting	Is lighting appropriate and appear to be in compliance with ACOP 'safety in docs' and the PFSP?	Not applicable – there is no lighting at the Pier, the facility is not used for loading or unloading vessels at night.		MJS

- The life ring housing was broken and not secured to its support.
- Some of the mooring rings were visibly deteriorated and may not provide sufficient restraint capacity.
- There is no signage at the Pier. It is recommended that signage with A&BC's details as the marine asset owner is installed.
