**BOUNDARY WALL, DUNGALLAN PARK, OBAN.**

**1. SUMMARY**

- 3.1 The retaining walls were inspected by Roads and Amenity Services on 25<sup>th</sup> May 2012.

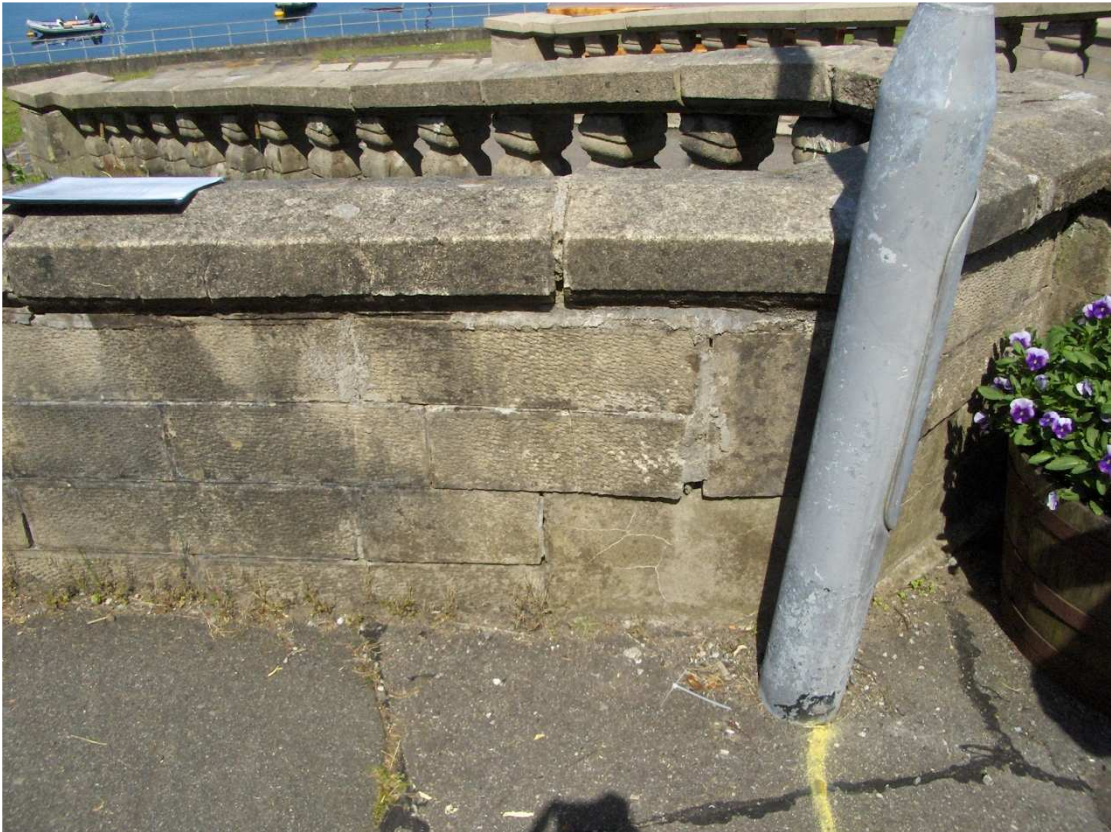
<b>Chainage (metres)</b>	<b>Retained Height (metres)</b>	<b>Comments</b>	<b>Risk</b>
0	0	Parapet Displaced (25mm max.)	Low
0 - 18		Some distortion in parapet (slight).	Low
18	0.9	Settlement. Pilaster moved slightly.	Medium
18 - 20		Some distortion in parapet, possibly due to settlement (slight).	Low
20 - 30		Some distortion in parapet, possibly due to settlement (slight).	Low
30 - 33	1.3	Some distortion in parapet, possibly due to settlement (slight).	Low
33	1.3	Tree growing from footpath level on seaward face.	Medium
33 - 60	1.3 – 1.8	Some distortion in parapet, possibly due to settlement (slight).	Low
60 - 83	1.8 – 2.0	No notable defects in parapets. Scrub / tree clearance required.	Low

South wall, Chainage 0: Displaced parapet blocks

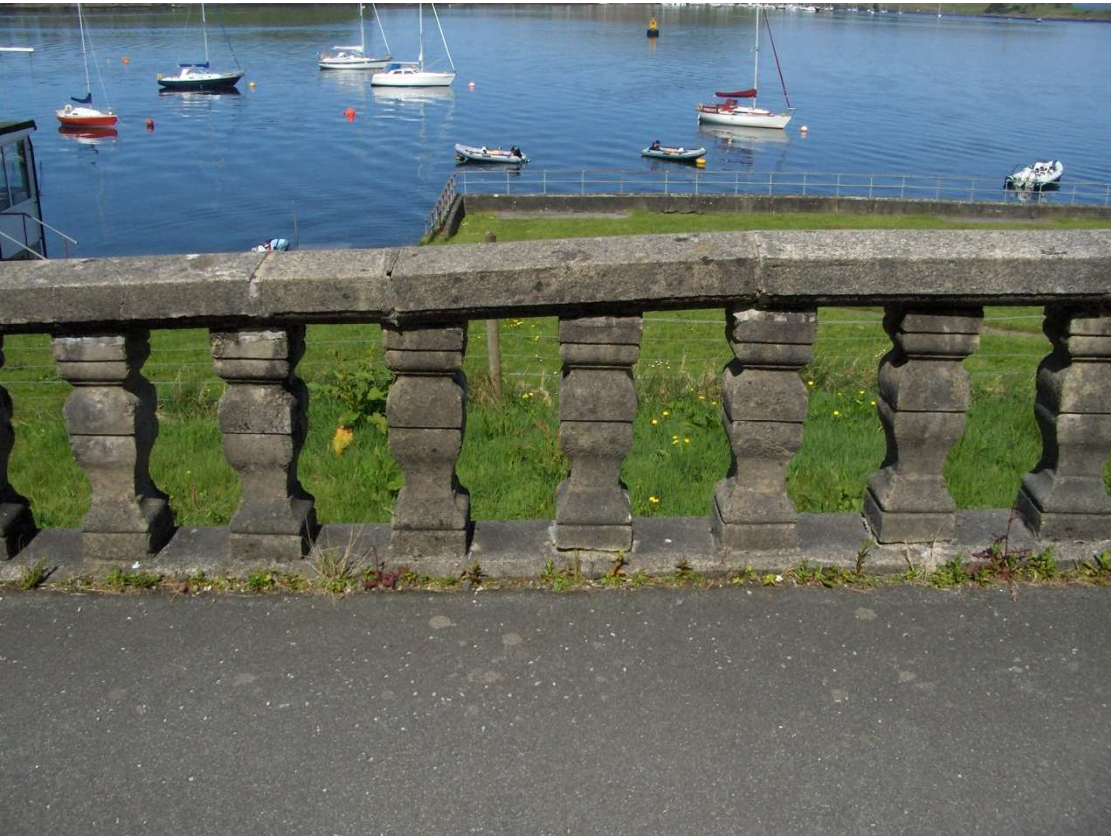
South wall, Chainage 18: Distortion of balustrade, loose baluster  
Appendix A

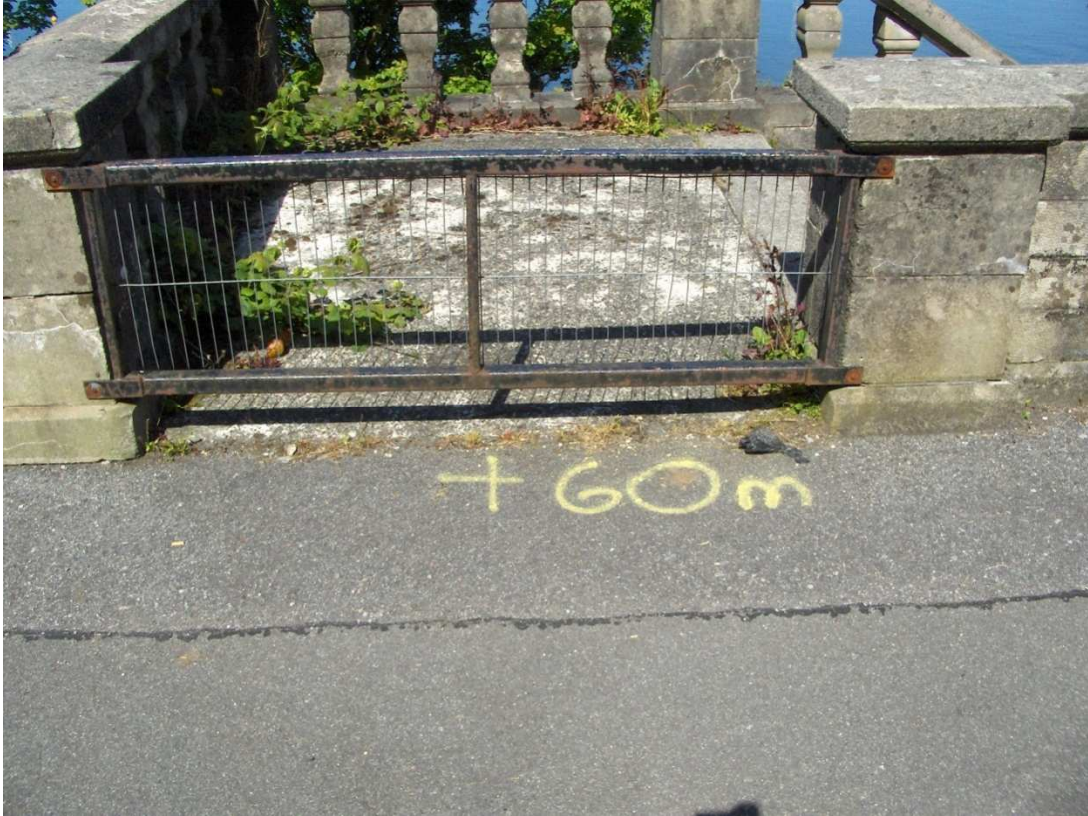
South wall, Chainage 60: Stairway closed

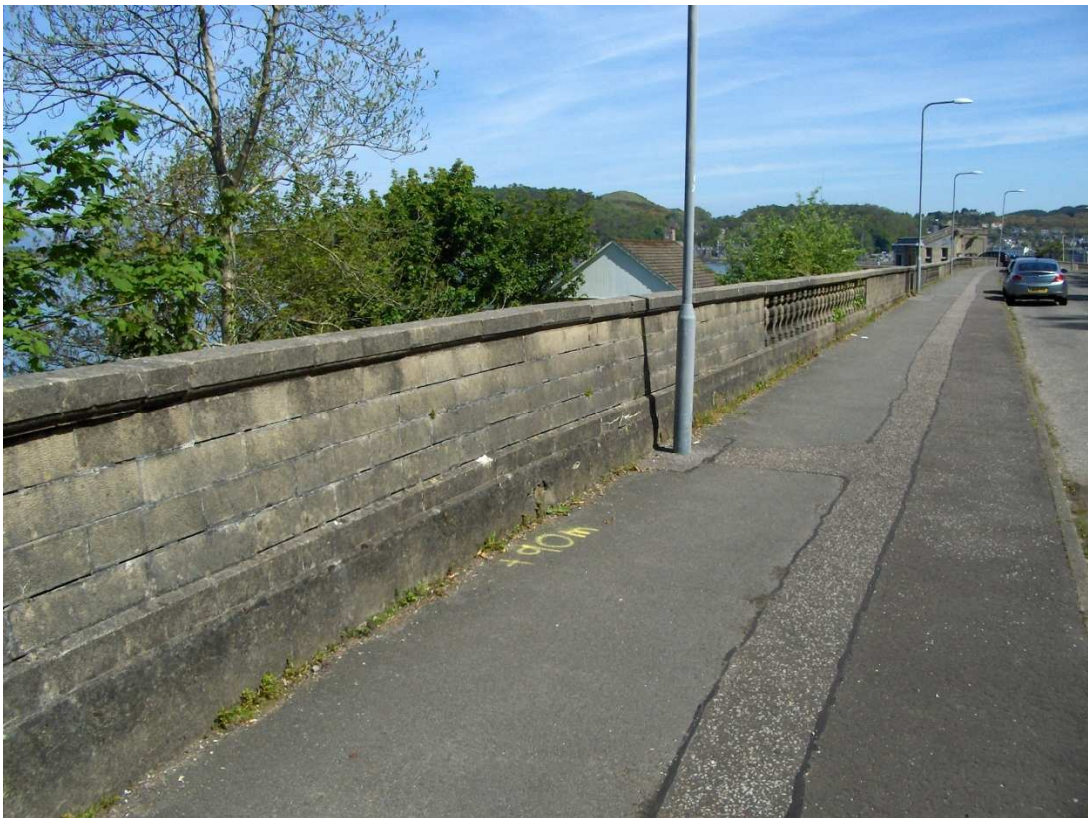
- 3.3.1 The random rubble retaining wall has a significant tilt in some areas, particularly at the southern end of the south wall. The concrete parapet and balustrades are can potentially be pushed over requiring an area of the park to be fenced off in the interest of safety.

General view of South wall

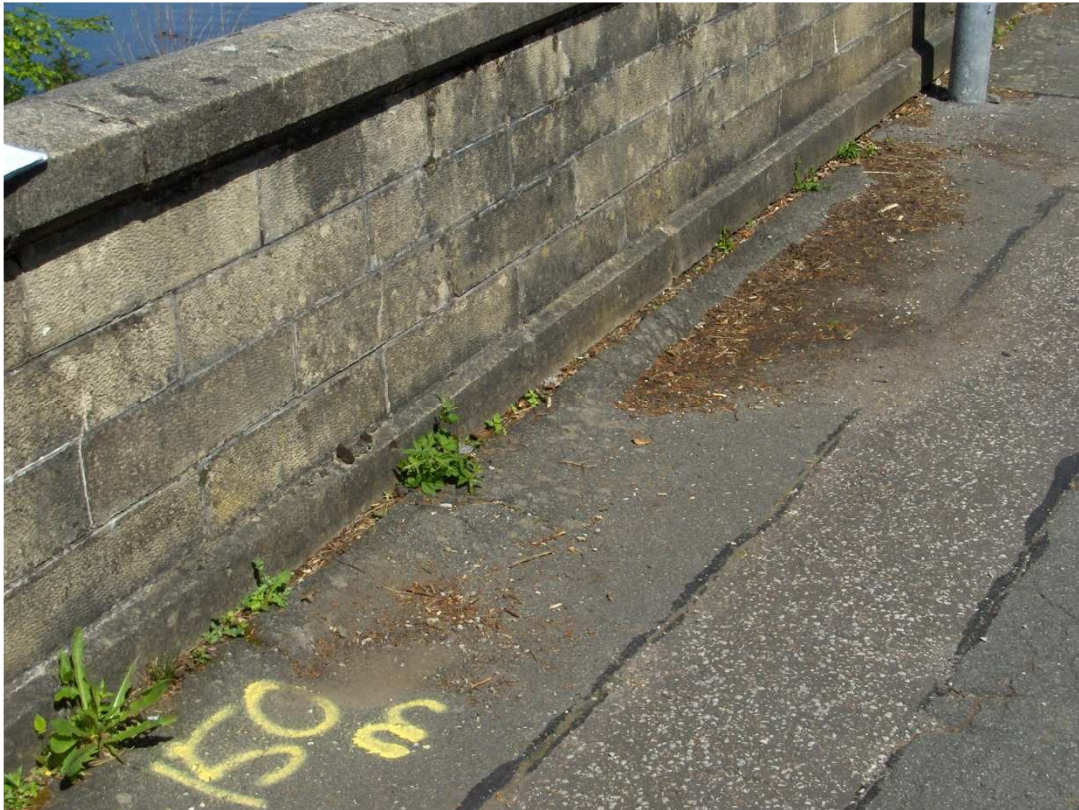
150	1.8	Retaining wall tilted seawards (120mm / metre height). Thick ivy growth. Pointing required. Minor distortions in parapet.	Medium
150 - 155	1.8	Minor distortions in parapet.	Low

South wall, Chainage 150: Settlement in footpath

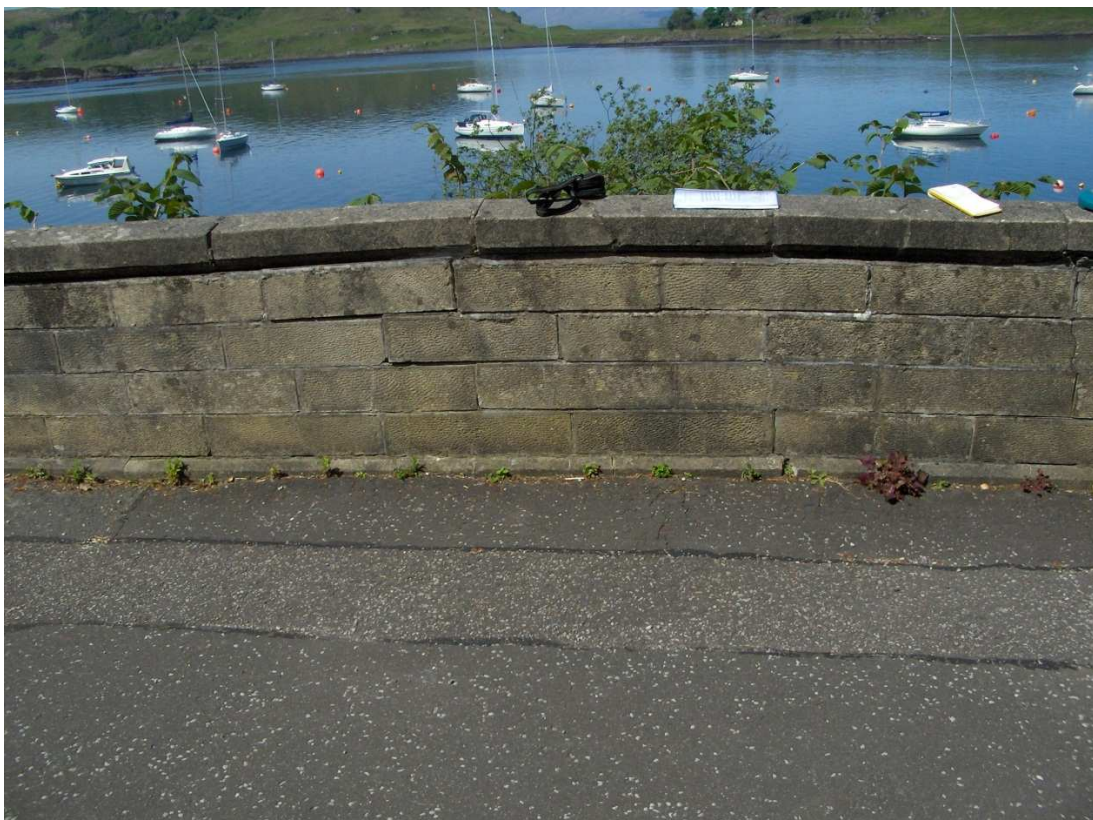
<b>Chainage (metres)</b>	<b>Retained Height (metres)</b>	<b>Comments</b>	<b>Risk</b>
158	1.8	Parapet blocks displaced upwards and cracked. Probably heave due to tree growth (previously cut but re-growing).	Medium
163	1.7	Impact damage to parapet. Blocks displaced seawards 30mm max.	Low
163 - 185		Cracked / loose pilasters (8 loose from a total of 23)	Medium

South wall, Chainage 158: Distortion of parapet, probably due to tree growth

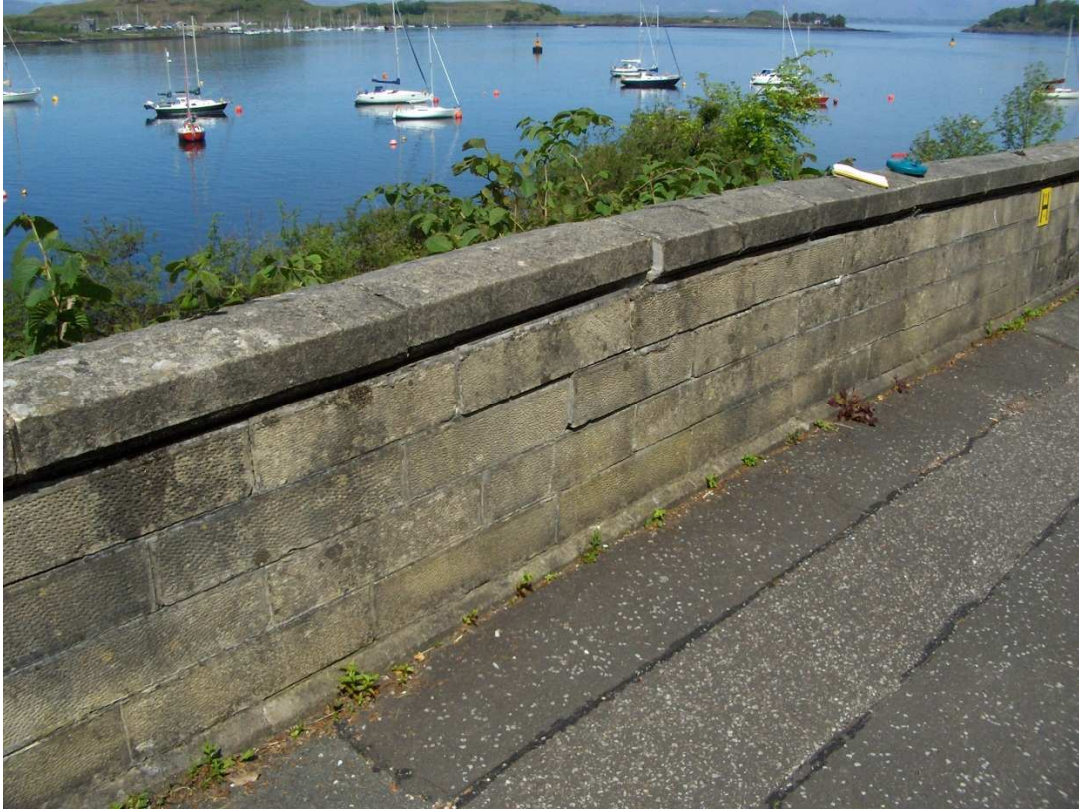
South wall, Chainage 158: Distortion of parapet, displaced cope

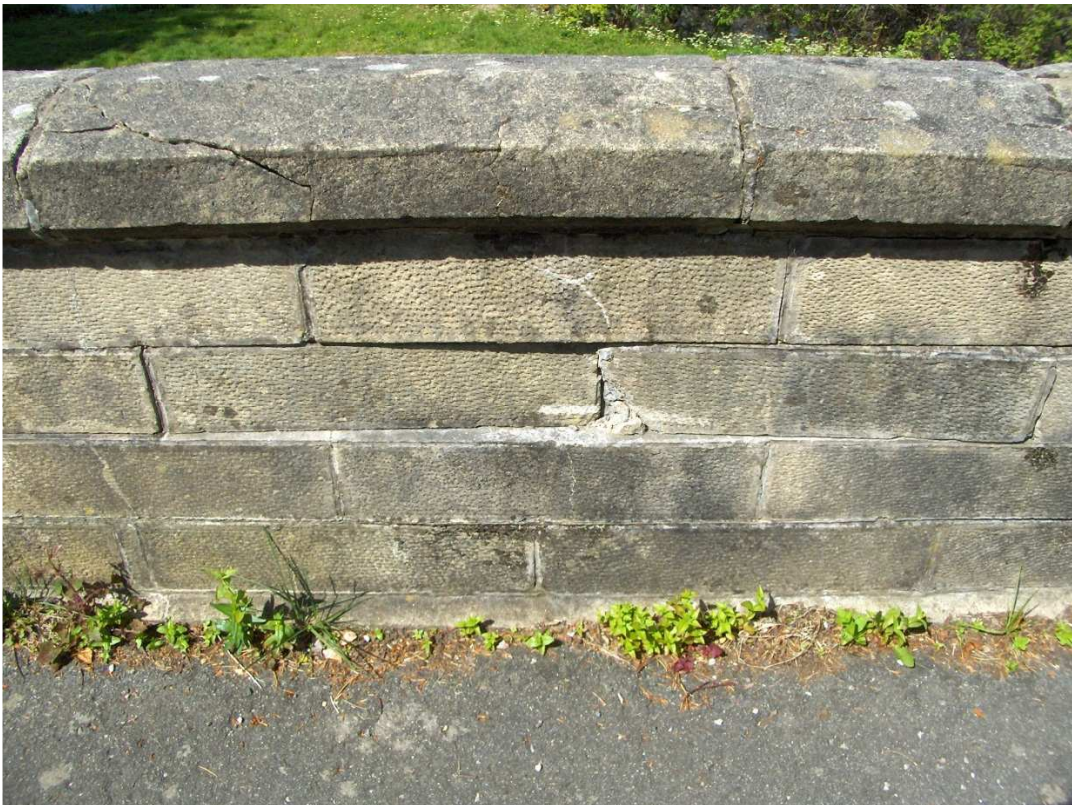
South wall, Chainage 163: Impact damage

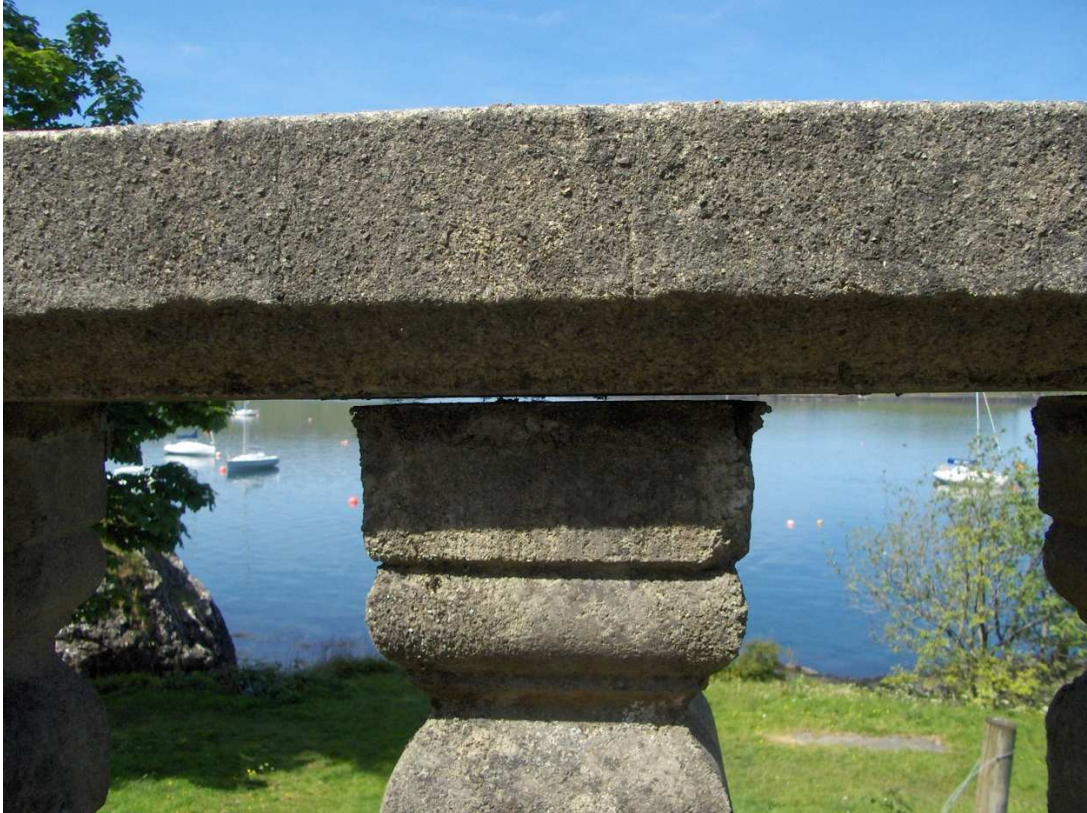
South wall: Loose pilaster (typical)

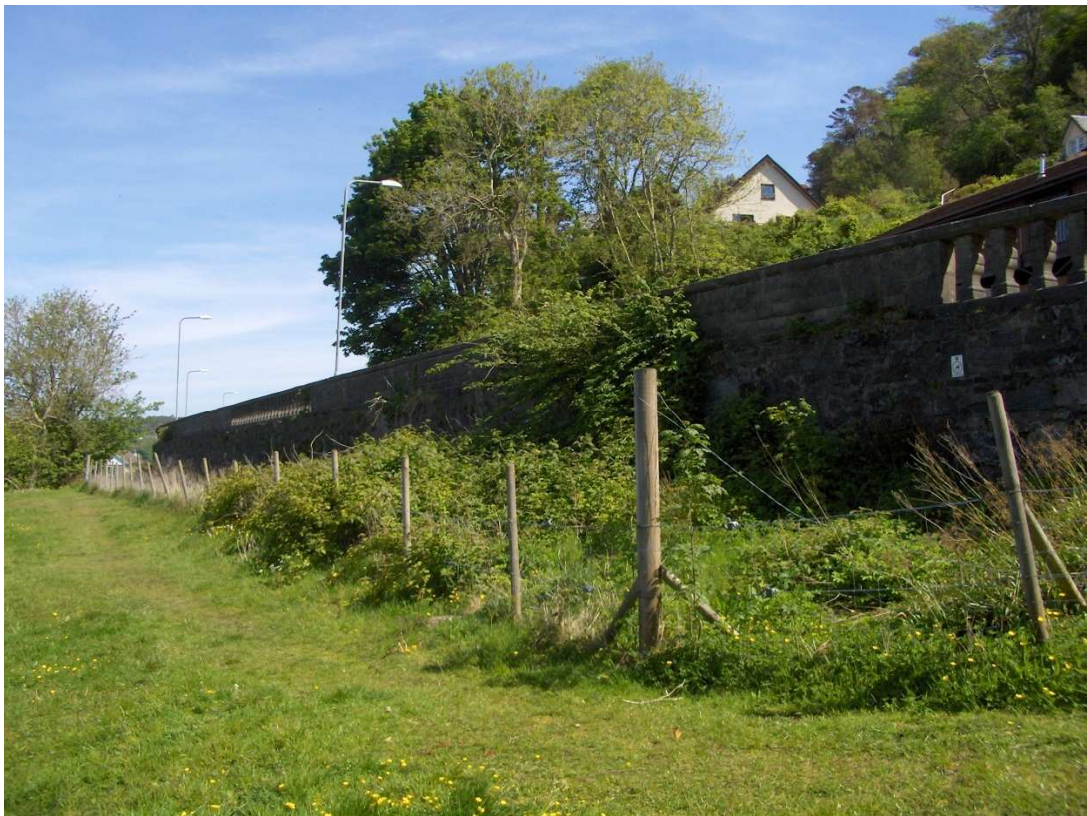
South wall: Tree growth at Chainage 158

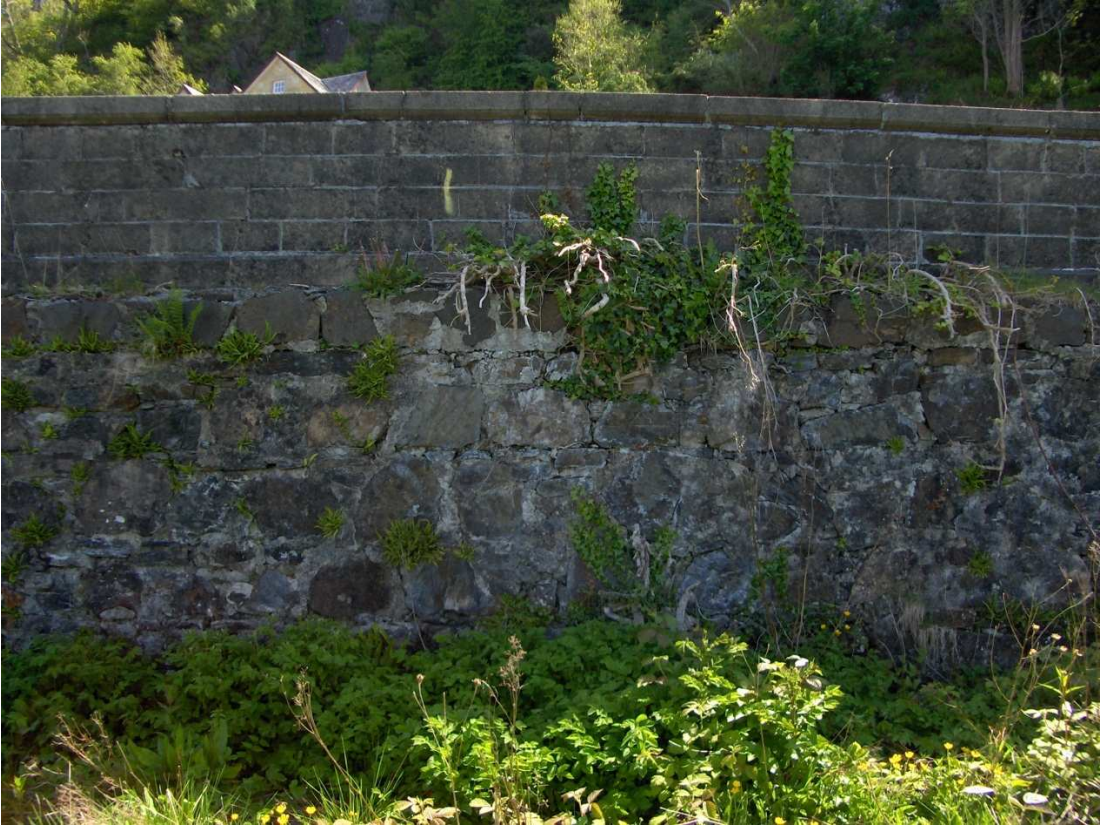
South wall: Ivy growth at Chainage 150

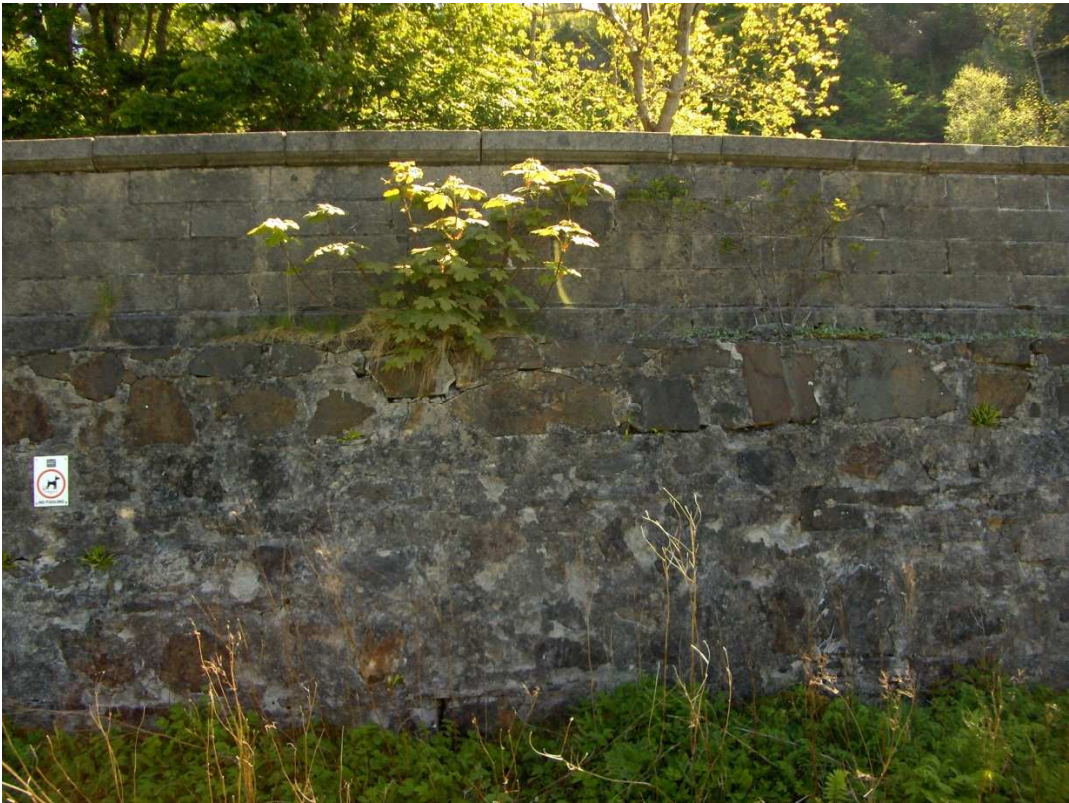
South wall, Chainage 120: Tree growth

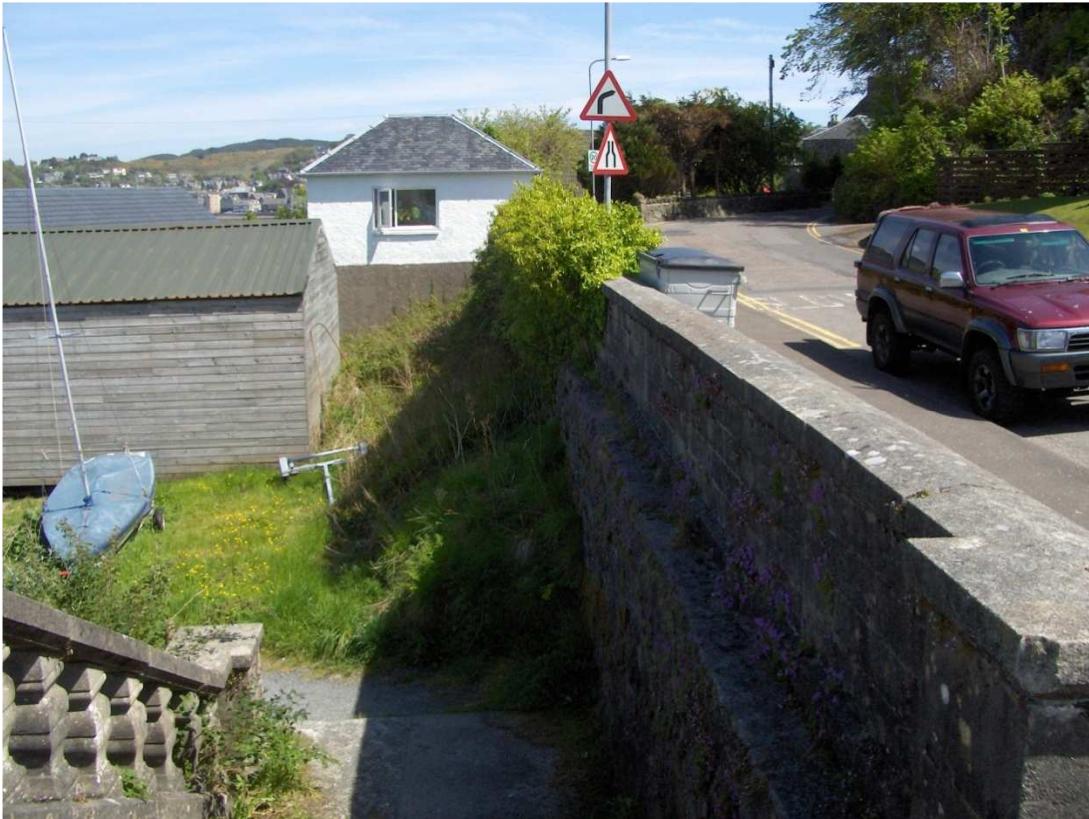
<b>Chainage (metres)</b>	<b>Retained Height (metres)</b>	<b>Comments</b>	<b>Risk</b>
0	1.0	No significant defects	Low
5 - 20		Dense ivy growth	Medium
60	1.5	Retaining wall tilted seawards (50mm / metre height). Parapet also tilted.	Low

North wall, Town centre end: Dense ivy growth

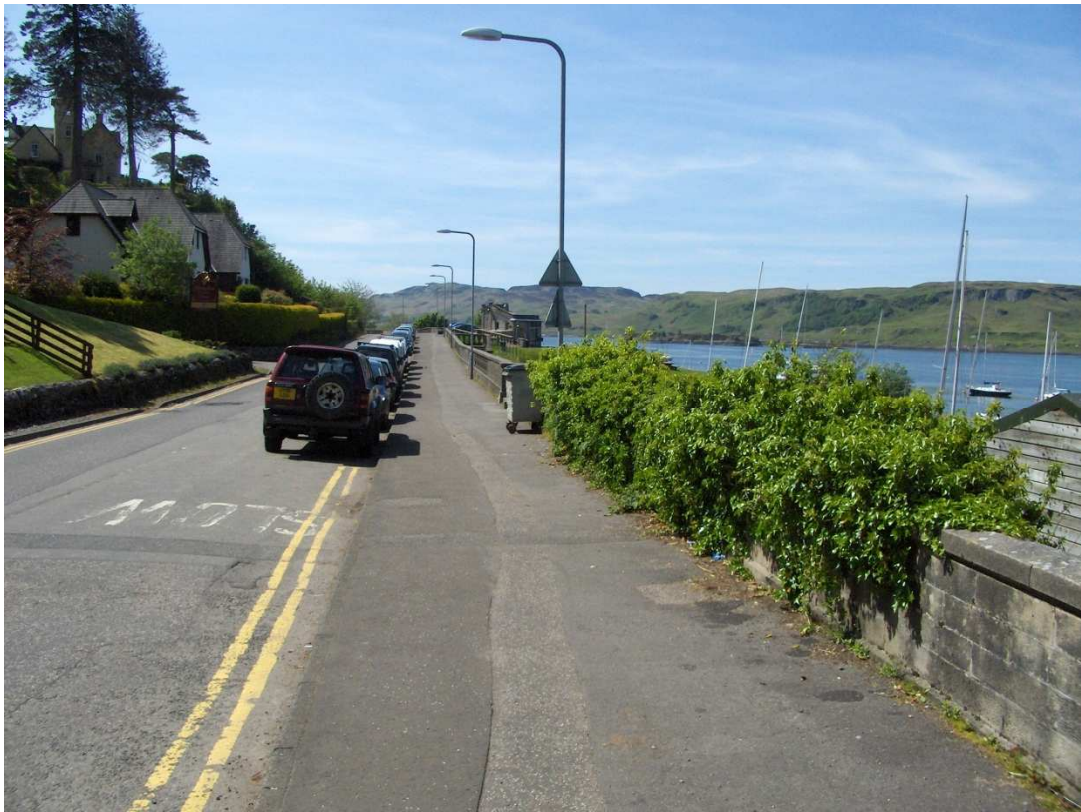
- 3.3.2 The north random rubble retaining wall is in significantly better condition than the south wall.

General view of north wall
