## Helensburgh Pier

### Market Scoping Study

On behalf of **Argyll & Bute Council**

Project Ref: 332010810 | Date: May 2023

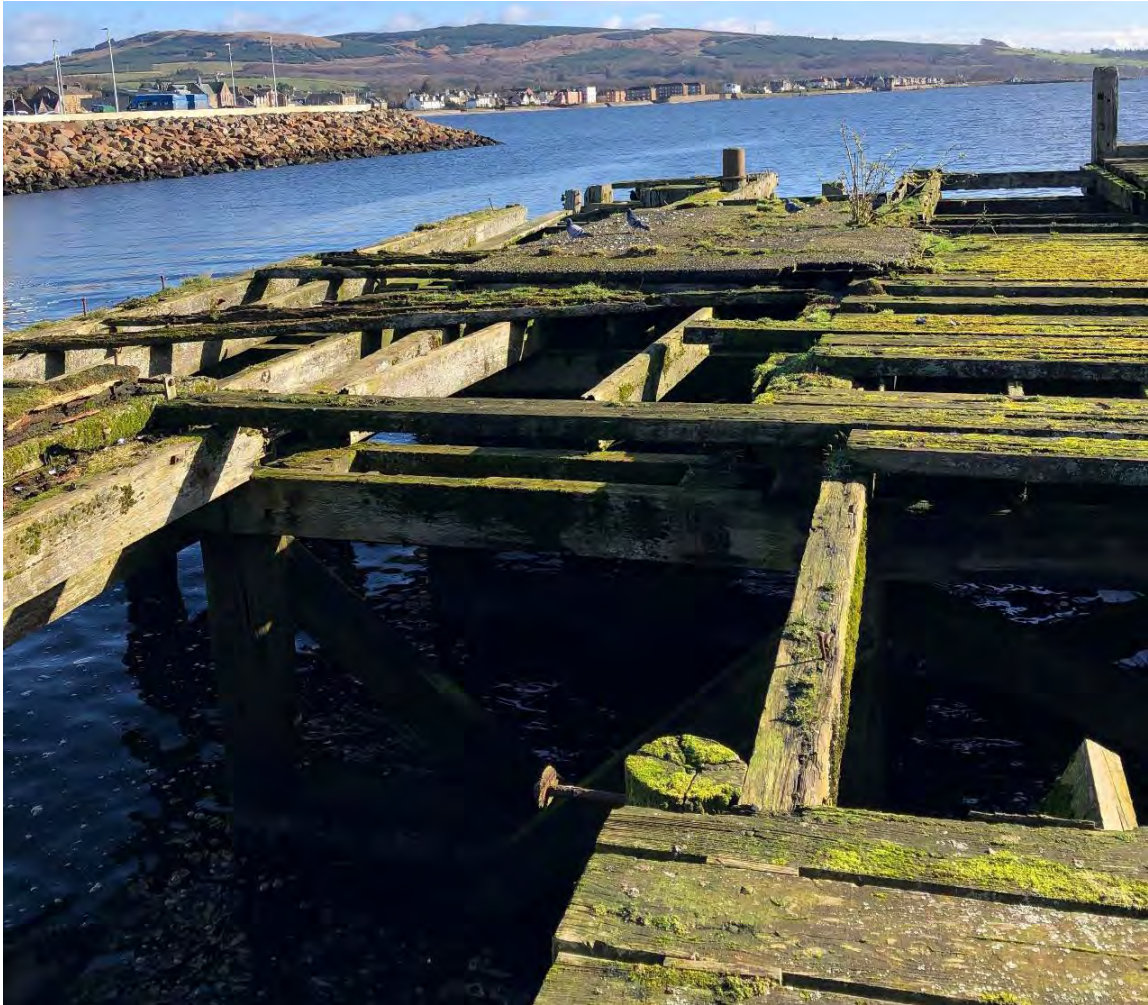
- 1.2.3 Whilst the Council has recently undertaken significant maintenance work on the masonry pier and resurfaced much of the timber pier, the north-east side of the timber structure has suffered significant fire damage and is fenced off to the public, as shown in the image below:

Figure 1.1: Damaged section of timber pier at Helensburgh

- 1.2.4 The condition of this part of the timber structure presents a risk and is also an eyesore. Whilst derelict or significantly deteriorated steamer piers are a prominent feature around the Firth of Clyde (e.g., Craigendoran, Arrochar etc.), the main difference with Helensburgh is that the pier lies at the heart of the town and in an area that has undergone extensive regeneration in recent years.

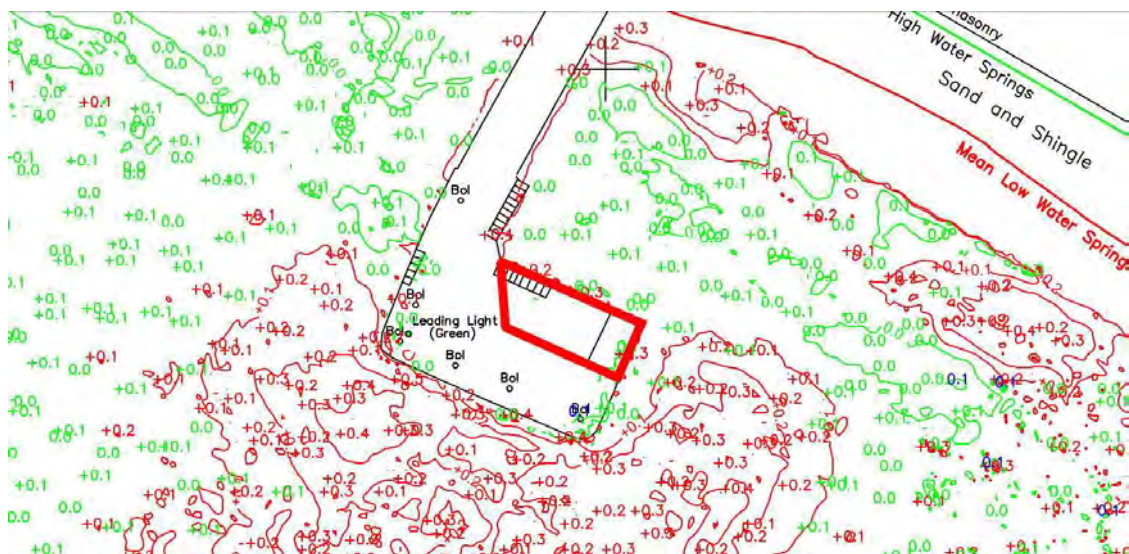
- 4.3.2 Due to the fire damaged section of the pierhead being in very poor condition, the area presented in Figure 4.2 was not accessed.

Figure 4.2 Access restrictions on pierhead

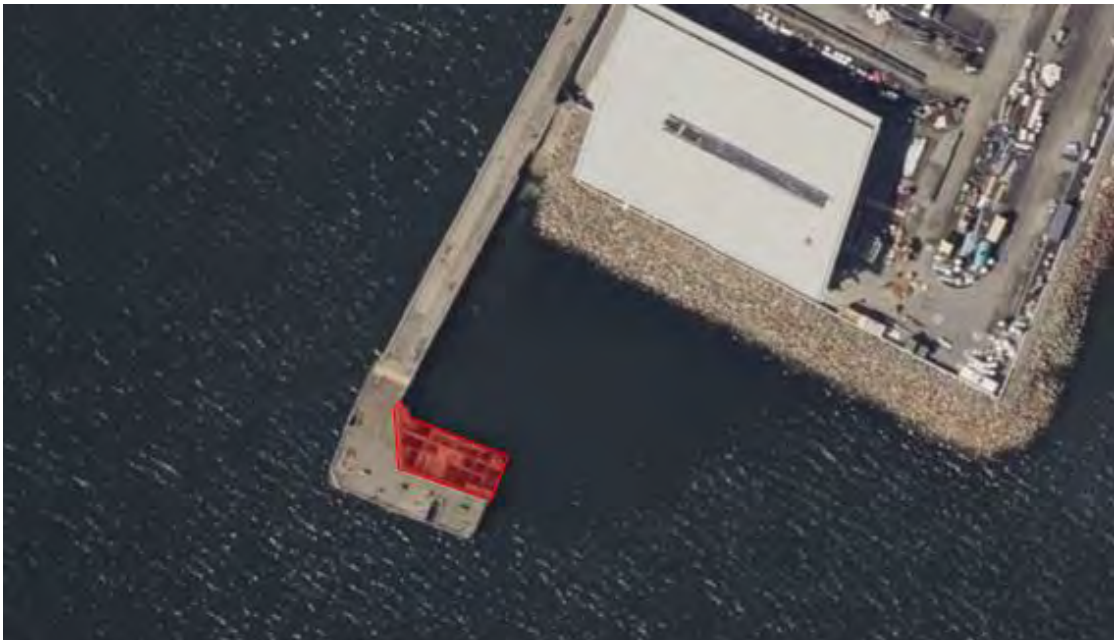
Figure 4.4 Area of Timber Pierhead to be Demolished as Part of Option 2

4.6.7 This option would remove the potential health and safety hazard of the fire damaged section of the pierhead, and potentially improve the image of the remaining section of the pierhead for use by the public. Figure 4.4 presents the area of the timber pierhead that would be removed as part of this option.

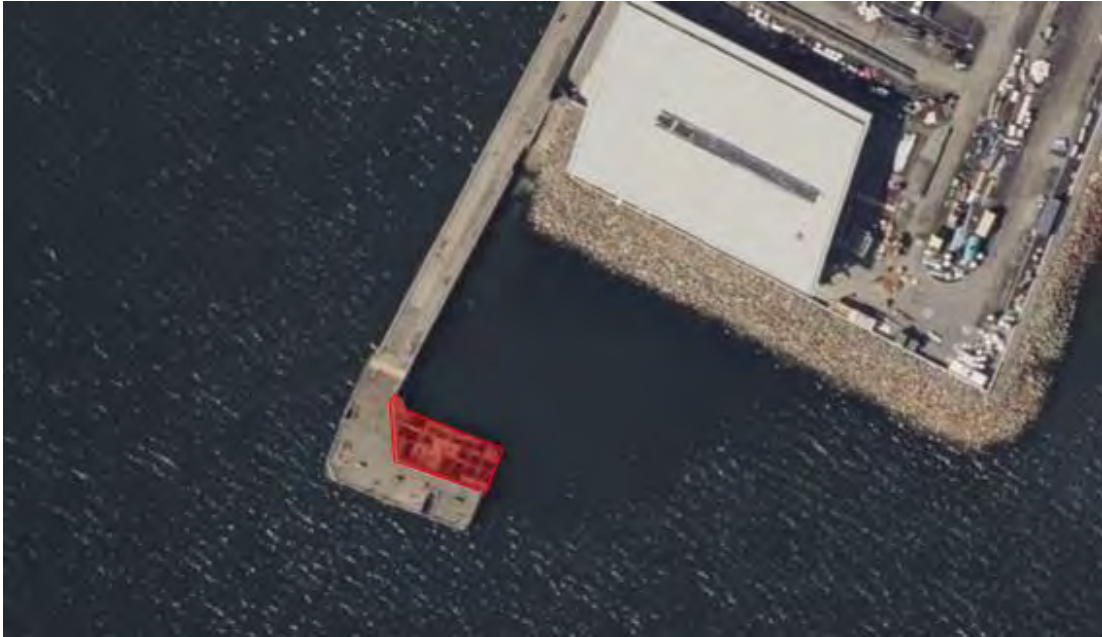
Figure 4.5 Section of timber pierhead to be demolished as part of Option 3

4.6.10 Whilst of a much smaller scale than the proposed pontoon option, subject to design, this option would likely permit the pierhead to be reinstated for use by a selection of vessels, **all subject to analysis to demonstrate that the reduced section of pier has the residual capacity to resist berthing loads**. Figure 4.5 below presents the area of timber pierhead that would be removed as part of this option.

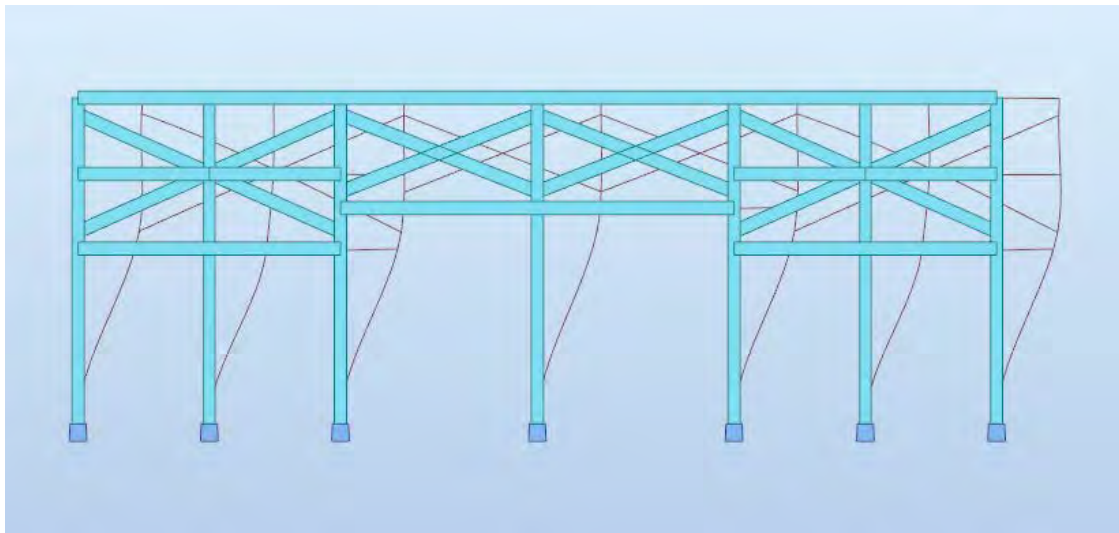
With the present condition of the timber elements, the structure failed with regards to BS 6349 calculated berthing and impact loads for a vessel representing the PS Waverley. The failure of the members was observed in exceeding the allowable displacements and stresses.

Further detailed structural analysis is in the process of being undertaken to determine to which extent the pier should be strengthened.

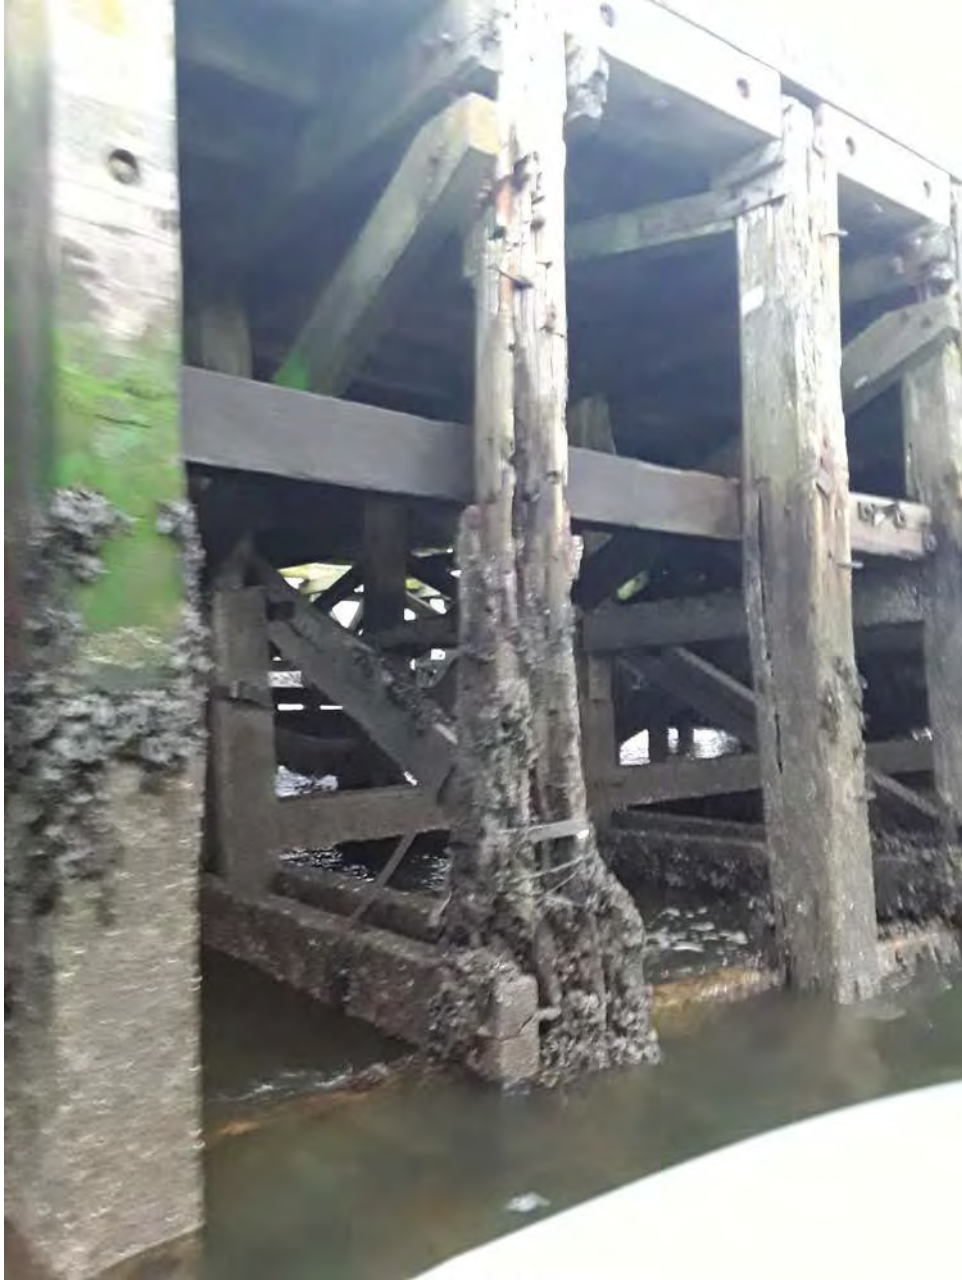
Pile section loss at west end of southern berthing face

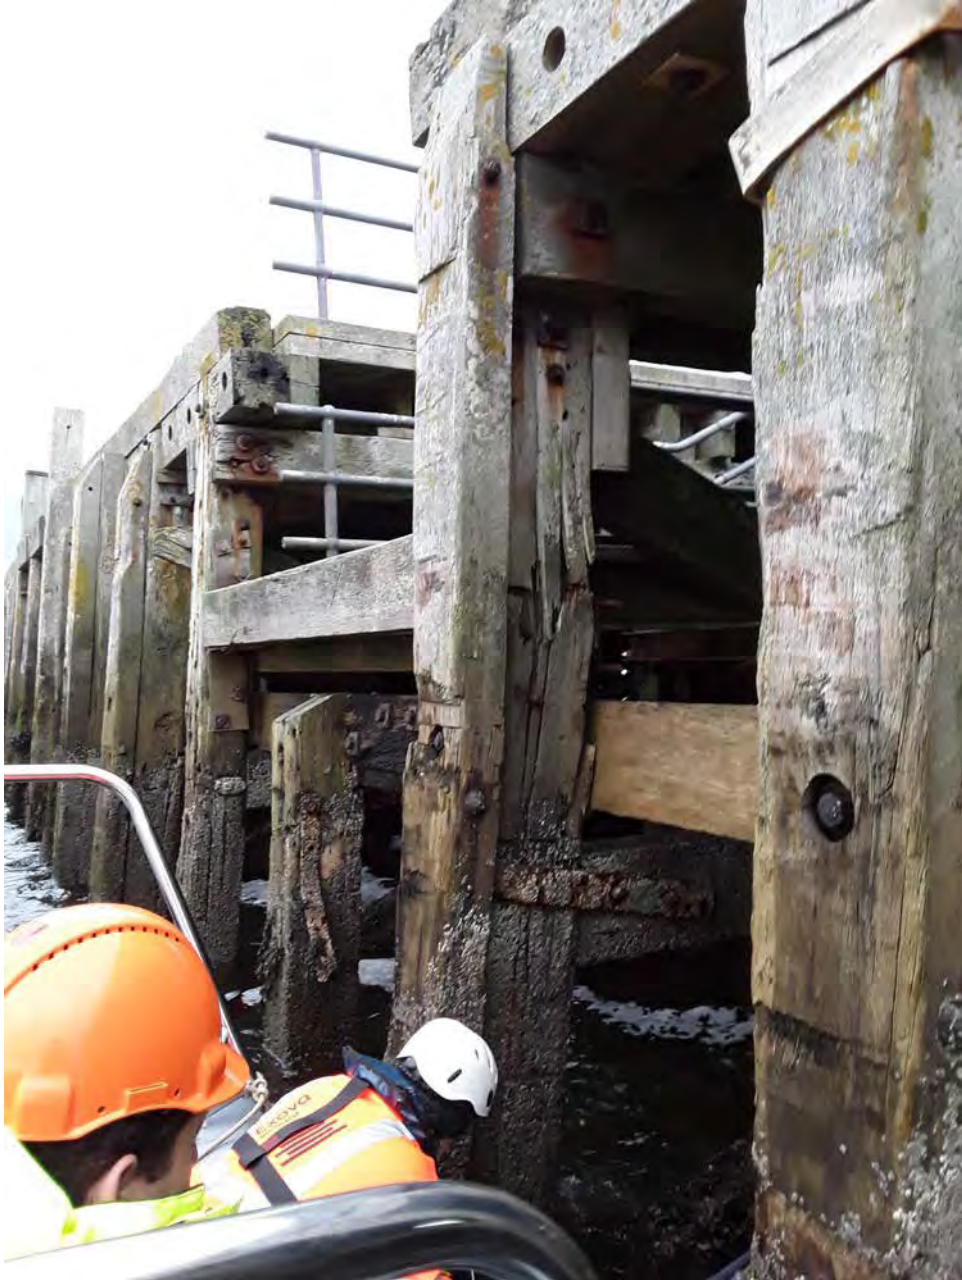
Splitting across the grain of timber fender from impact damaged, adjacent to stairs.

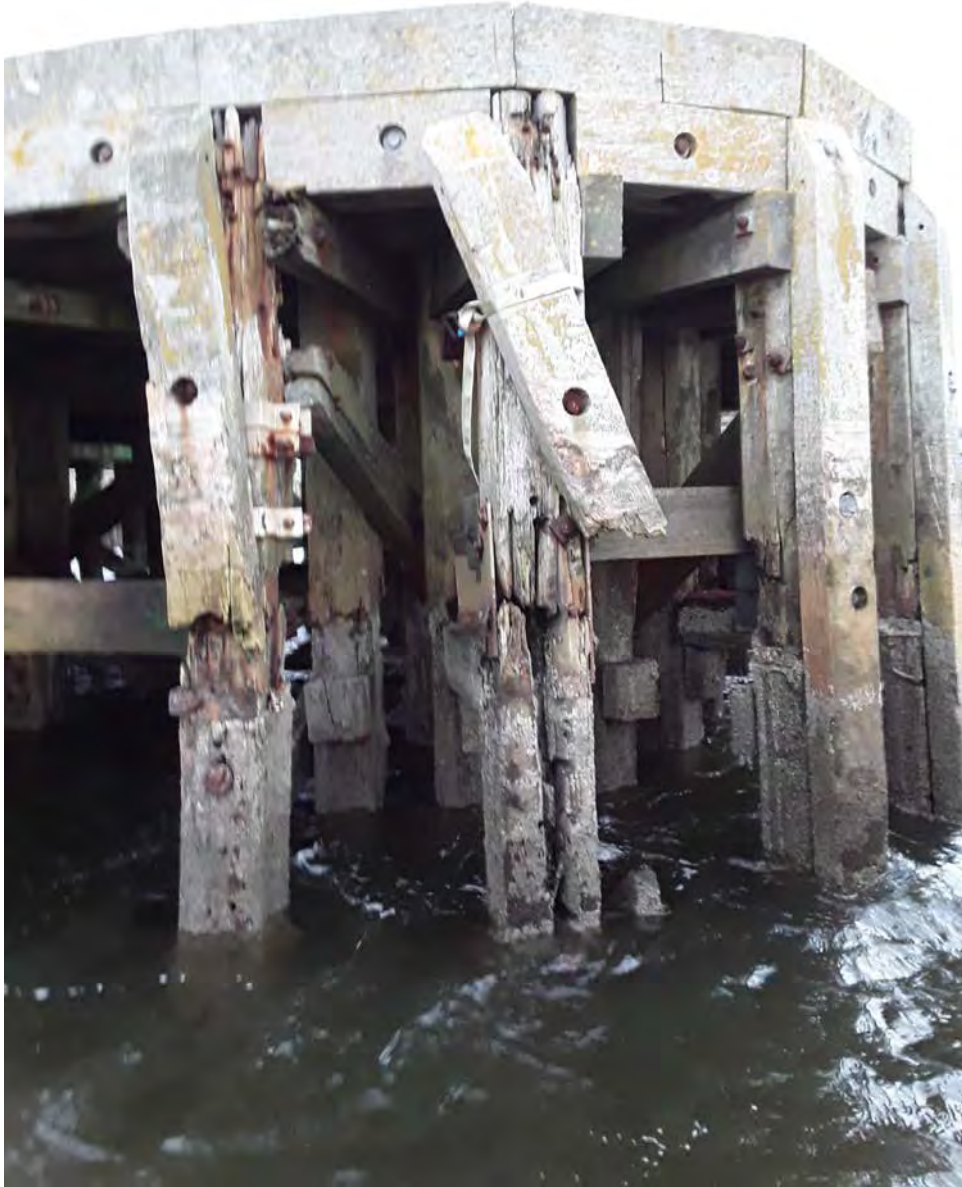
South east corner pile and fender impact damage and previous repairs

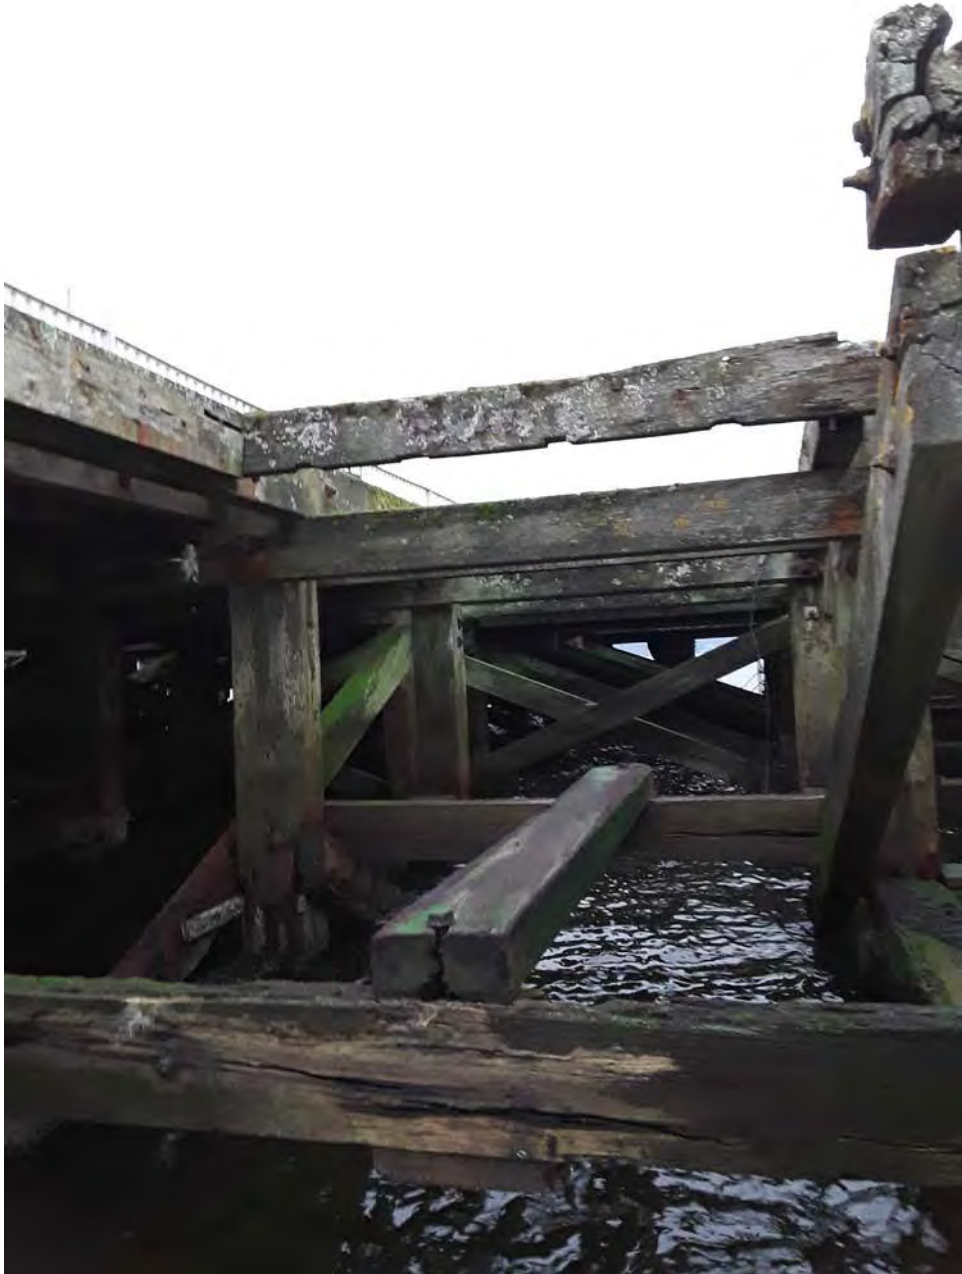
Fire damaged area missing deck planks

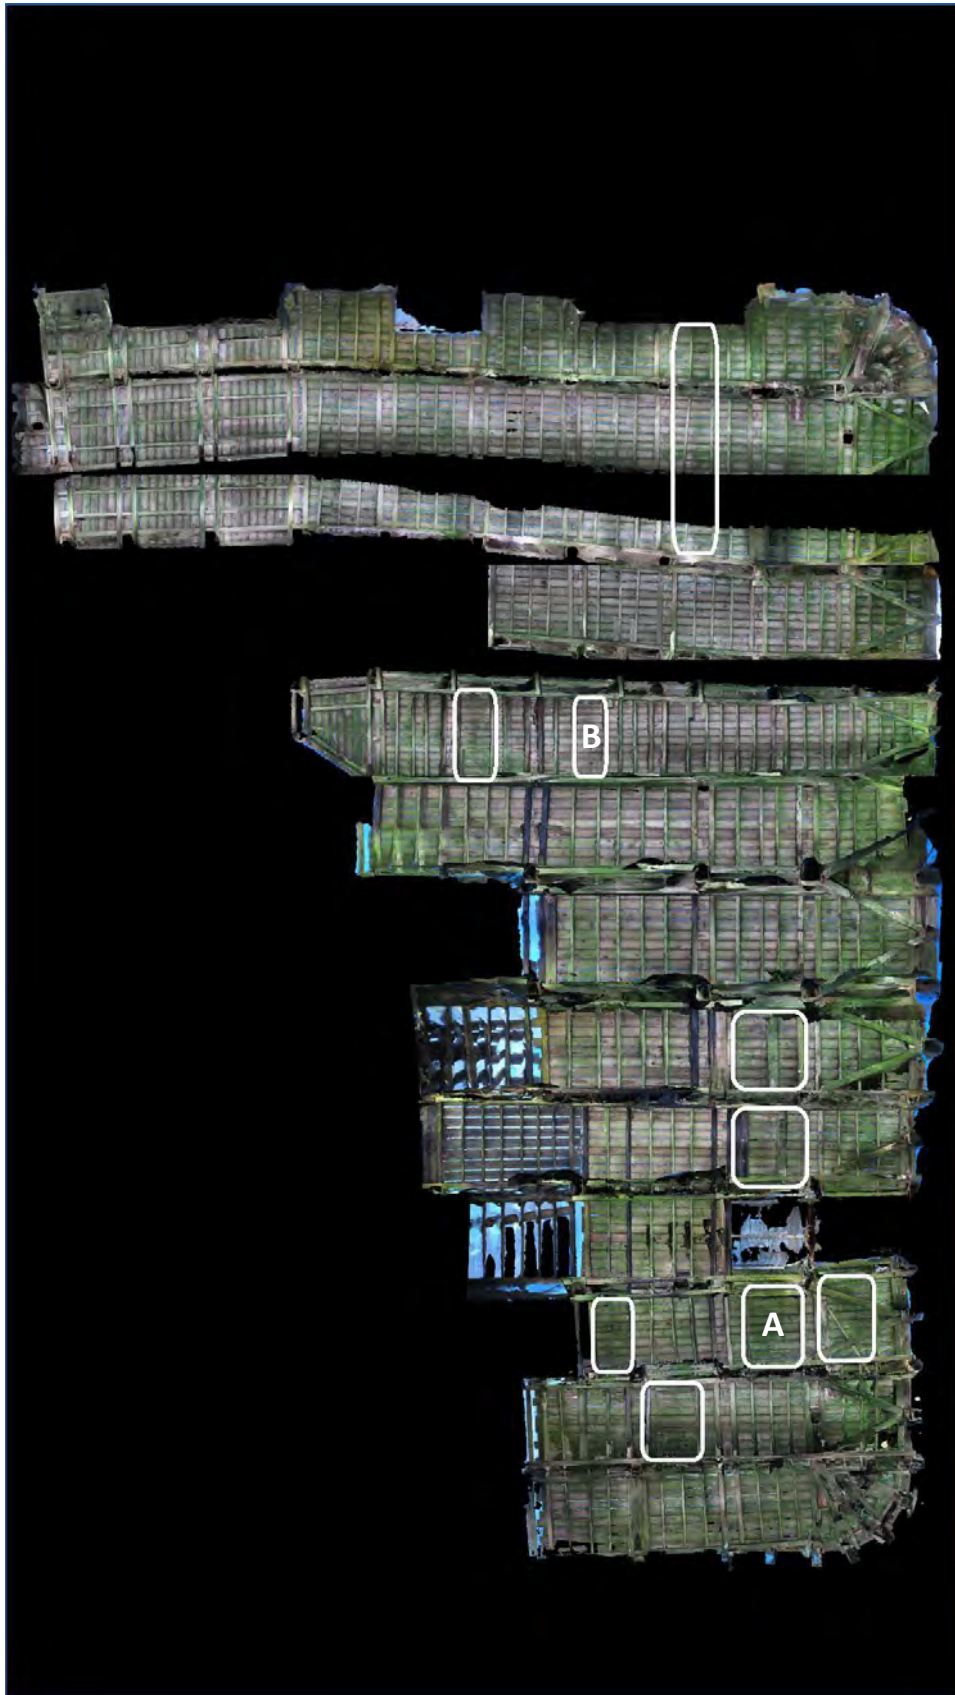
**FIGURE 10: Helensburgh Pier – Composite image of the underside of the pier showing areas with missing rafters (in white)**

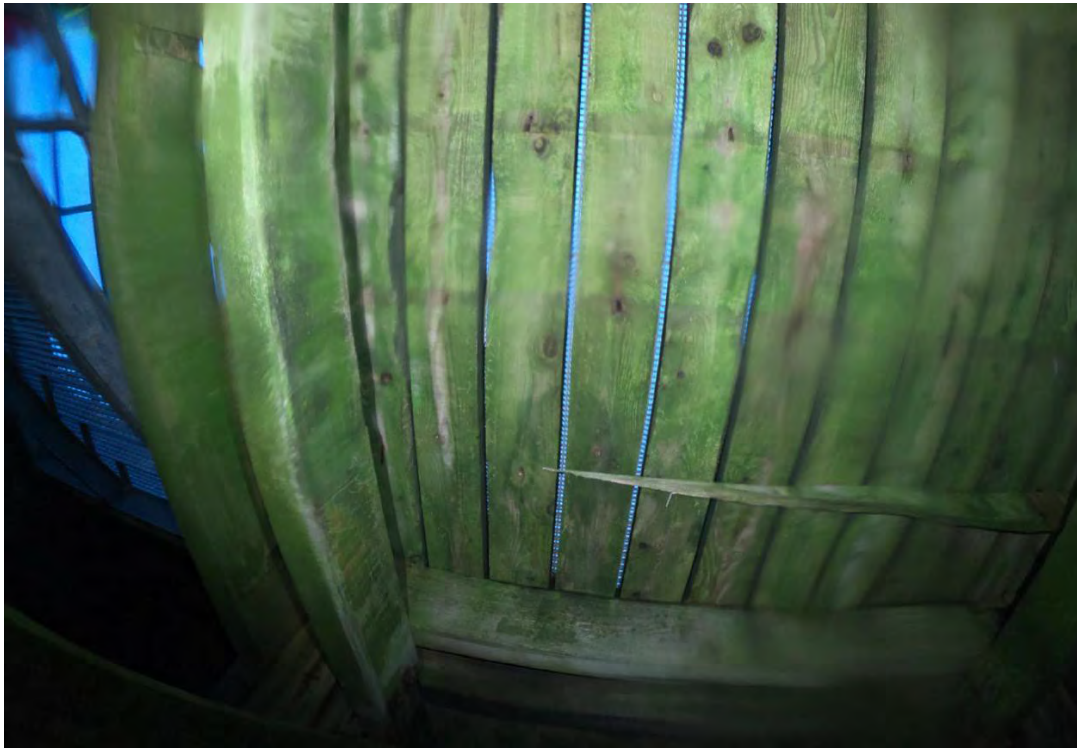
**FIGURE 11: Helensburgh Pier – Missing and broken rafters (“A” in Figure 10)**

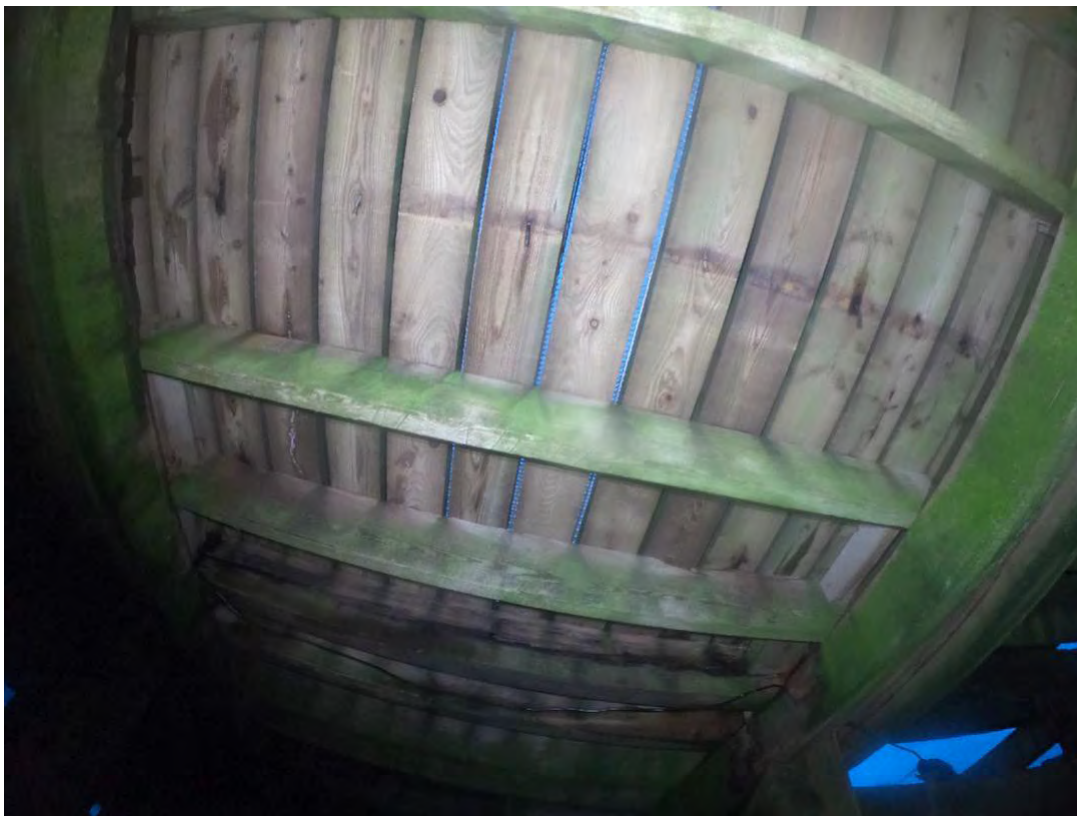
**FIGURE 12: Helensburgh Pier – Missing rafter (“B” in Figure 10)**

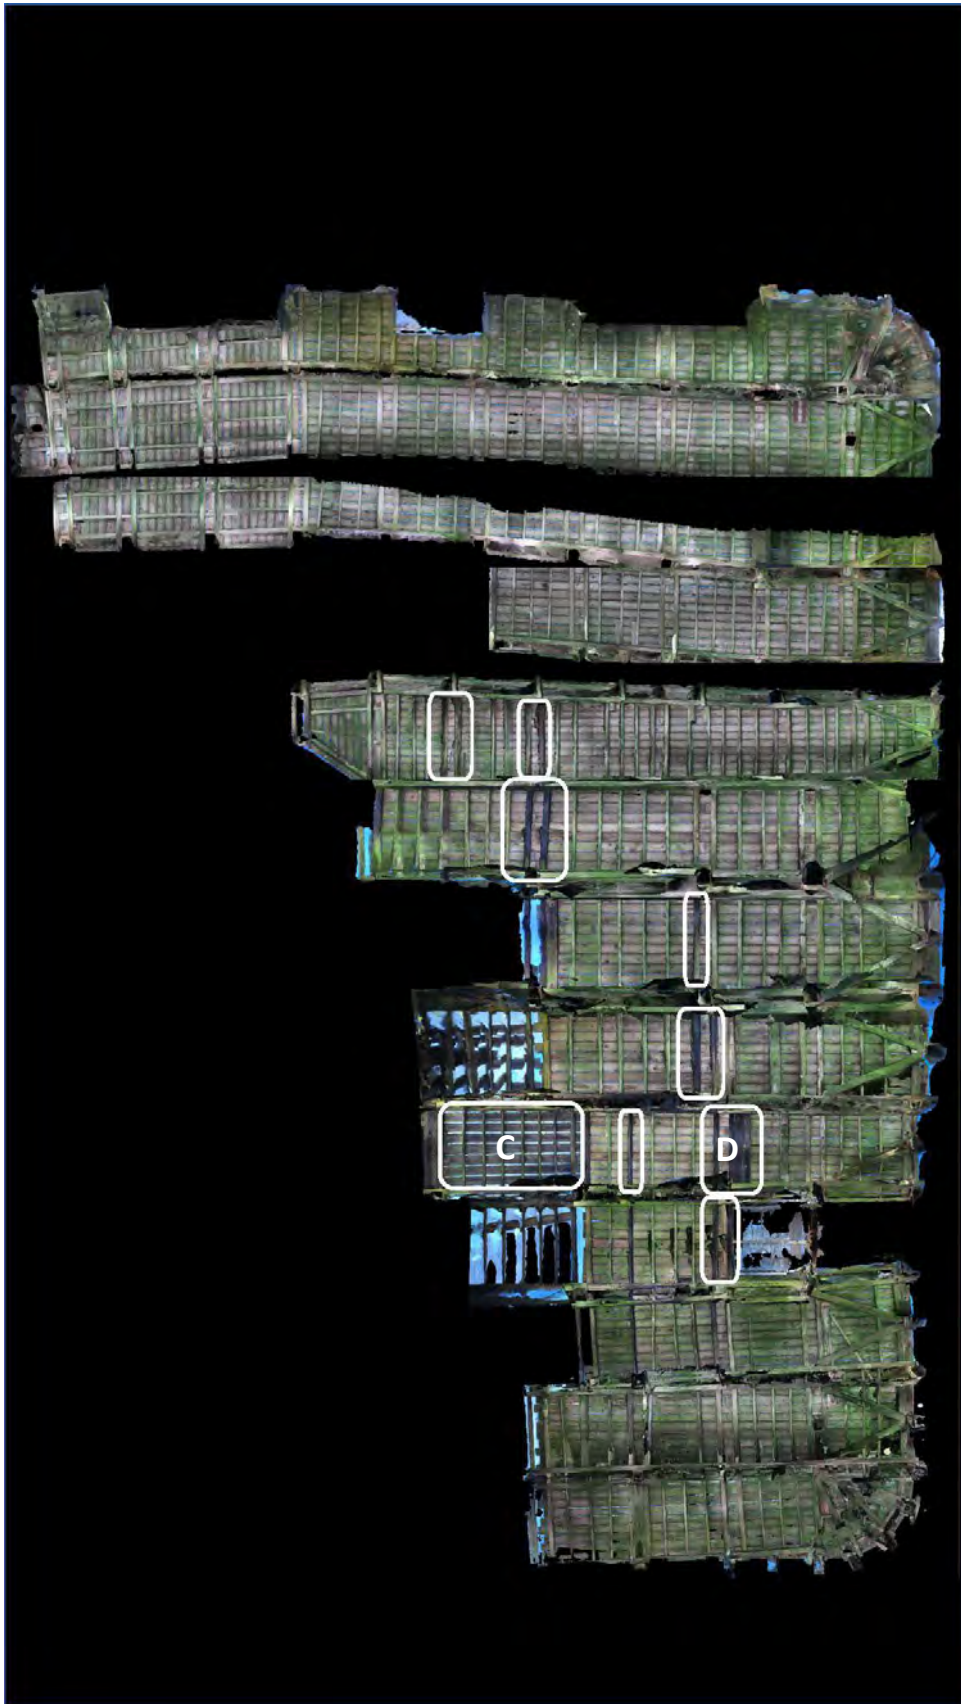
**FIGURE 13: Helensburgh Pier – Composite image of the underside of the pier showing areas with presumed fire damage (in white)**

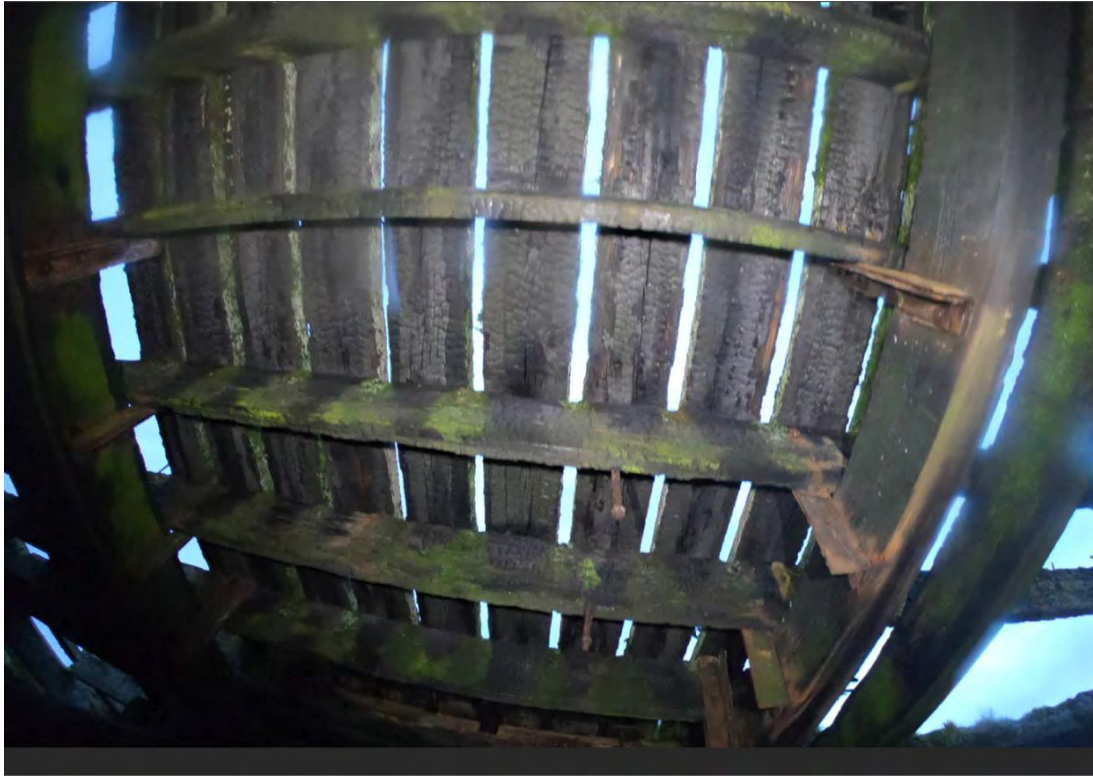
**FIGURE 14: Helensburgh Pier – Burnt beams, rafters and floor boards (“C” in Figure 13)**

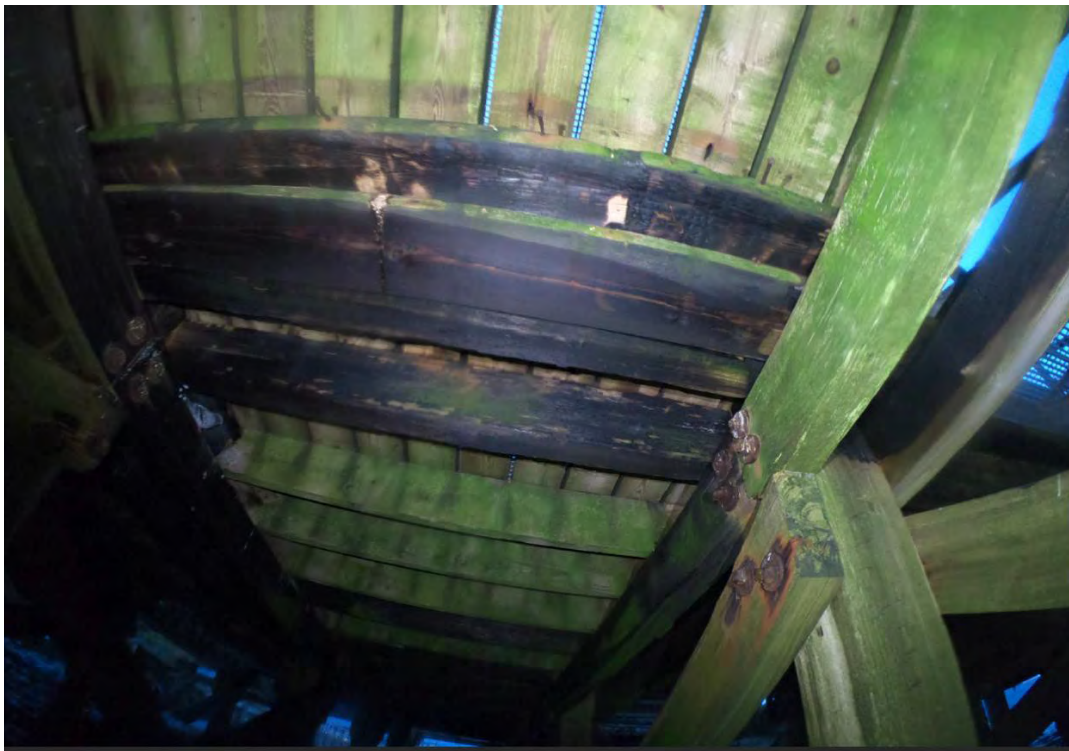
**FIGURE 15: Helensburgh Pier – Burnt rafters (“D” in Figure 13)**

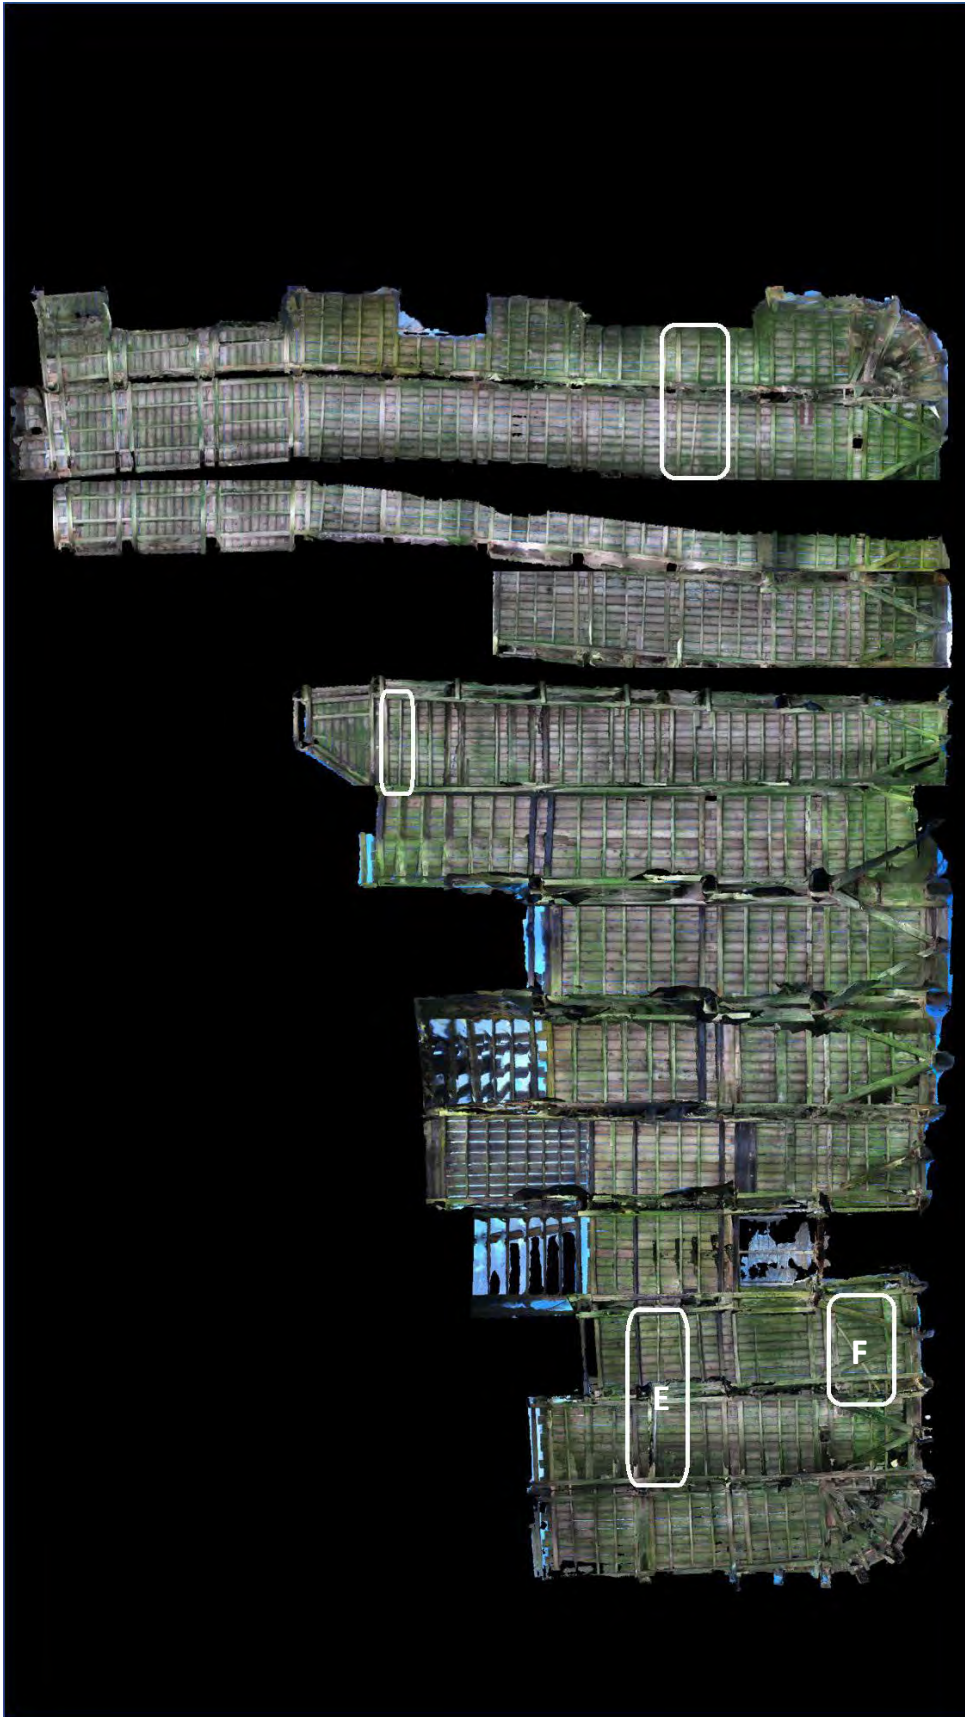
**FIGURE 16: Helensburgh Pier – Composite image of the underside of the pier showing areas where rafters are out of alignment (in white)**

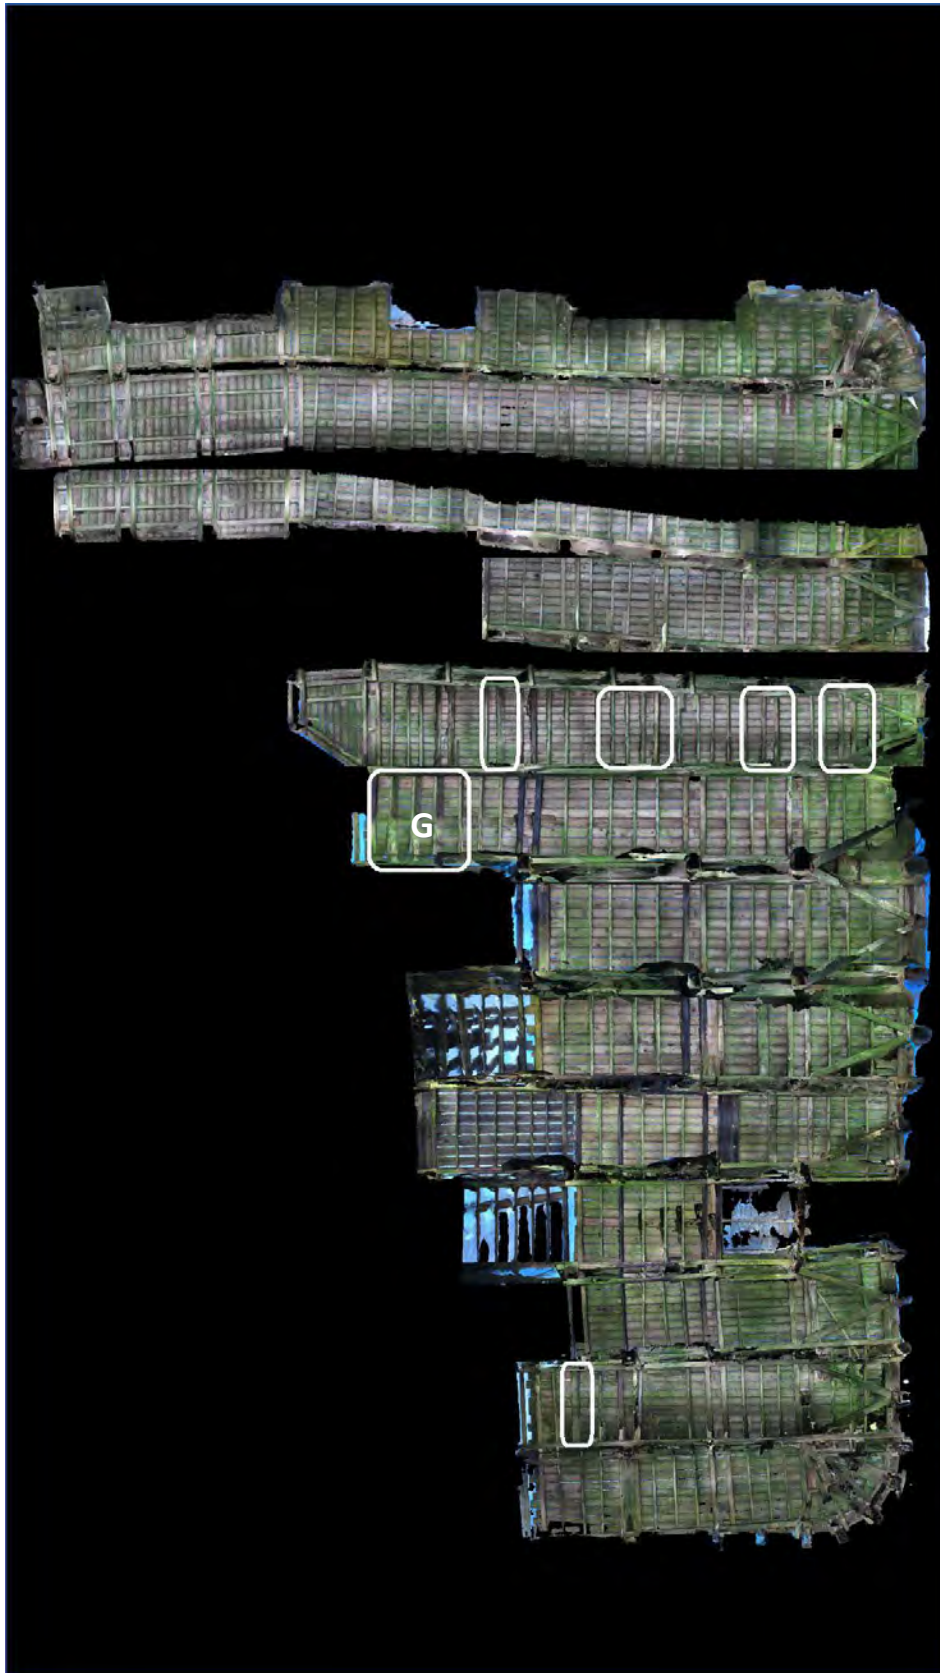
**FIGURE 19: Helensburgh Pier – Composite image of the underside of the pier showing areas with angled rafters (in white)**

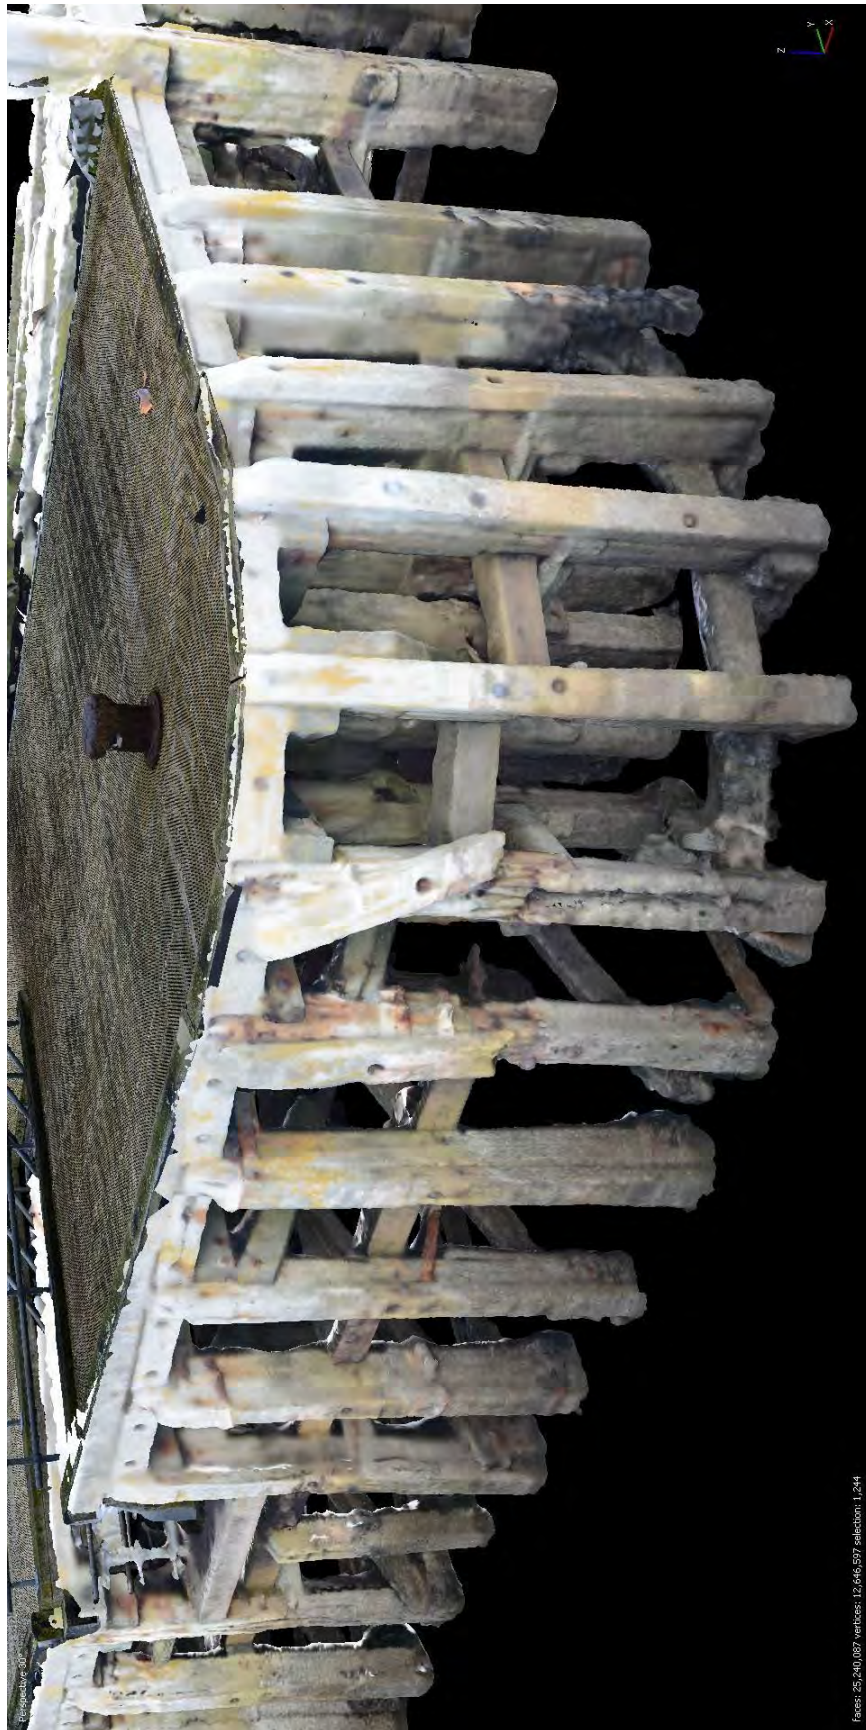
**FIGURE 23: Helensburgh Pier – Screen grab of exterior piling damage**

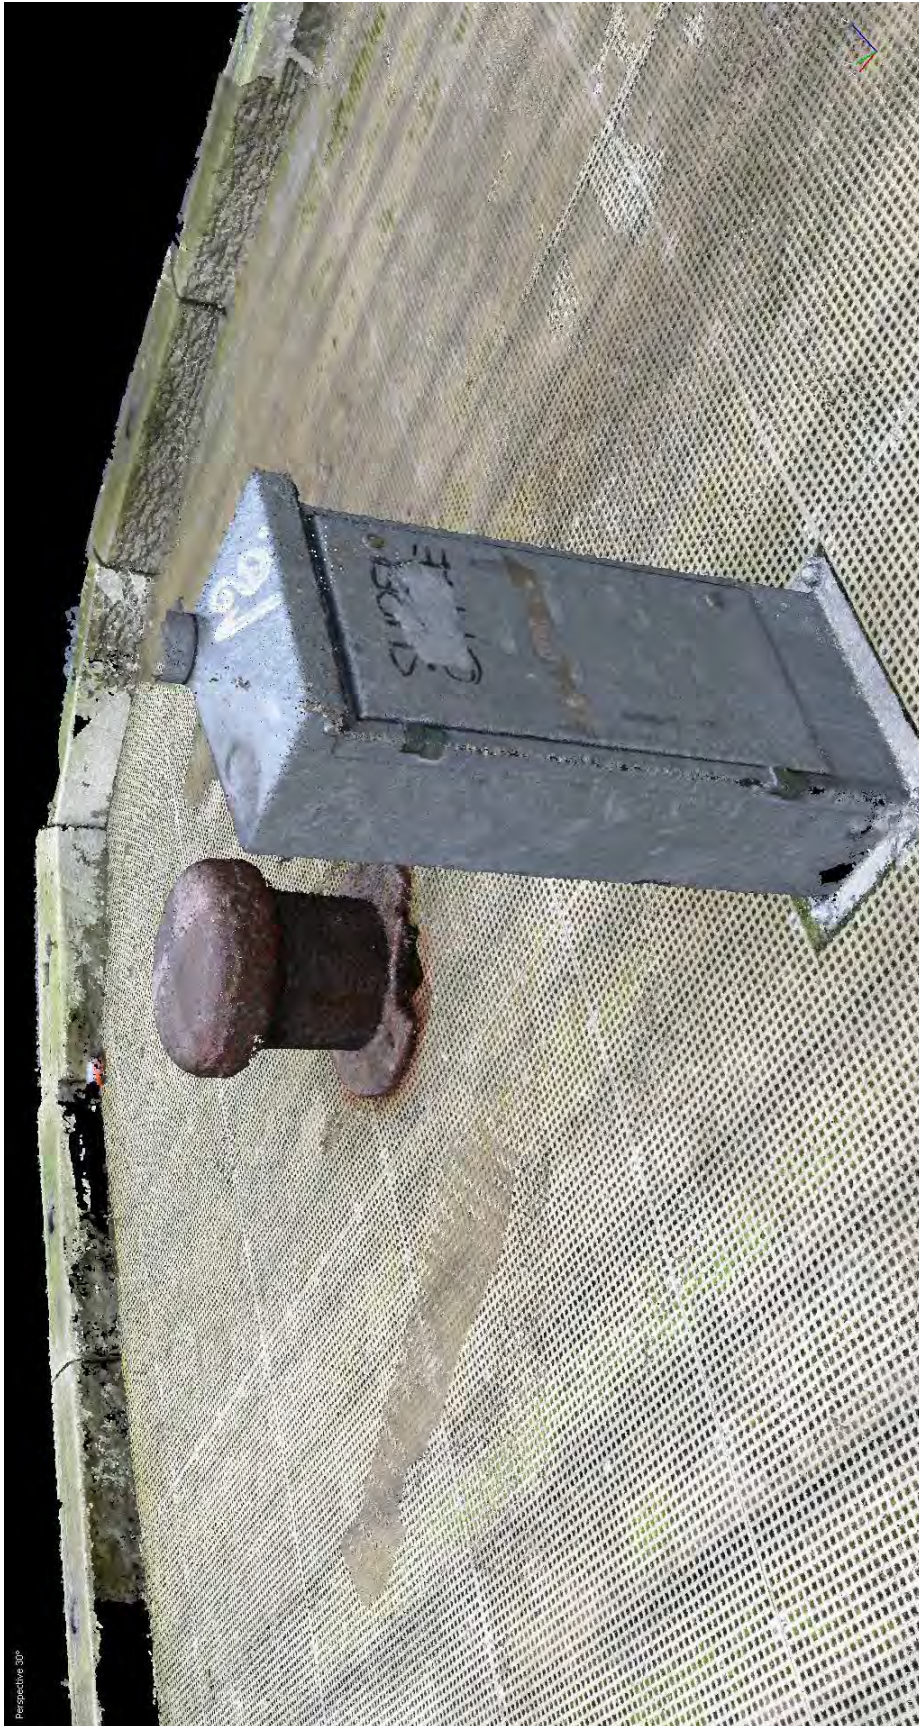
**FIGURE 24: Helensburgh Pier – Screen grab of deck bollard damage**

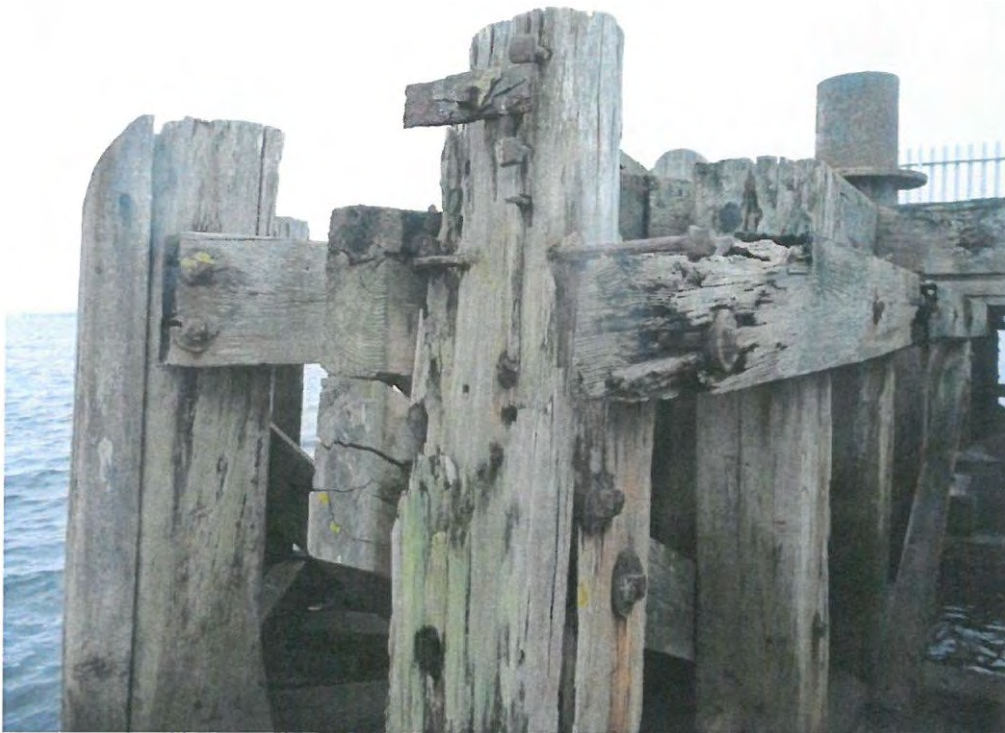
**Photograph 1** Rounded post (1-2) as a result of sapwood erosion/decay.
