## Helensburgh Pier

### Market Scoping Study

On behalf of **Argyll & Bute Council**

Project Ref: 332010810 | Date: May 2023

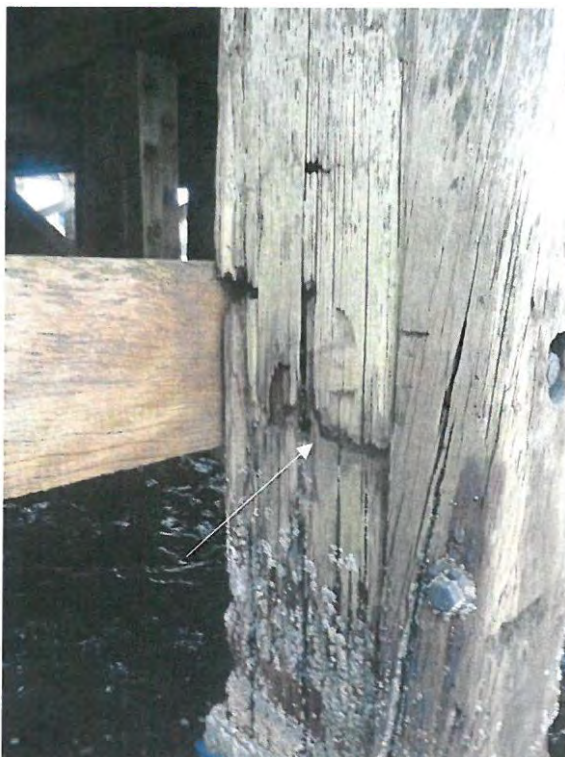
**Photograph 2** Significant cross grain fracture to inner pile A-3-b.

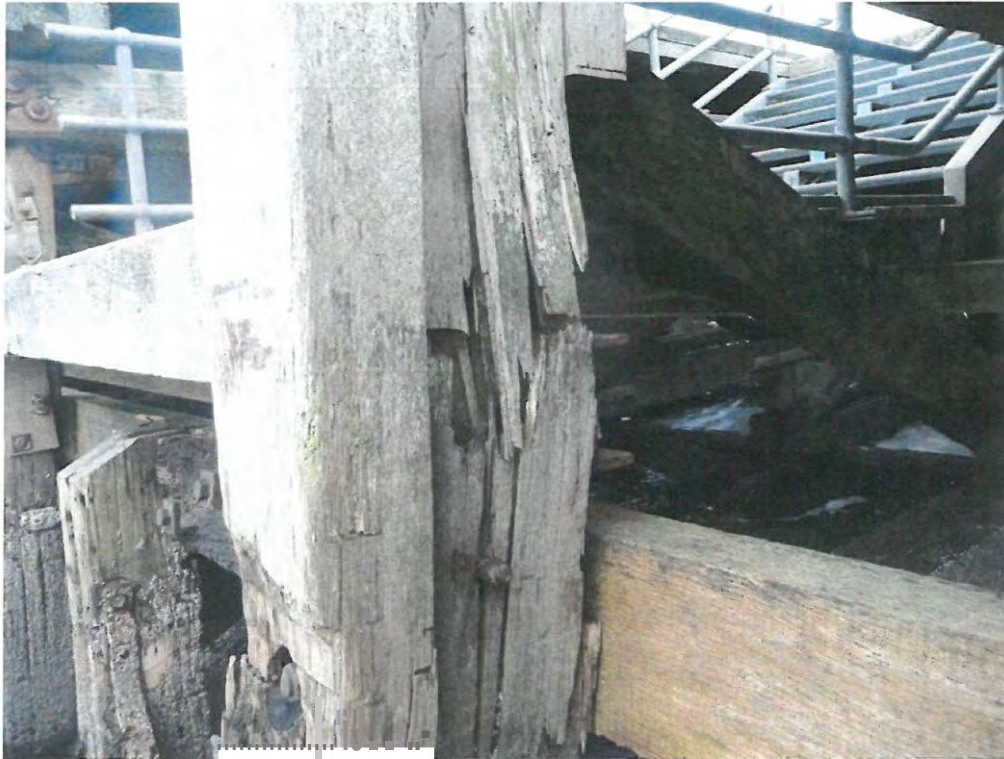
**Photograph 3 Significant cross grain fracture to inner pile A-4-a.**

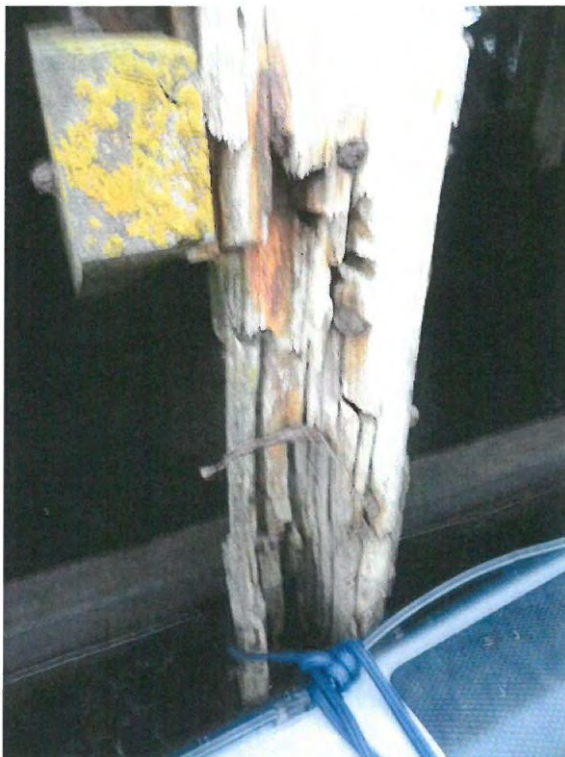
**Photograph 4 Significant loss of cross section due to impact damage and erosion to pile A-11-a.**

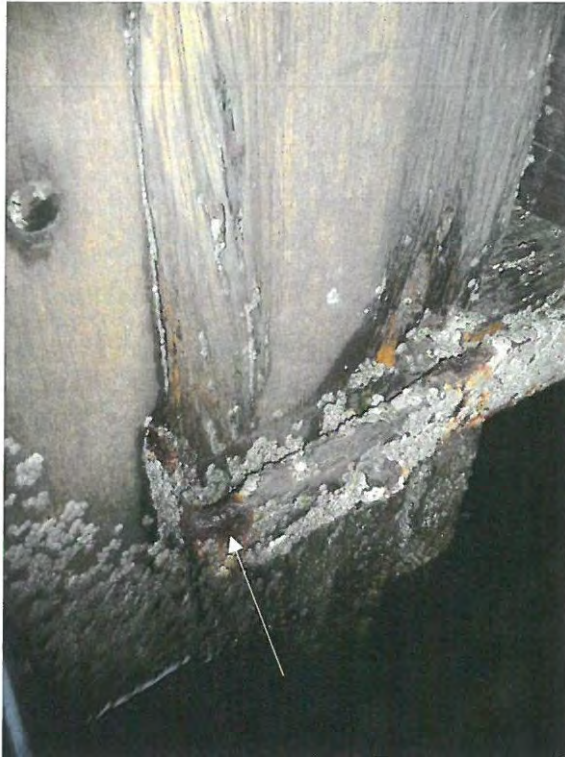
**Photograph 5 broken steel strap around pile D-13.**

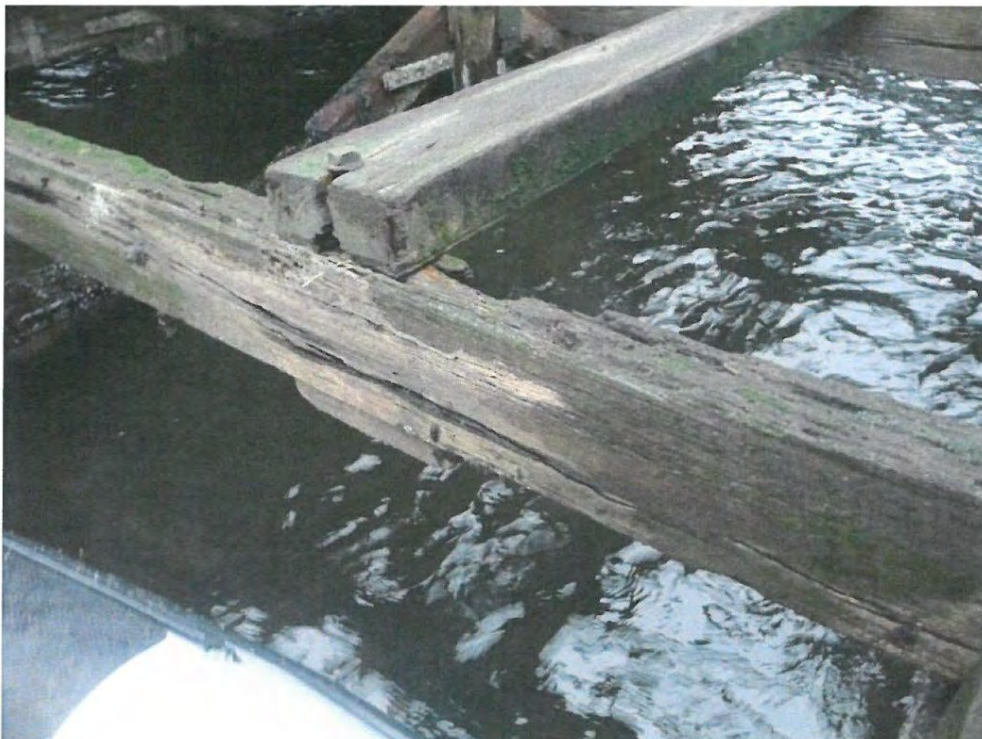
**Photograph 6 Example of significant decay and erosion to mid horizontals E-1 to F-1, E-2 to F-2 and F-1 to G-1.**

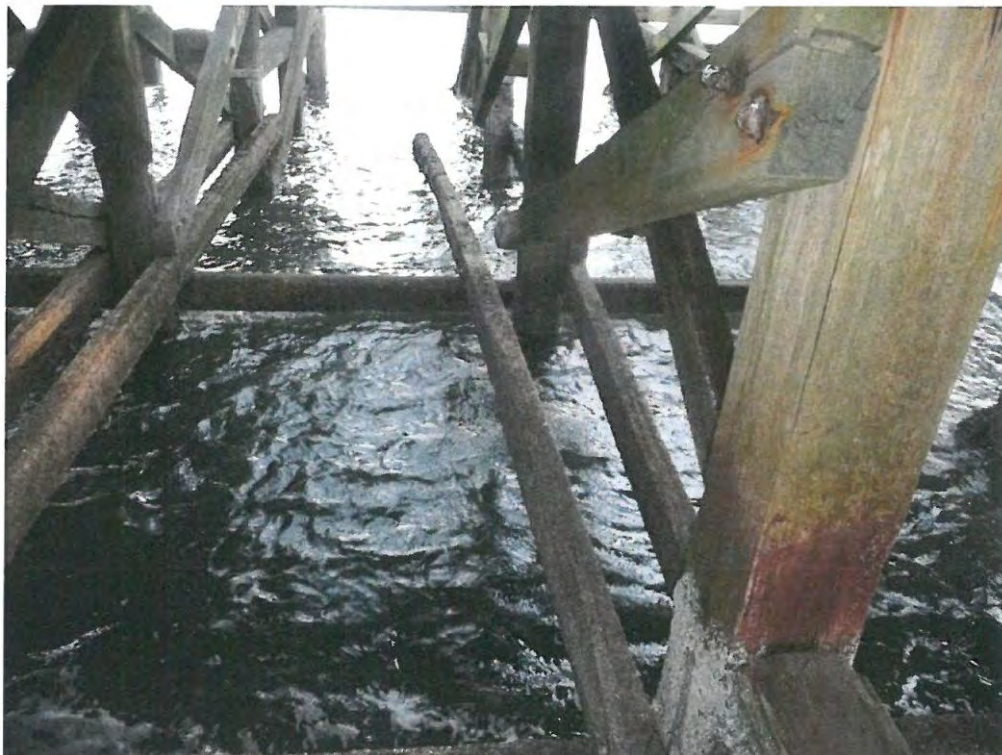
**Photograph 8 Horizontal beam C-6 to E-6 disconnected.**

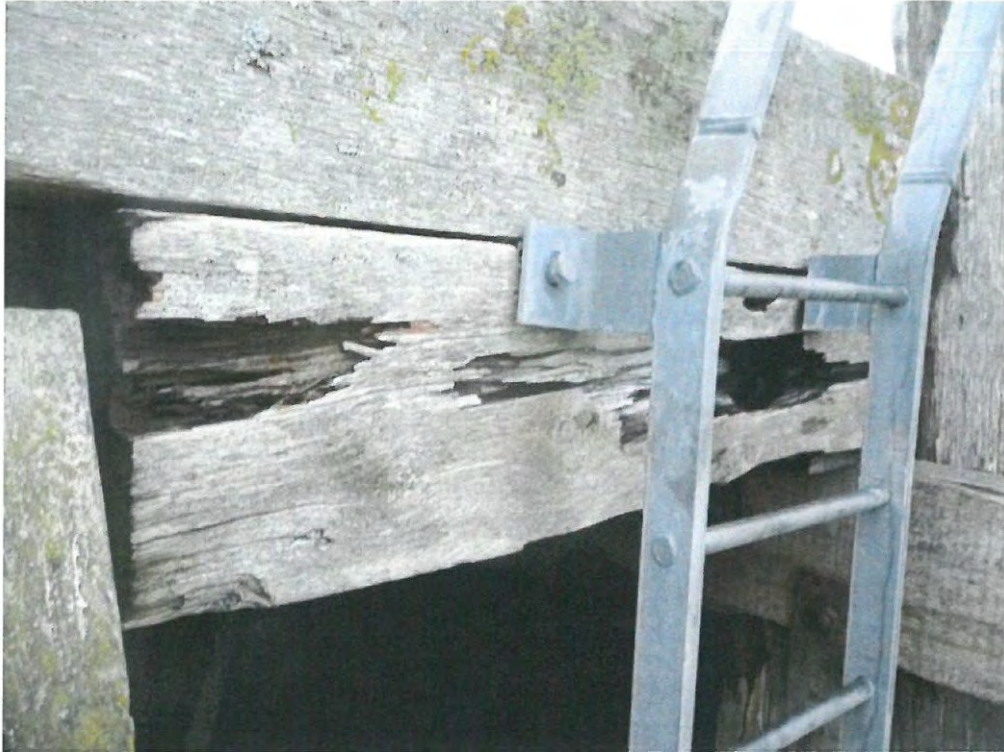
**Photograph 9 Significant decay to softwood noggings on the south elevation between piles A-6 and A-8.**

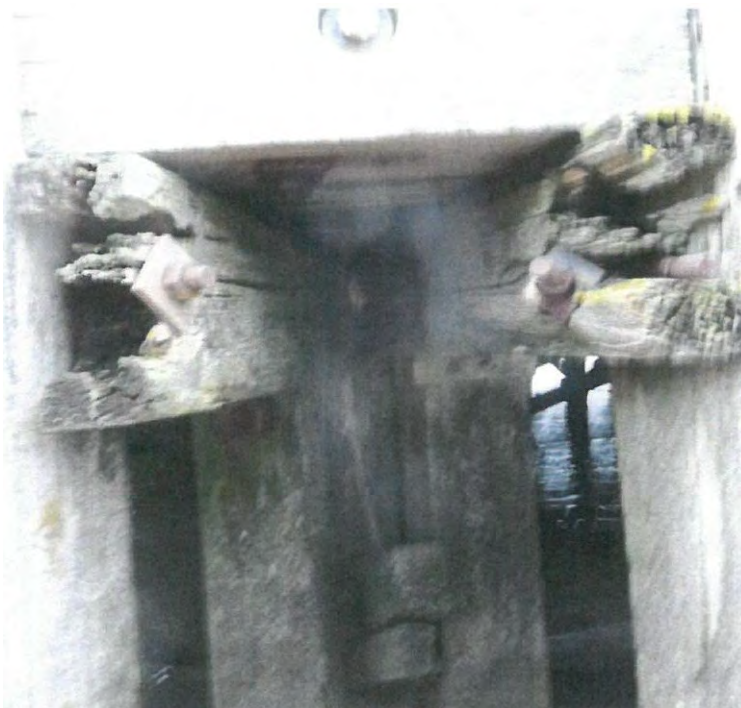
**Photograph 10 Significant decay to the south west ends of double deck joists at the south west corner.**

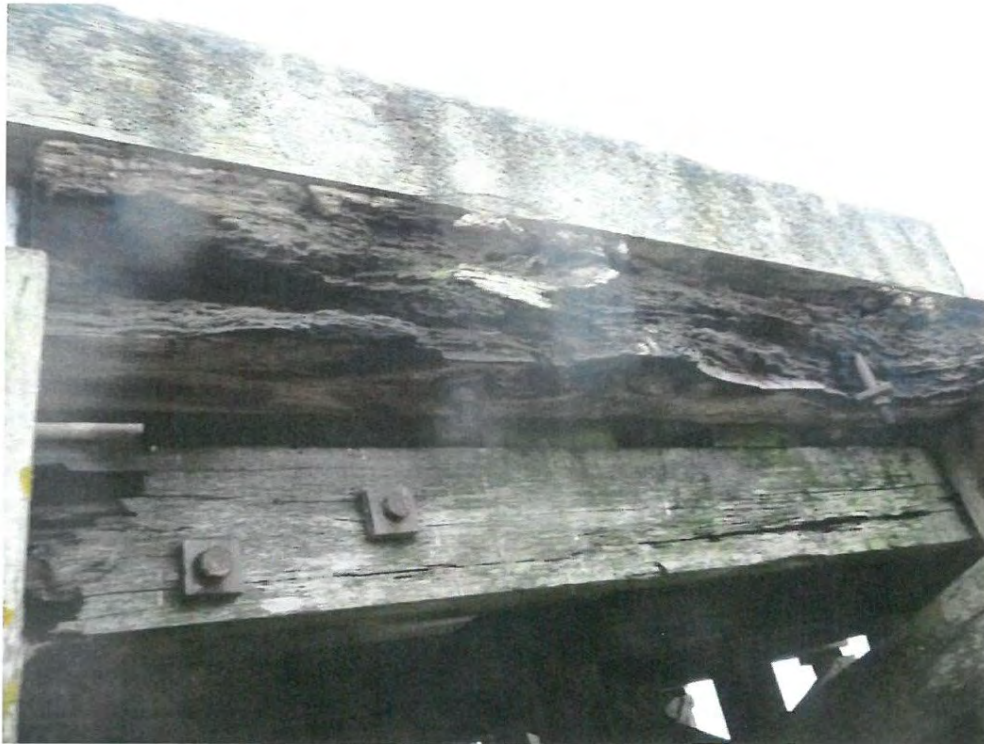
**Photograph 11 Significant decay to nogging on west elevation and horizontal member below.**

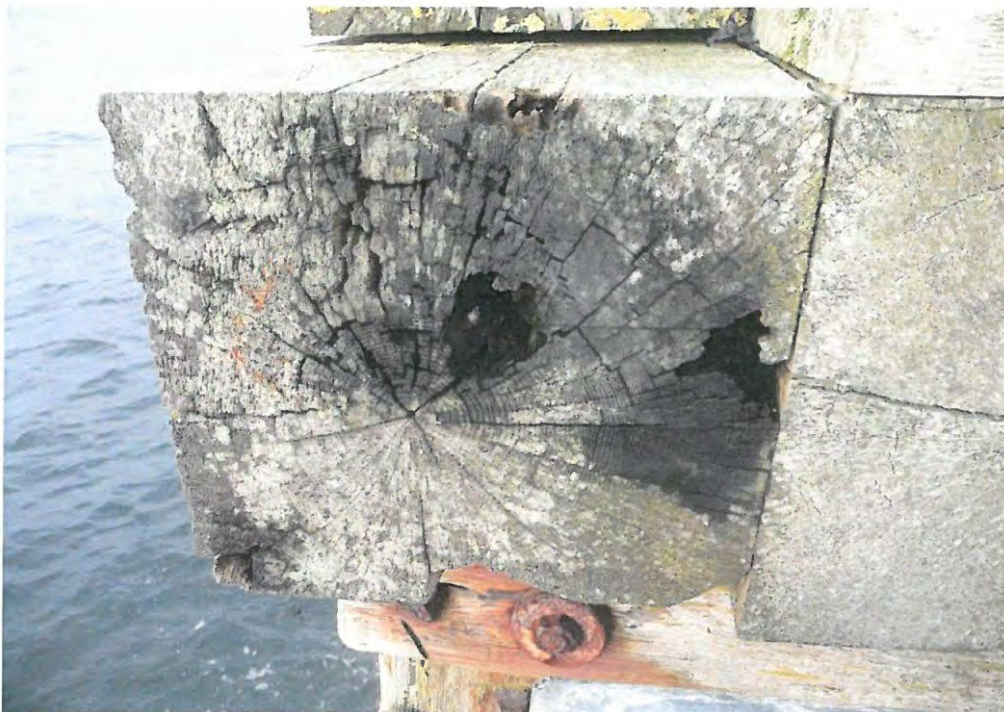
**Photograph 12 Fungal decay seen at end grain of a softwood nogging on the south elevation.**

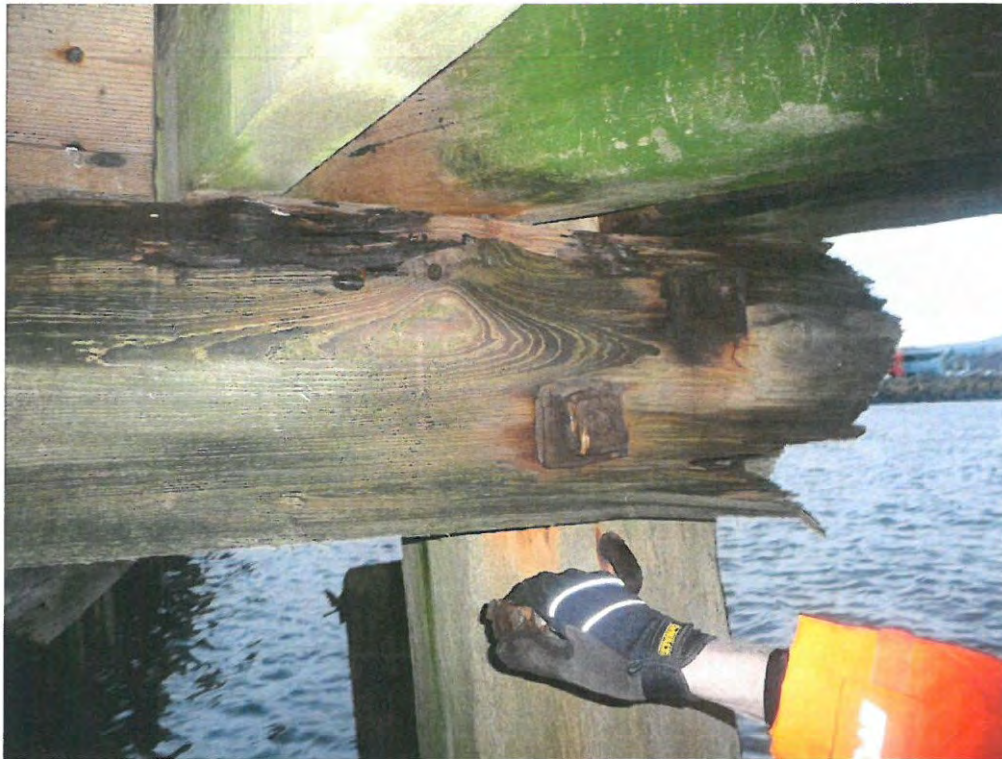
**Photograph 13 Example of a softwood double deck joist significantly decayed.**

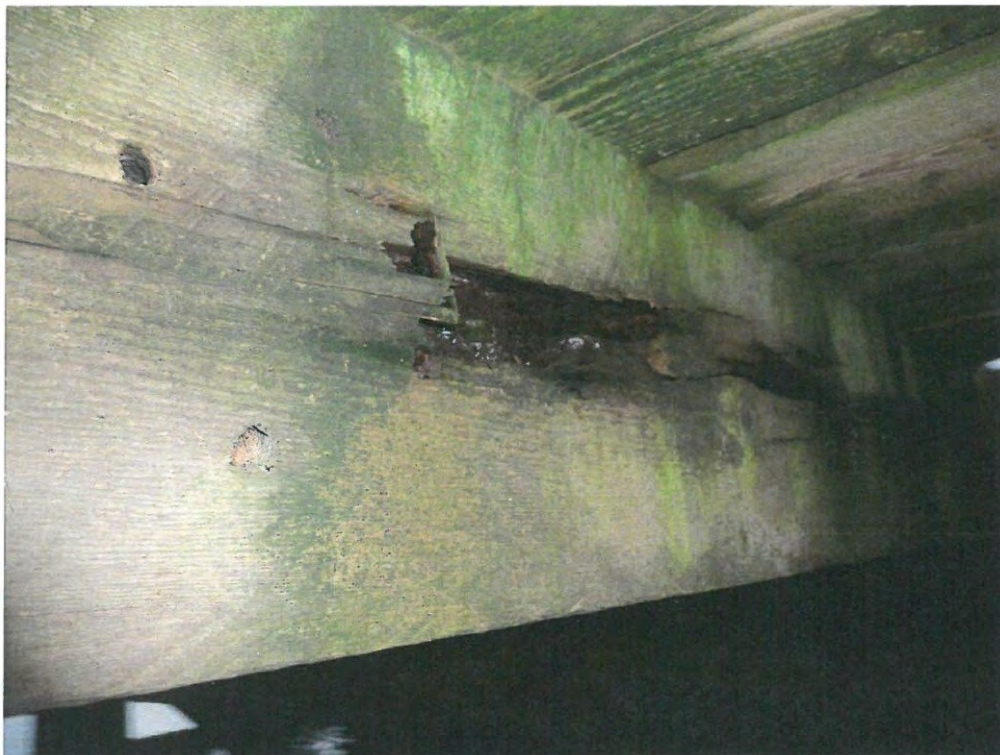
**Photograph 14 Example of a softwood deck joist significantly decayed.**

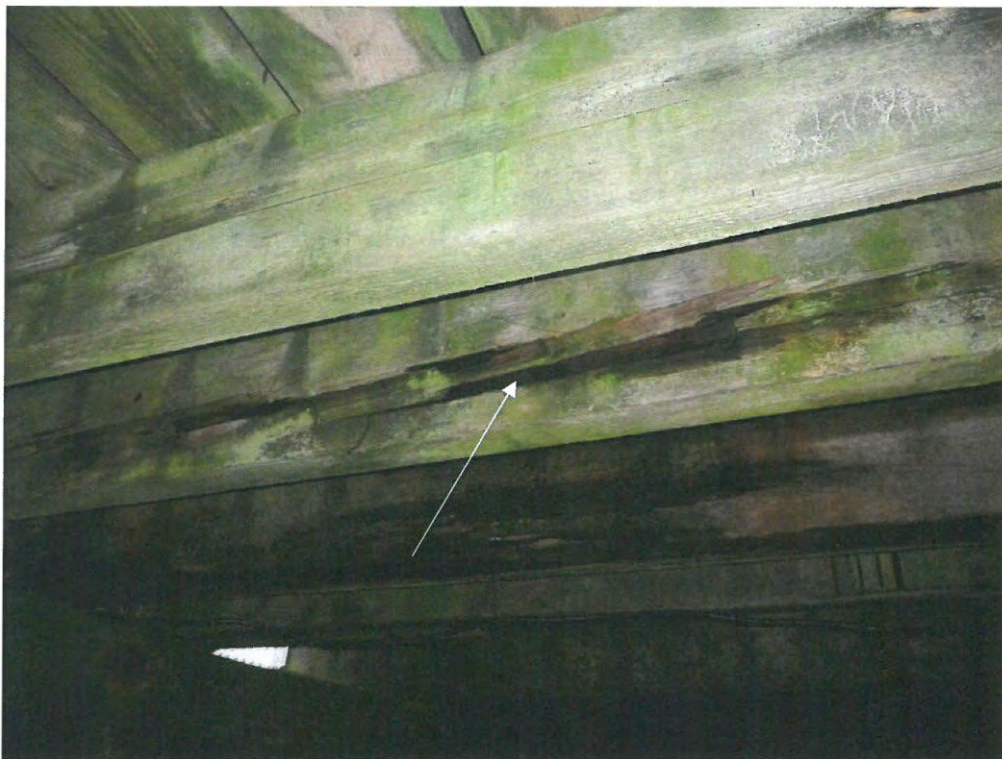
**Photograph 15 Example of a softwood deck joist significantly decayed.**

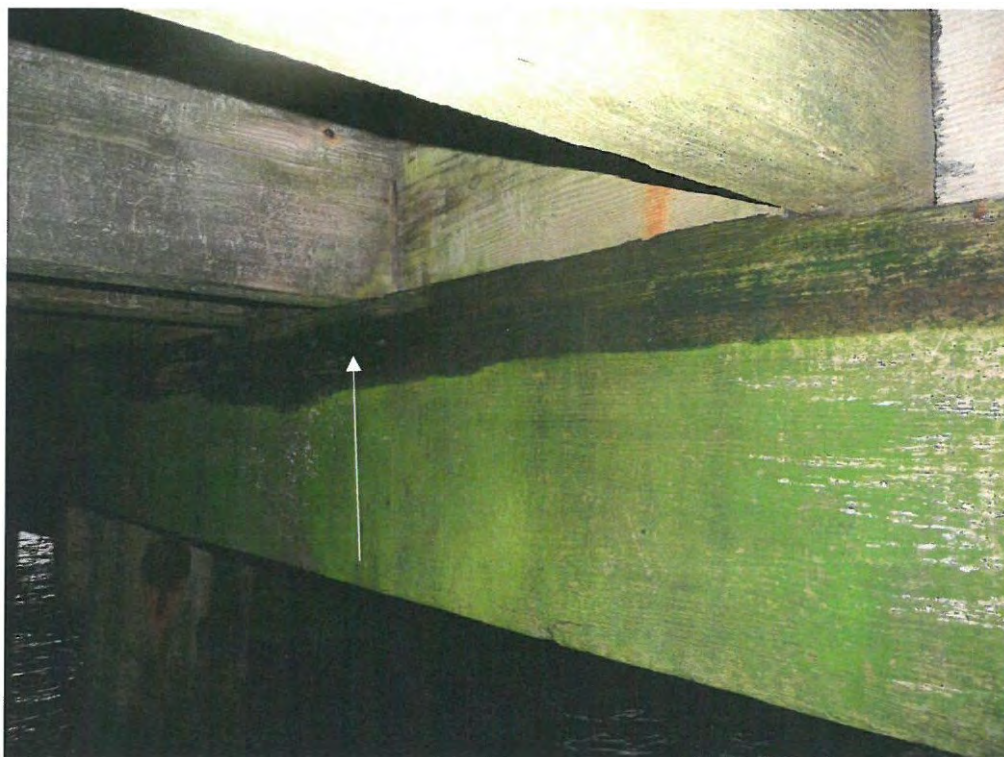
**Photograph 16 Example of a softwood double deck joist significantly decayed.**

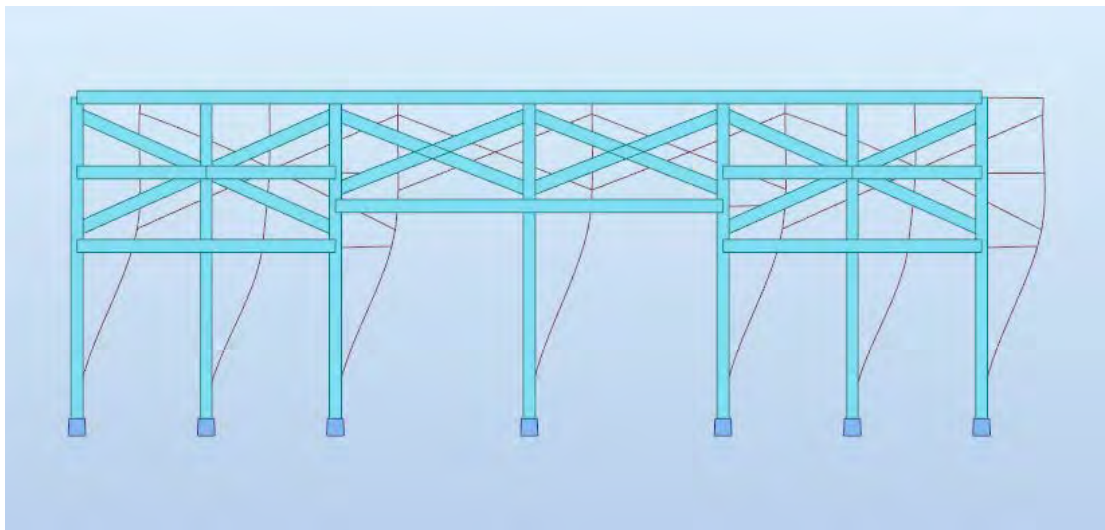
With the present condition of the timber elements, the structure failed with regards to BS 6349 calculated berthing and impact loads for a vessel representing the PS Waverley. The failure of the members was observed in exceeding the allowable displacements and stresses.

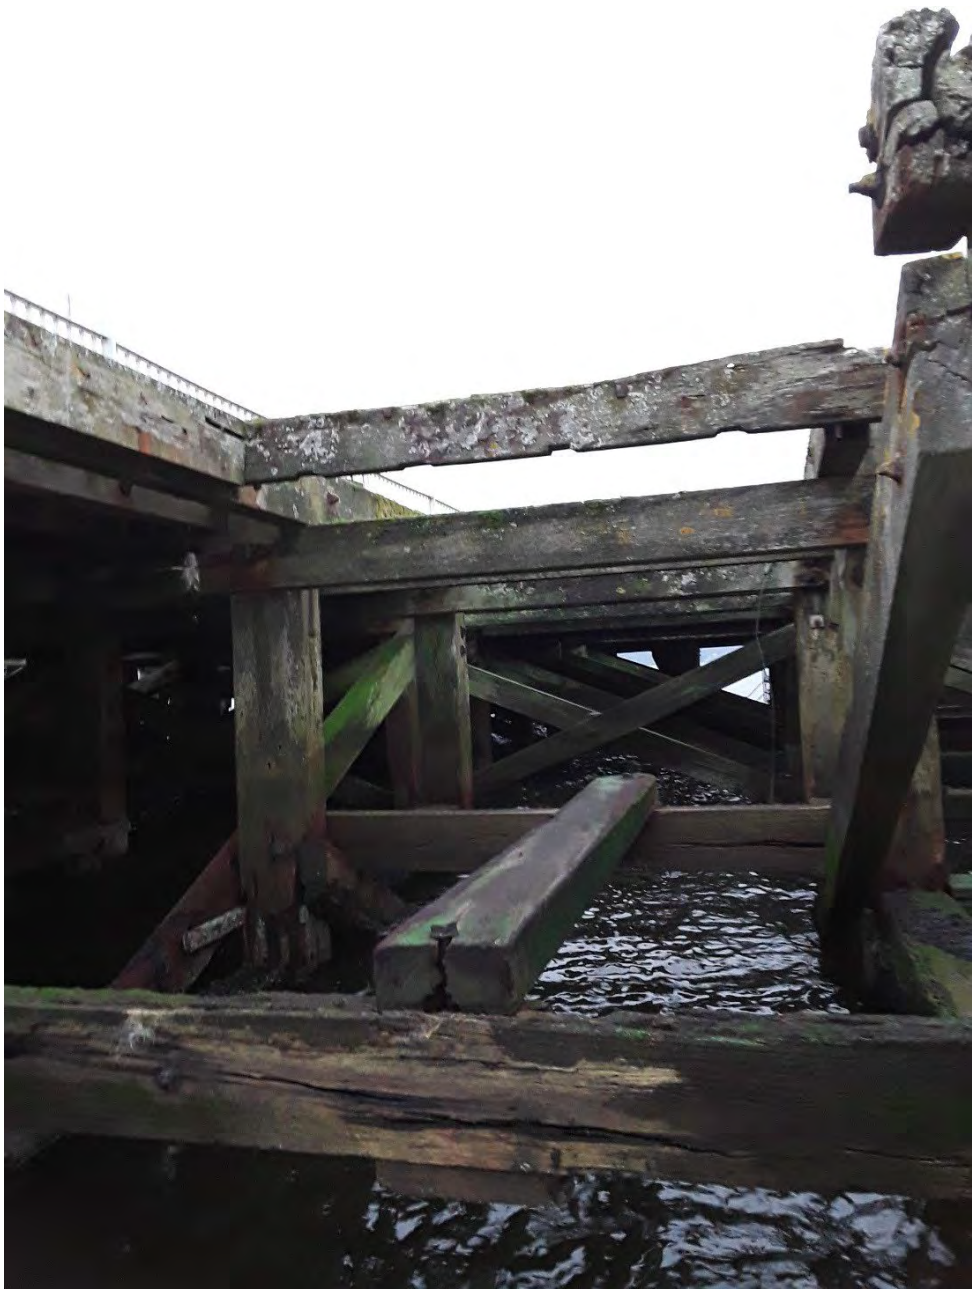
Fire damaged area missing deck planks

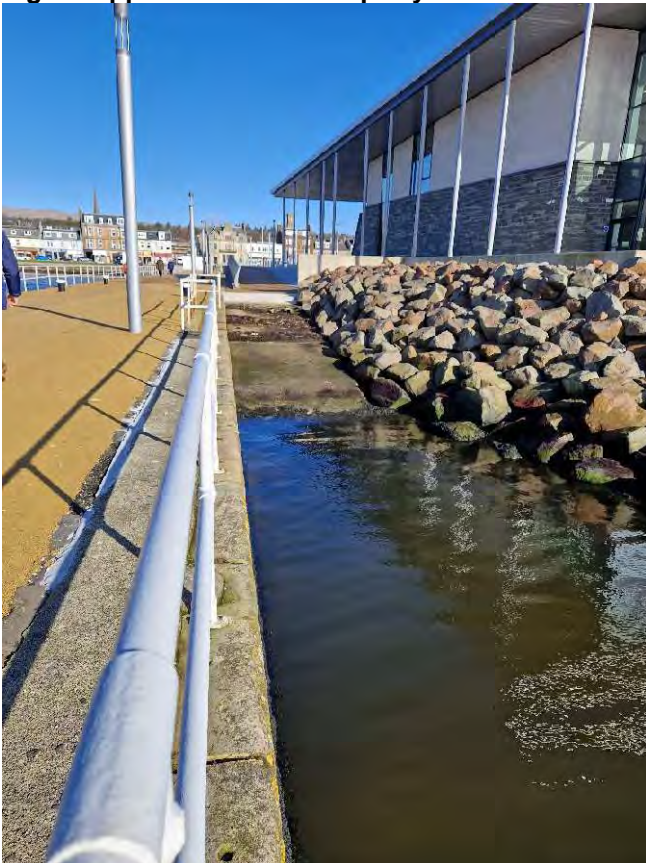
**Figure App B 5: Missing Steps on Western Side of Pierhead**

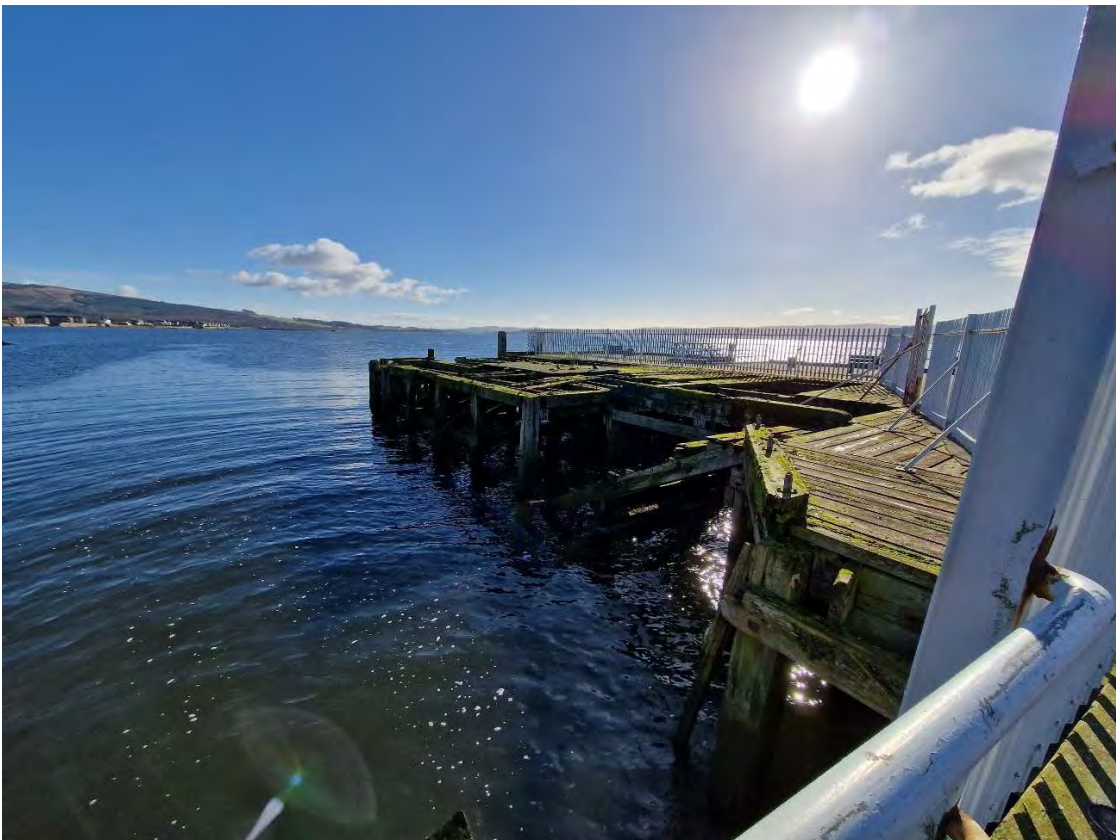
**Figure App B 8: Fire Damaged Section of Pierhead (1)**
