B8035 - Mull Rockfall Interim Assessment

10 October 2025

B8035 - MULL ROCKFALL

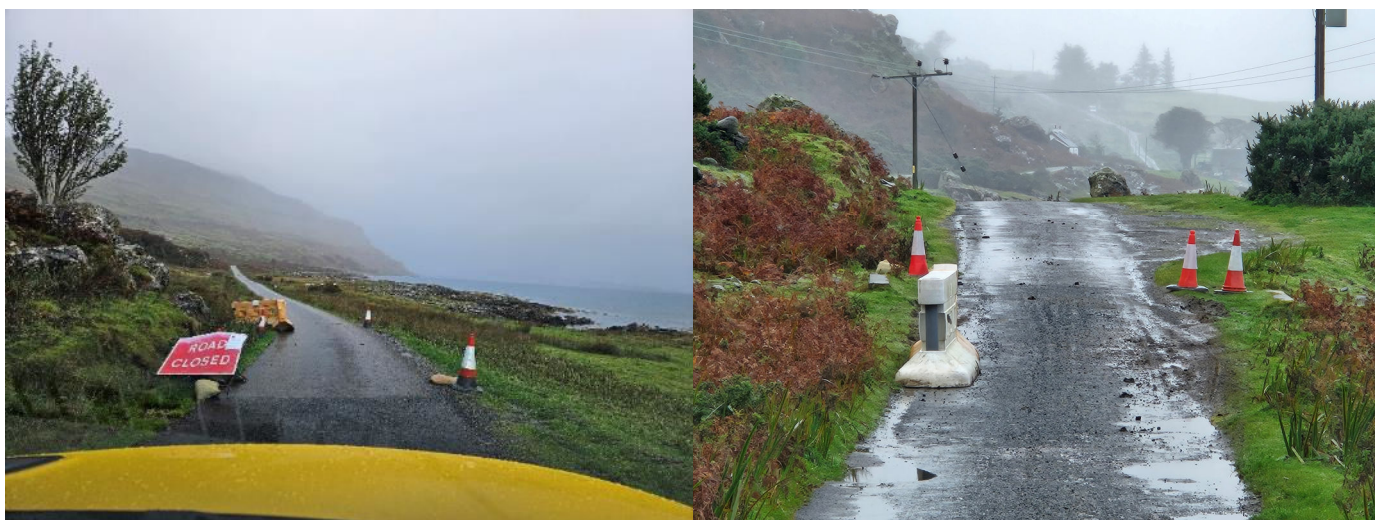
Upon arrival to site, it was noted that the safety barrier denoting the road closure had been pushed aside to allow for access Figure 2-1. This had occurred at both ends of the closure. During the site walkover, three vehicles belonging to members of the public passed through the closure area, with one vehicle passing in both directions.

It has been reported that the debris on the road from recent failures has been removed by members of the public, indicating that the road is still in use, despite the closure notice. (Wild, 2025)

Figure 2-1 - Removal of road closure barriers

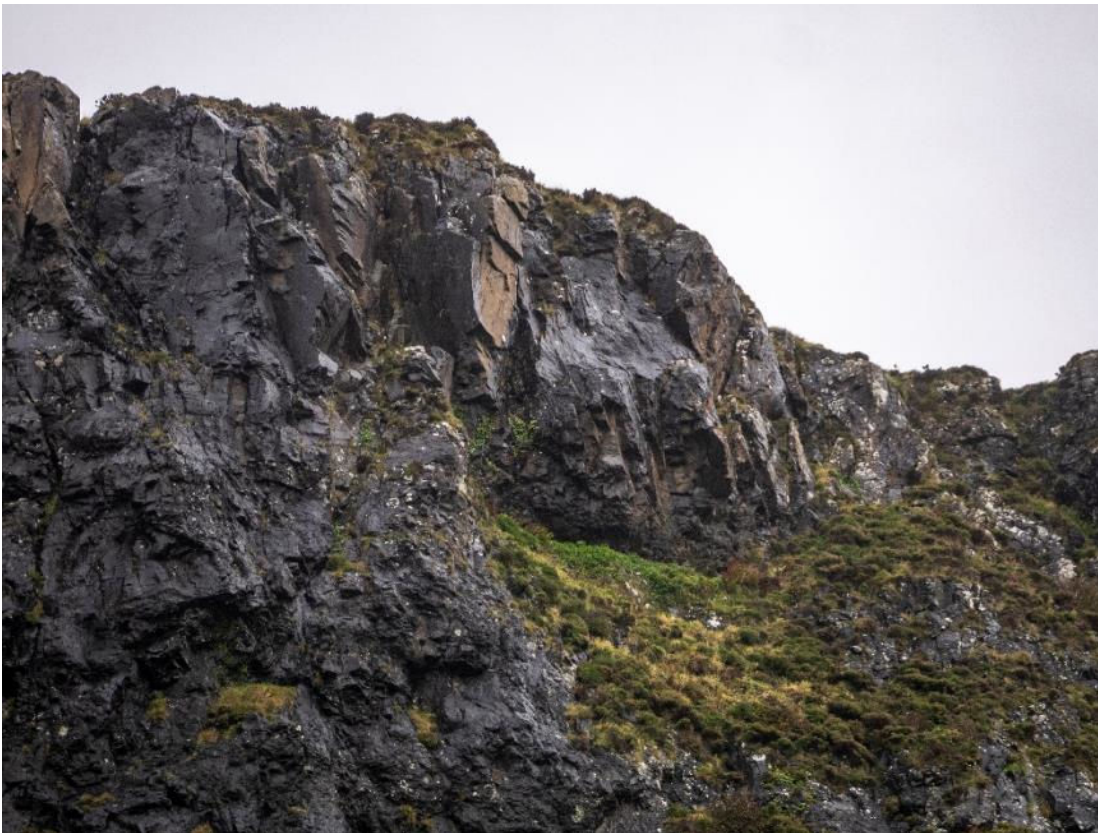
The rock slopes can primarily be split into two units based upon their expected engineering properties. These units are a stronger, relatively unweathered unit of basalts, and a weaker, more weathered basalt unit.

Figure 3-1 – The upper section of rock face consist of the jointed, unweathered basaltic rock unit with the more weathered, less well jointed unit visible in the lower section.

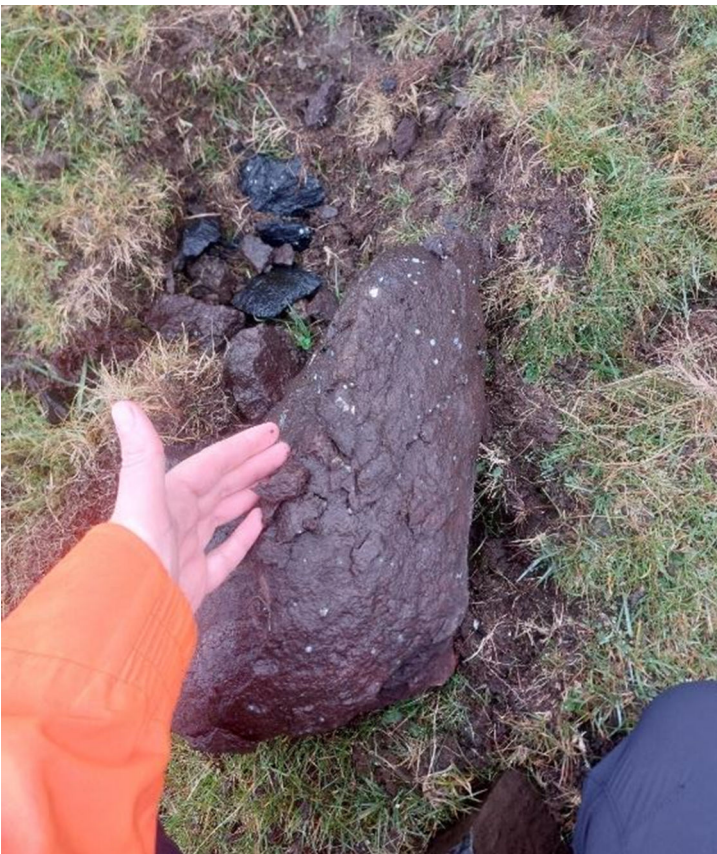
This unit showed a loss of strength (10-20 MPa) when compared to the unweathered rock, and the surface of blocks of this unit was able to be peeled and crushed by hand. This indicates a weak to moderately weak rock (British Standards Institute, 2020). Reddish discolouration of this unit was observed. Joint sets were not as well developed within this unit. With relatively few kinematically controlled failures due to the intersection of discontinuities being observed.

Figure 3-2 - Weathered basalt block (in impact crater) which the surface layer was able to be broken by hand, indicating a loss in strength

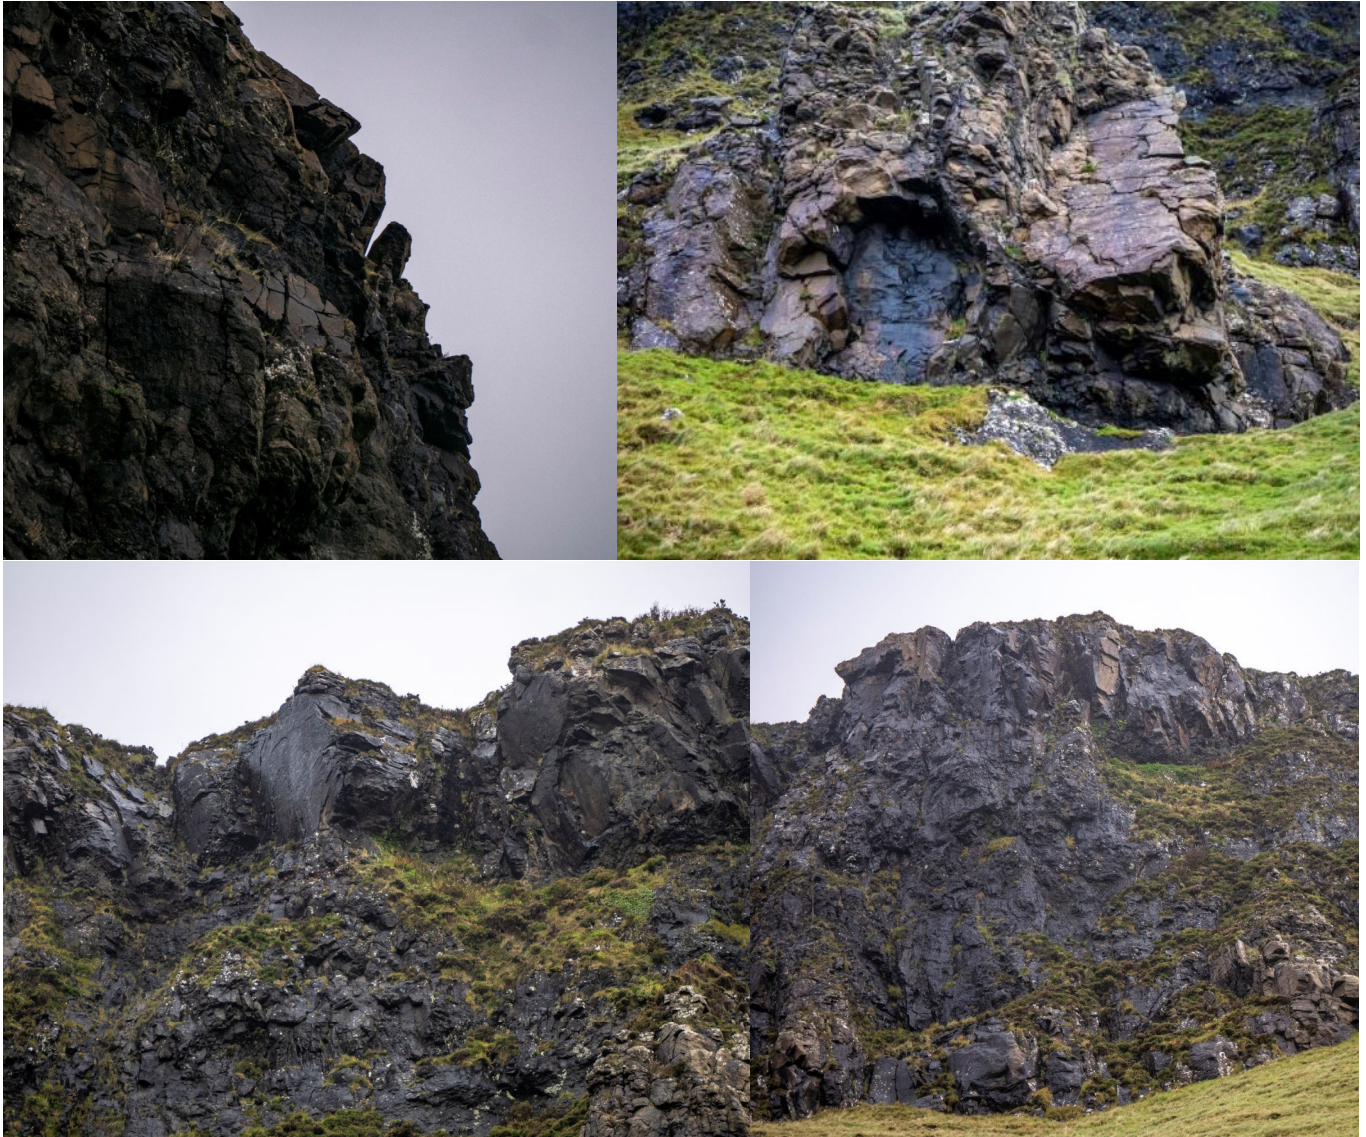
Several contributing factors to rock slope instability were identified during the site walkover. More competent rock units have been undermined due to the erosion of the weaker, more weathered rock underlying it. This process has resulted in formerly stable blocks of competent rock becoming unsupported, leading to failure along intersecting discontinuity sets. Multiple kinematic failure mechanisms were observed in the field, including planar sliding, wedge failure, and toppling, as illustrated in Figure 3-3.

Figure 3-3 - (Top left) Potential toppling failure, (Top right) Planar sliding failure, (Bottom) Planar and wedge failures due to intersecting discontinuities

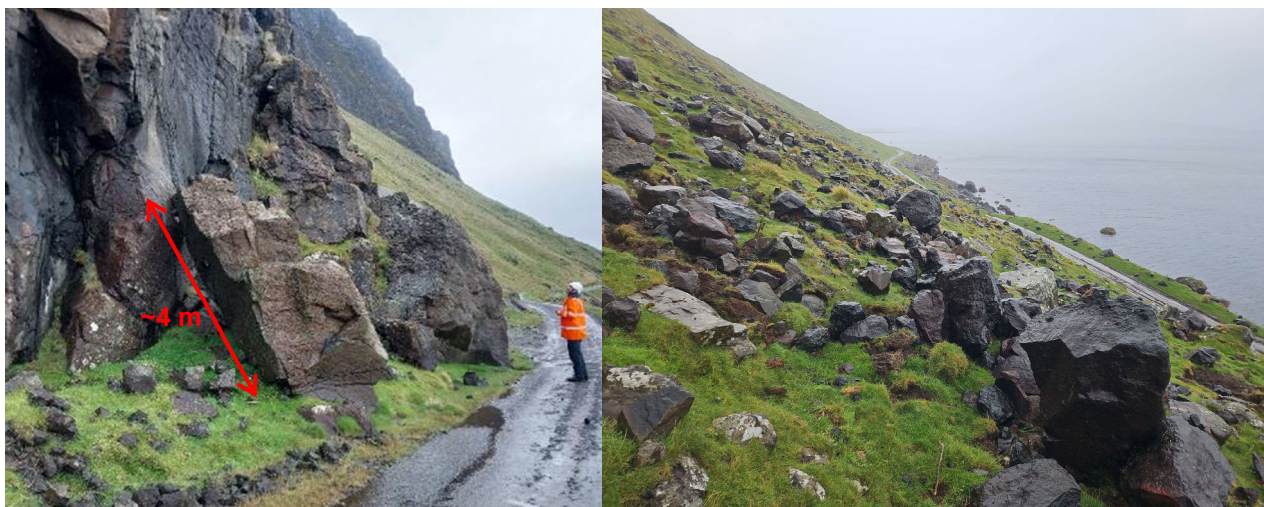
A variety of block sizes were observed on site ranging from small blocks a few cm across to several large blocks around 3-5 m in length. Many of these larger blocks were located downslope of the road and tended

to have a cubic shape. Blocks deposited adjacent to the road generally were of the scale of 0.2 - 0.5 m across, including those deposited during the recent rockfalls (Figure 3-4).

Figure 3-4 - (Left) Large approx. ~4m tall block located immediately adjacent to the road, person is approx. 2 m tall. (Right) Range of block sizes deposited next to the road including those from the most recent failures.

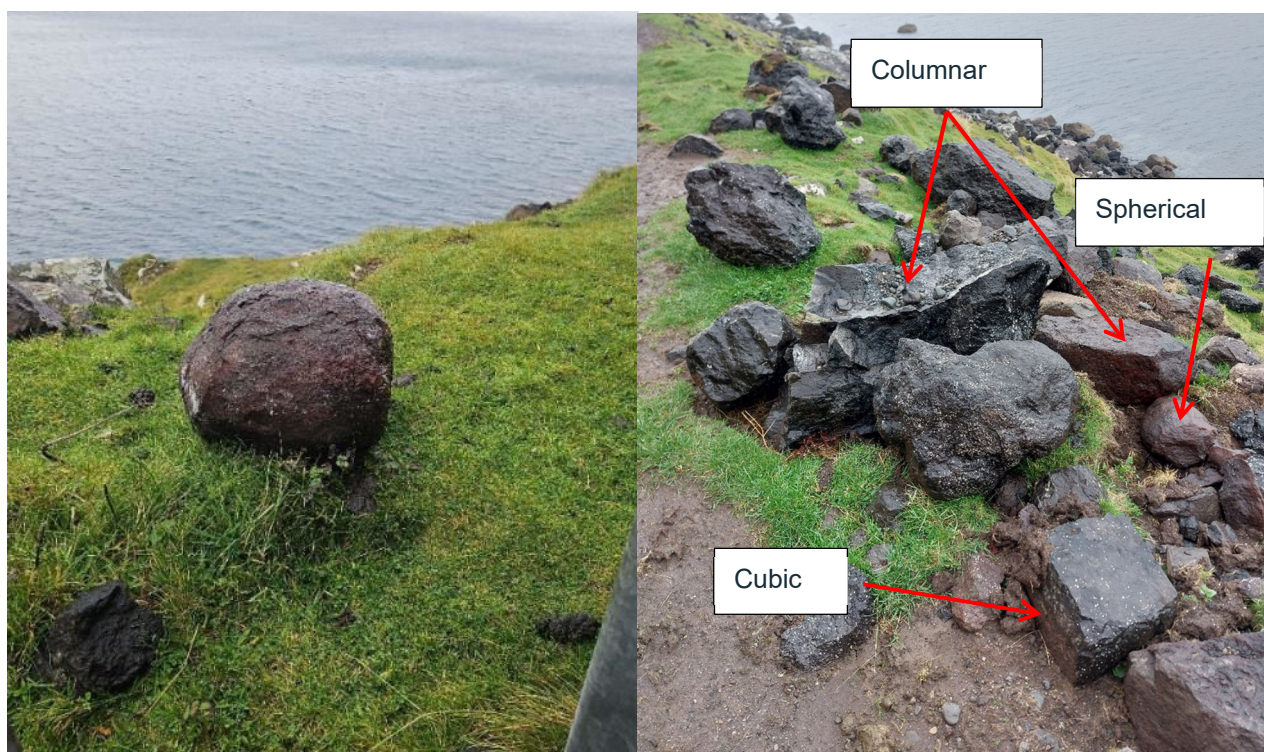
A variety of block shapes were observed across the site area including cubic, spherical, and columnar, as shown in Figure 3-5. Block shape impacts the expected runout of the block, with more equant shaped blocks (e.g. spherical or cubic blocks) expected to travel further than those with a flatter shape and therefore present a greater risk due to the increased likelihood of these rocks rolling and bouncing.

Figure 3-5 - (Left) Rounded block (0.3 m across), (Right) Variety of block shapes cleared from the recent event.

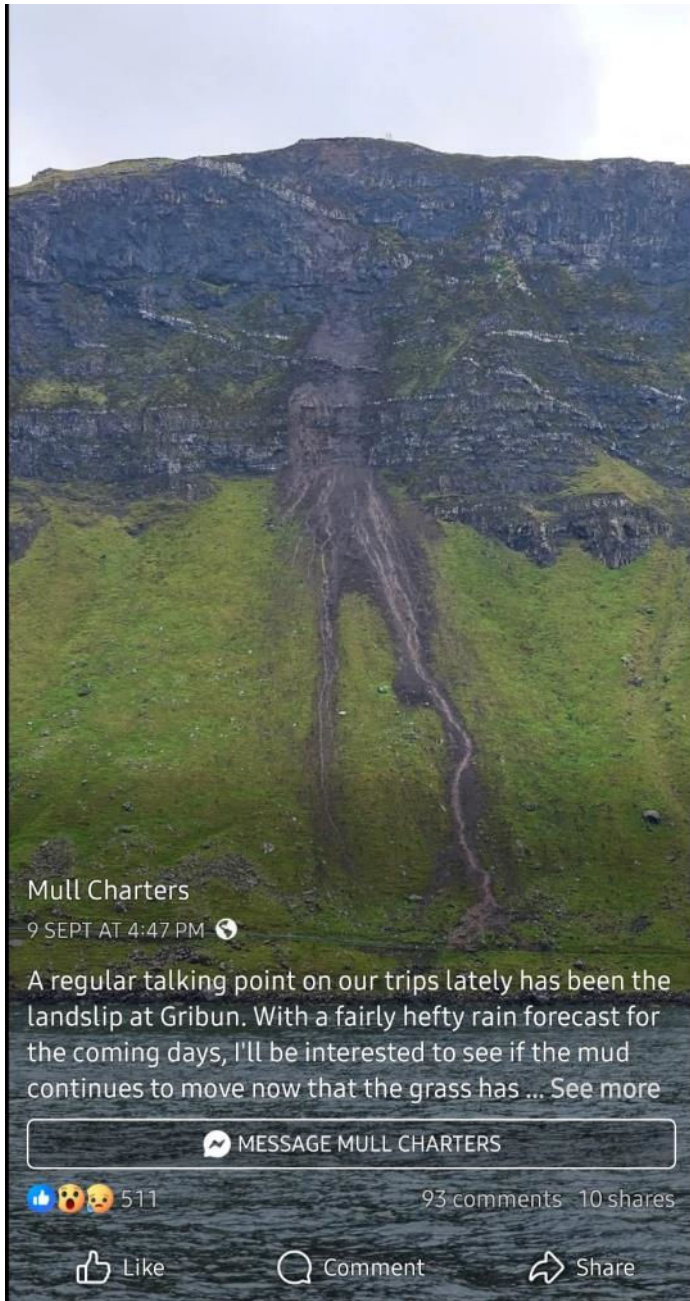
There was further washout of fine material onto the road which has been estimated to have occurred in early September, as evidenced by a photograph posted to the “Mull Charters” Facebook page on the 9th of September showing muddy water flowing below the failure area within the deposited material (Figure 3-6). The exact timing of movement is unknown but is assumed to be close to the time that the image was posted.

Figure 3-6 - Photograph posted on the "Mull Charters" Facebook page showing muddy water transporting failure material down to the road

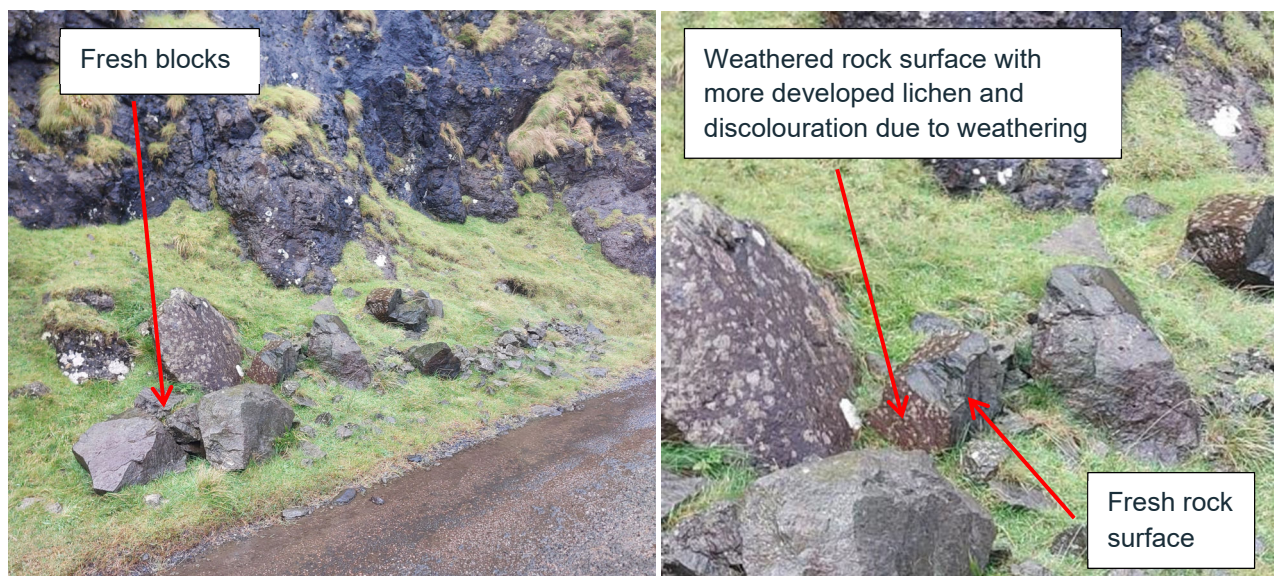
Throughout the site area there were many blocks located immediately above and below the road, indicating that rockfalls have frequently reached the road level in the past. While many of these blocks were covered in lichen indicating that they had been at their current location for a significant amount of time, many blocks showed fresh surfaces, indicating that they had been mobilised fairly recently¹. The positioning of some of these smaller blocks within the verge right next to the road indicates that they may have been deposited on the road and have been moved by road users, seen in Figure 3-7

Figure 3-7 - (Left) Fresh rock blocks located immediately adjacent to the road, their positioning indicates that they may have been removed from the road by road users following failure. (Right) fresh surfaces visible on an otherwise weathered rock block indicating that the block may have been mobilised from the rock face, or impacted by another falling rock fairly recently

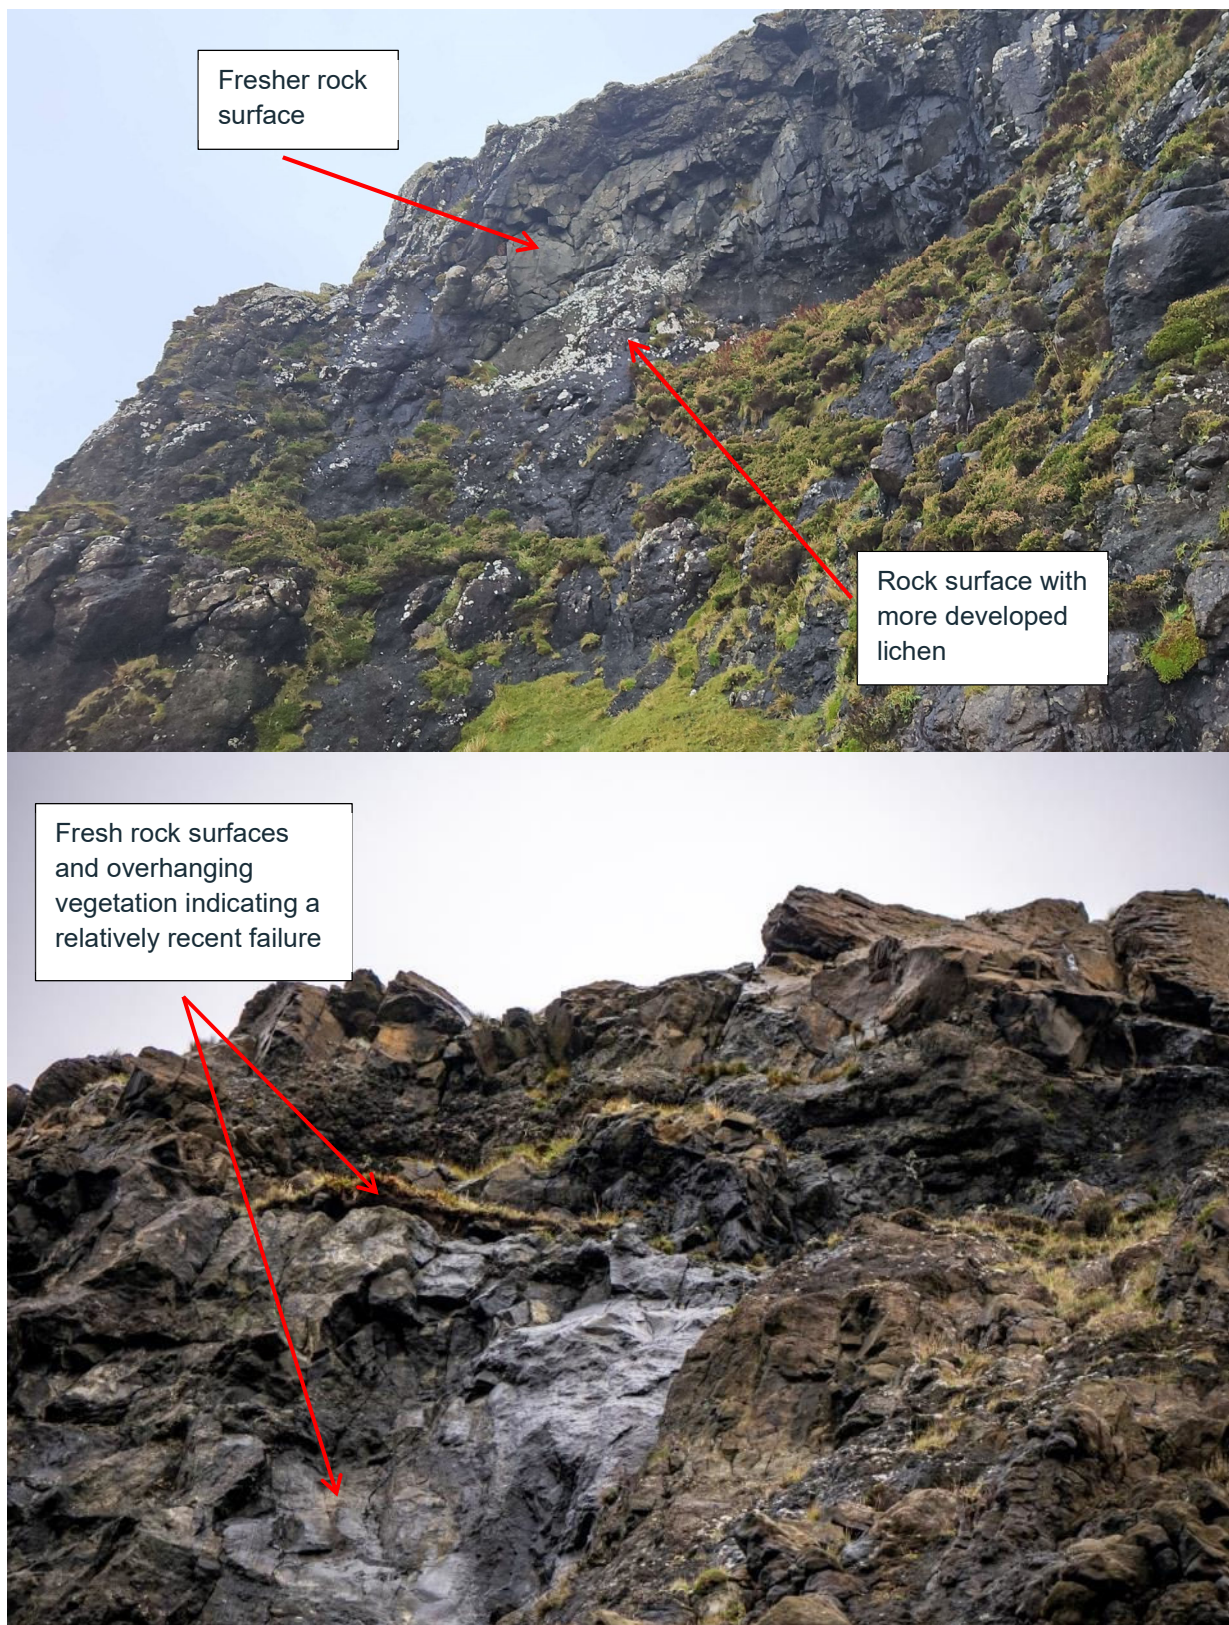
Fresh rock surfaces are also visible within the rock faces across the site. This is also indicated by the presence or absence of lichen and other vegetation, and lack of surface discolouration indicative of weathering processes affecting the rock face, as seen in Figure 3-8.

Figure 3-8 - (Top) Rock face showing areas with differing amounts of lichen development. (Bottom) Rock face showing fresh, non-discoloured rock faces and overhanging vegetation.

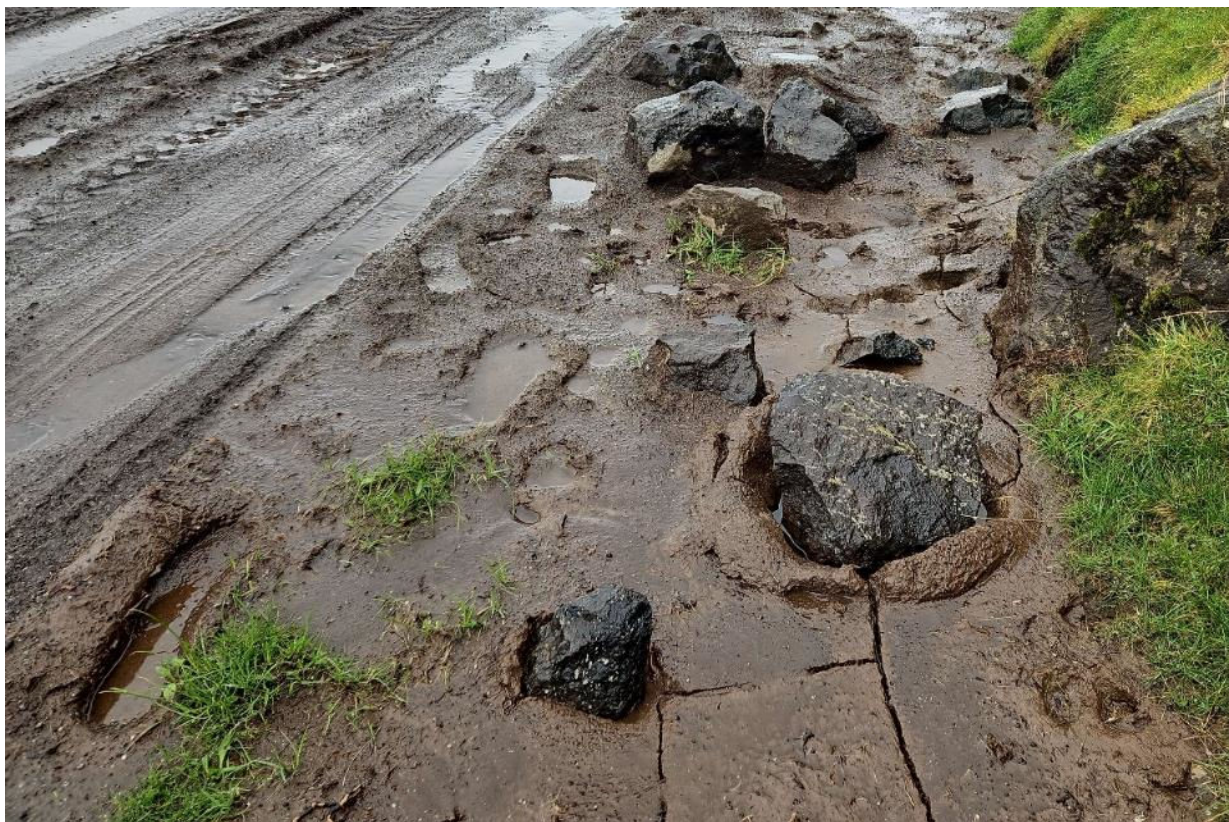
Blocks observed during the site visit (Figure 3-9) had displaced the fine material previously deposited on the road surface, indicating that their mobilisation occurred after the deposition of this material, which is estimated to have taken place in early September 2025.

Figure 3-9 - Block that has displaced fine debris material, indicating that it mobilised after the debris was washed onto the road. Block is approximately 0.2 m across

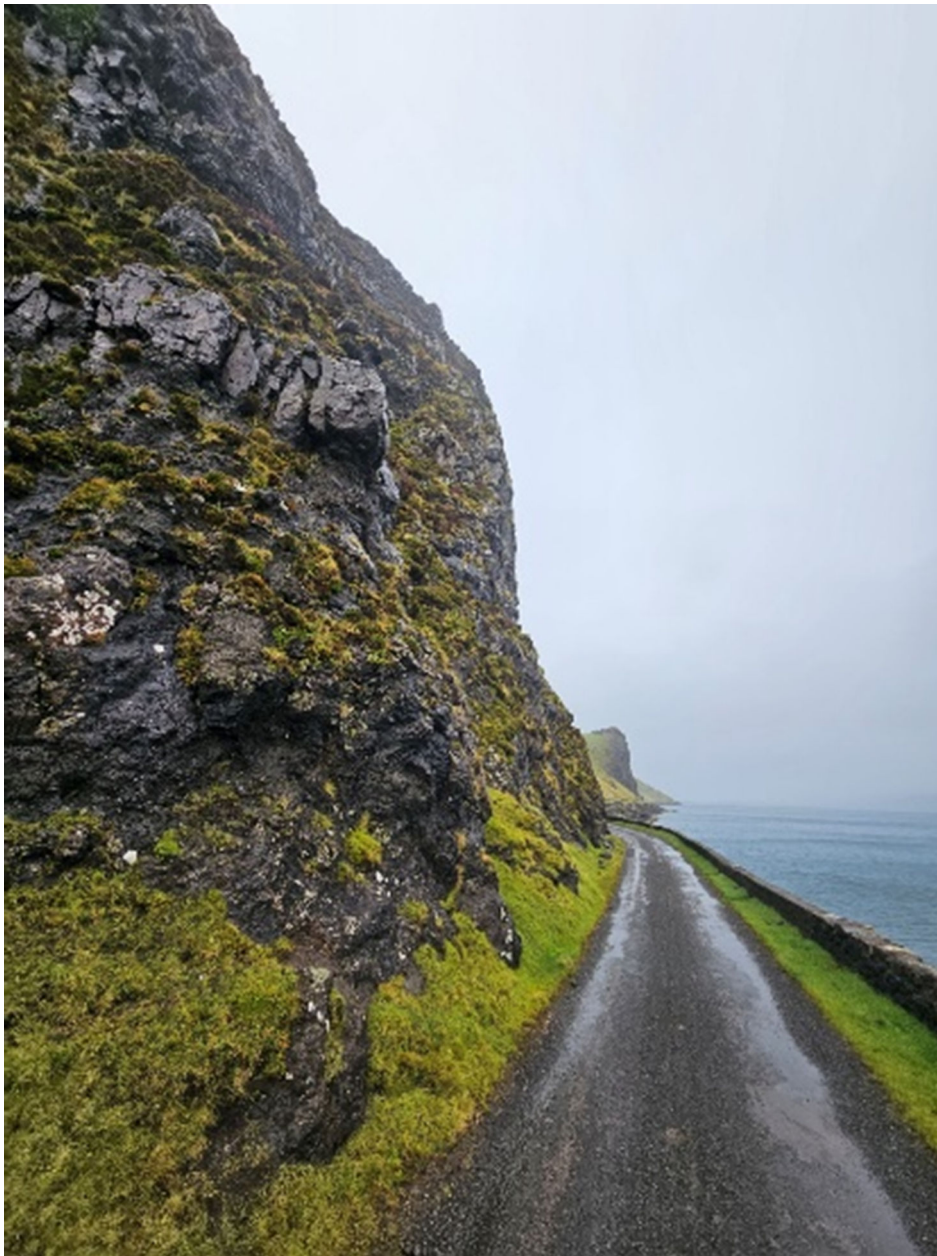
Due to the topography of the site, it is assumed that the likelihood of detached blocks reaching the B8035 is extremely high. Several rock faces are located immediately adjacent to the road, and any material detaching here will impact the road as seen in Figure 3-10.

Figure 3-10 - Rock slope immediately adjacent to the road

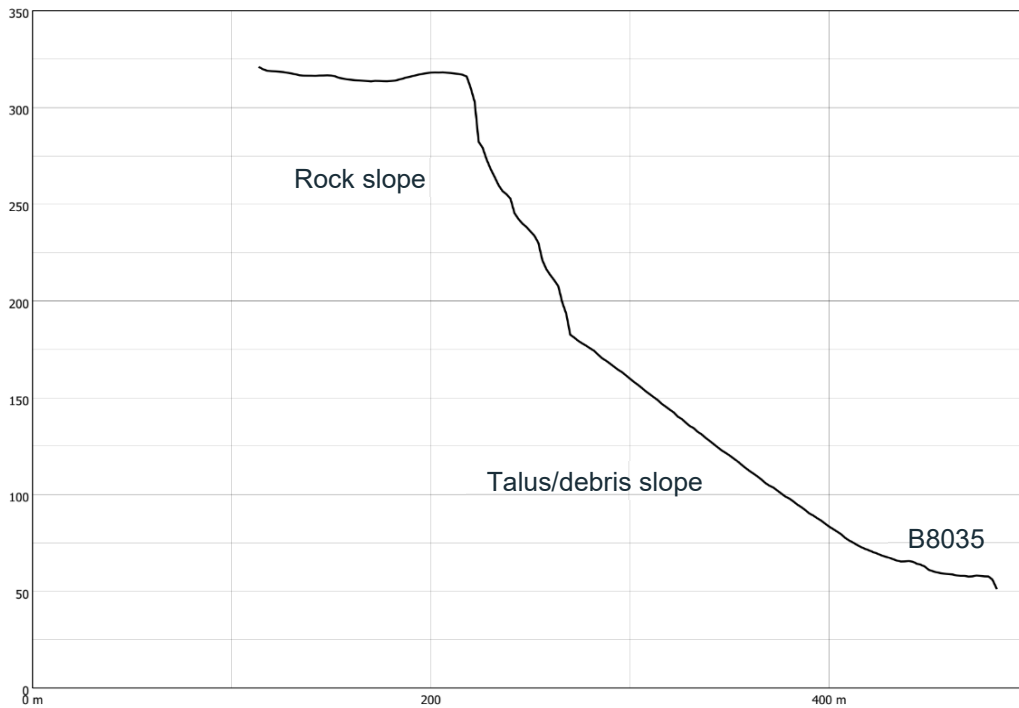
Within the central area of the site, there is a steep slope consisting of talus and debris from previous slope failures between the main rock slope and the road.

Figure 3-11 - Sample slope profile generated from the digital terrain model collected during the drone survey

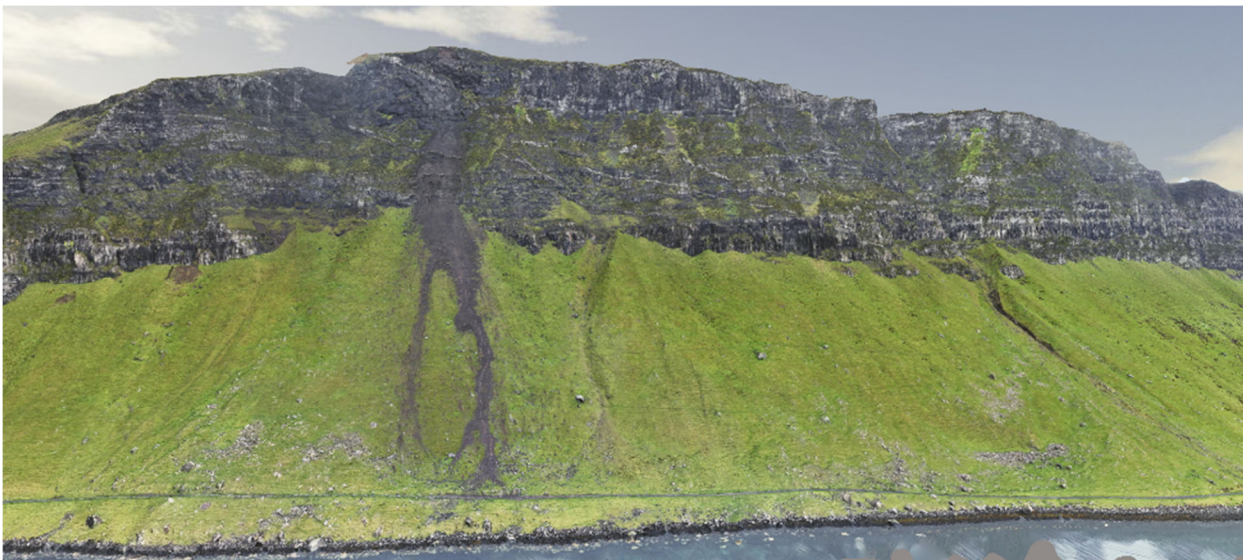
Relatively few blocks can be observed having been deposited in the upper sections of this slope, with the majority of visible blocks being immediately above and below the road. This indicates that a high percentage of mobilised blocks are likely to reach the road level.

Figure 3-12 - Drone model showing blocks deposited immediately adjacent to the road

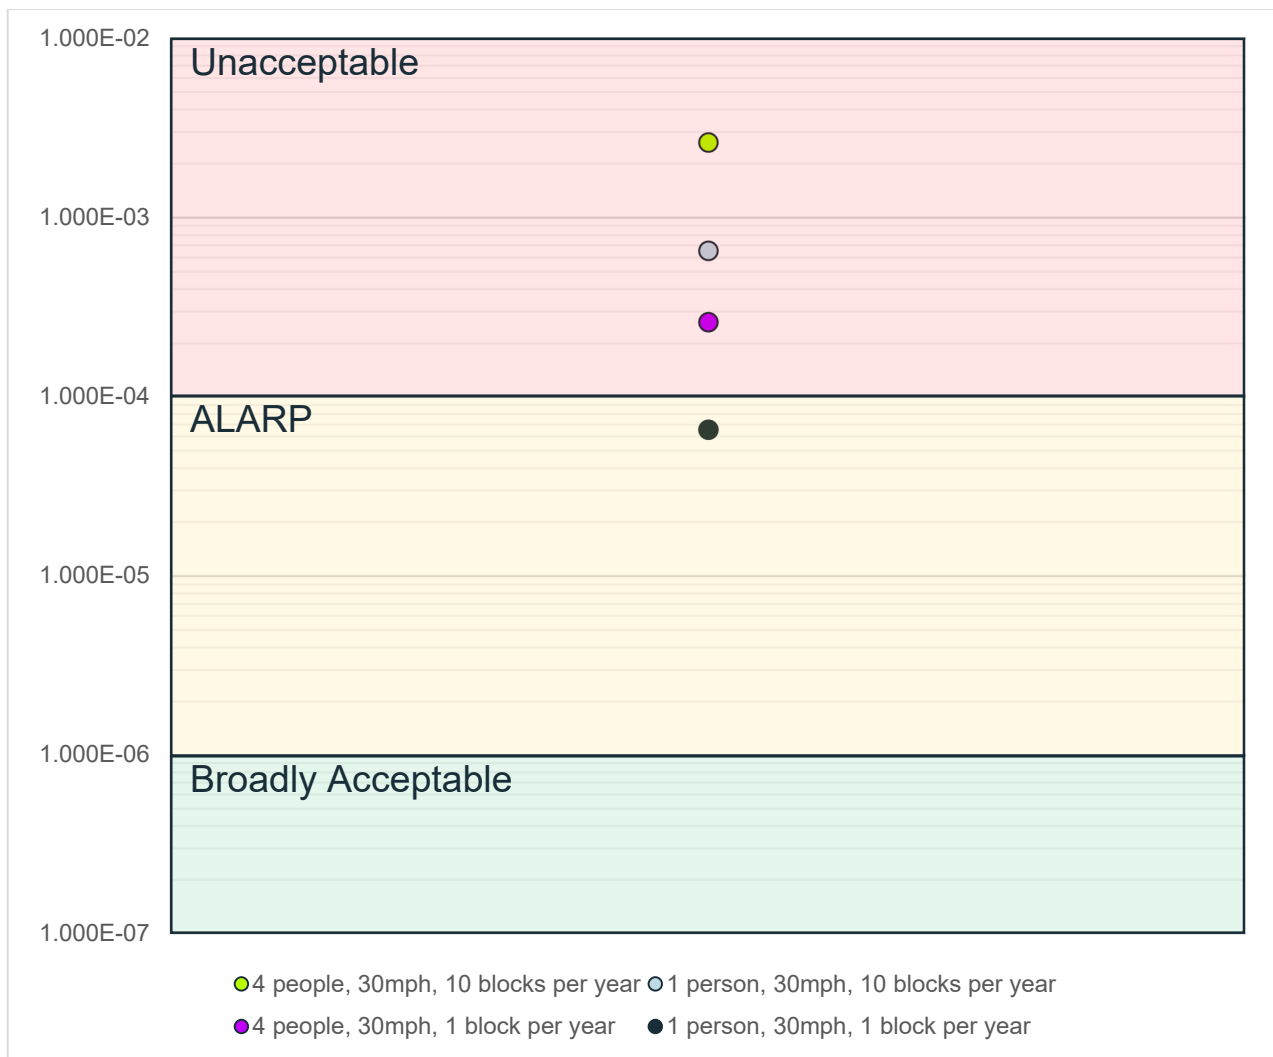
For the considered scenario, the risk to road users has been calculated to be between 6.55×10^{-5} and 2.62×10^{-3} . This places the risk between the ALARP region and the unacceptable region and means that intervention to reduce the risk to road users to a more tolerable level is required.

Figure 4-2 shows the relationship between blockfall numbers and occupancy numbers on the risk tolerability rating.

Figure 4-2 - Sensitivity analysis of risk zones at various occupancies and blockfall numbers

Our interim assessment, prior to modelling concludes that the current level of risk posed to users of the B8035 within the considered site area is classified as unacceptable. Therefore, before the road can be re-opened to the public mitigation measures must be put in place to reduce the level of risk to an tolerable level.
