SECTION 4

CONSERVATION AREA MANAGEMENT

4.1 Negative Features

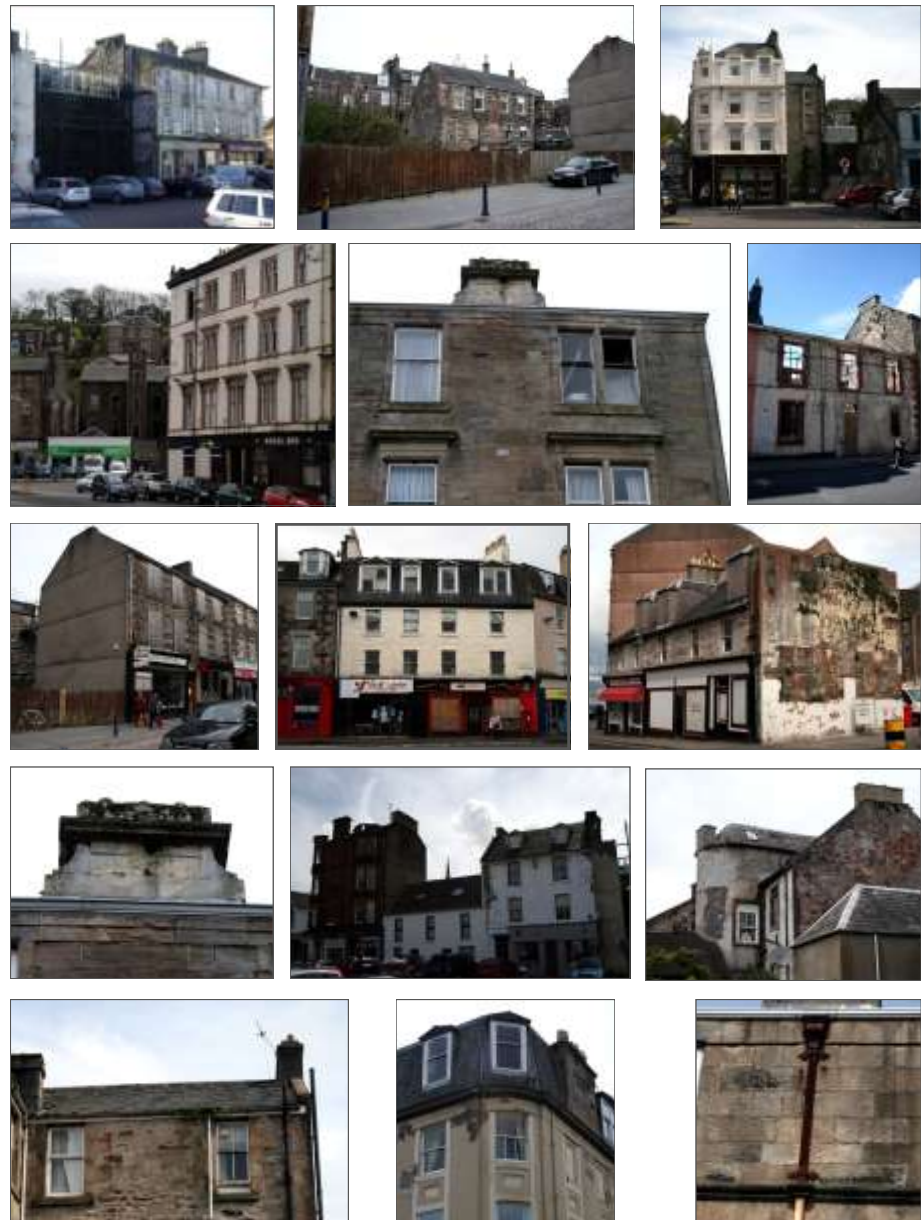
Negative Feature	Area of Character Area affected
Gap sites	All areas. In particular Guildford Square (L); Montague Street (C) including rear of large-scale re-development in Victoria Street; Watergate (R) multiple sites; Bishop Street (to rear of East Princes St).
Dereliction	All areas. The seafront: the former Co-op bakery (L); former Albert Hotel (L); Argyle Street (C); Linking streets: Gallowgate, Bishop Street (R), West Princes Street. <i>(Note: Queen Street, close to the castle in the Industrial Character Area is completely derelict).</i>
Vacancy & Under-use	Castle Area: Former Stuarts' House; Seafront: Former Albert Hotel; Victoria Street shops. Principal shopping street: upper floors (L). Linking streets: Gallowgate (C), Watergate, Bishop Street (R) and West Princes St all have empty shops and flats.
Need for repair	All areas: age of buildings (generally 100years+) original fabric in need of substantial renewal/repair e.g. stonework, and lime mortar pointing; slate roofs, leadwork, chimneys. In particular, Guildford Square (R); Albert Place; West Princes St; Duncan Halls; Guildford Court Hotel.

Lack of maintenance	All areas. In particular, the seafront and linking streets. Problems include all high level repairs (blocked gutters, missing slates, dormer windows); masonry decay, painting of external woodwork, peeling paintwork on facades.

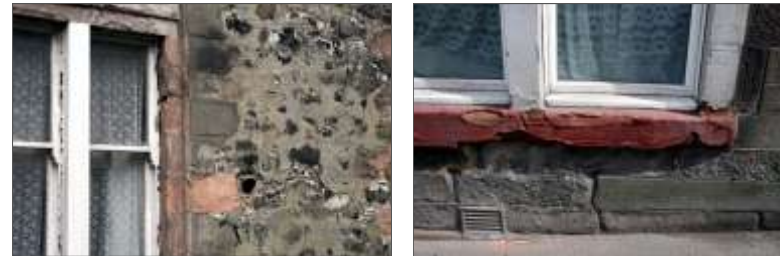
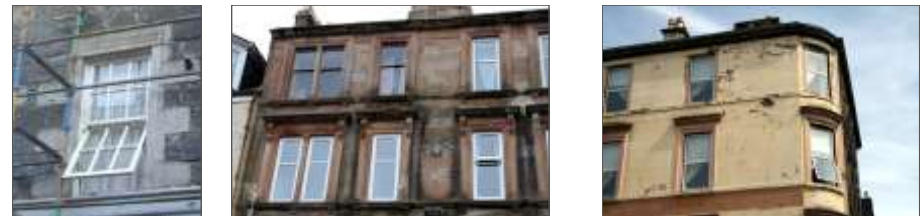
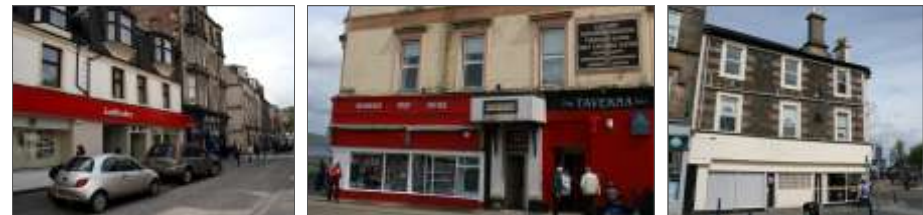
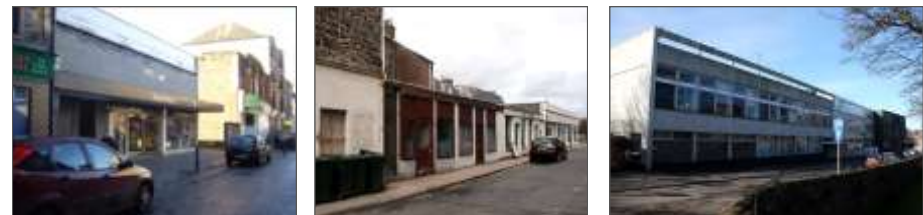
Negative Feature	Area of Character Area affected
Inappropriate repair	All areas. Particularly painting of facades in modern paints leading to failure and masonry decay. Resin & cement based stone repairs typically leading to extended failure of stonework; plastic rainwater goods, poor quality slate.
Damaging small changes: windows	All areas (Castle Area less so) Loss of original timber sash & case windows and inappropriate replacement in a variety of design, operational methods and material (uPVC, aluminium) heavy detailing, trickle vents.
Damaging small changes: shops	All areas. In particular along seafront where impact is most obvious. Over-large and dominate coloured house styles; concealment of good historic details. Unsympathetic modern shopfronts.
Inappropriate change: scale	A number of 20th century developments have not responded well to the scale of neighbouring property or the streetscape requirements. In particular the Co-op, East Princes St; Superdrug (L) and Bank of Scotland in Montague Street, and buildings in Dean Hood Place (C); new ticket office West Pier; Job Centre, King Street (R).

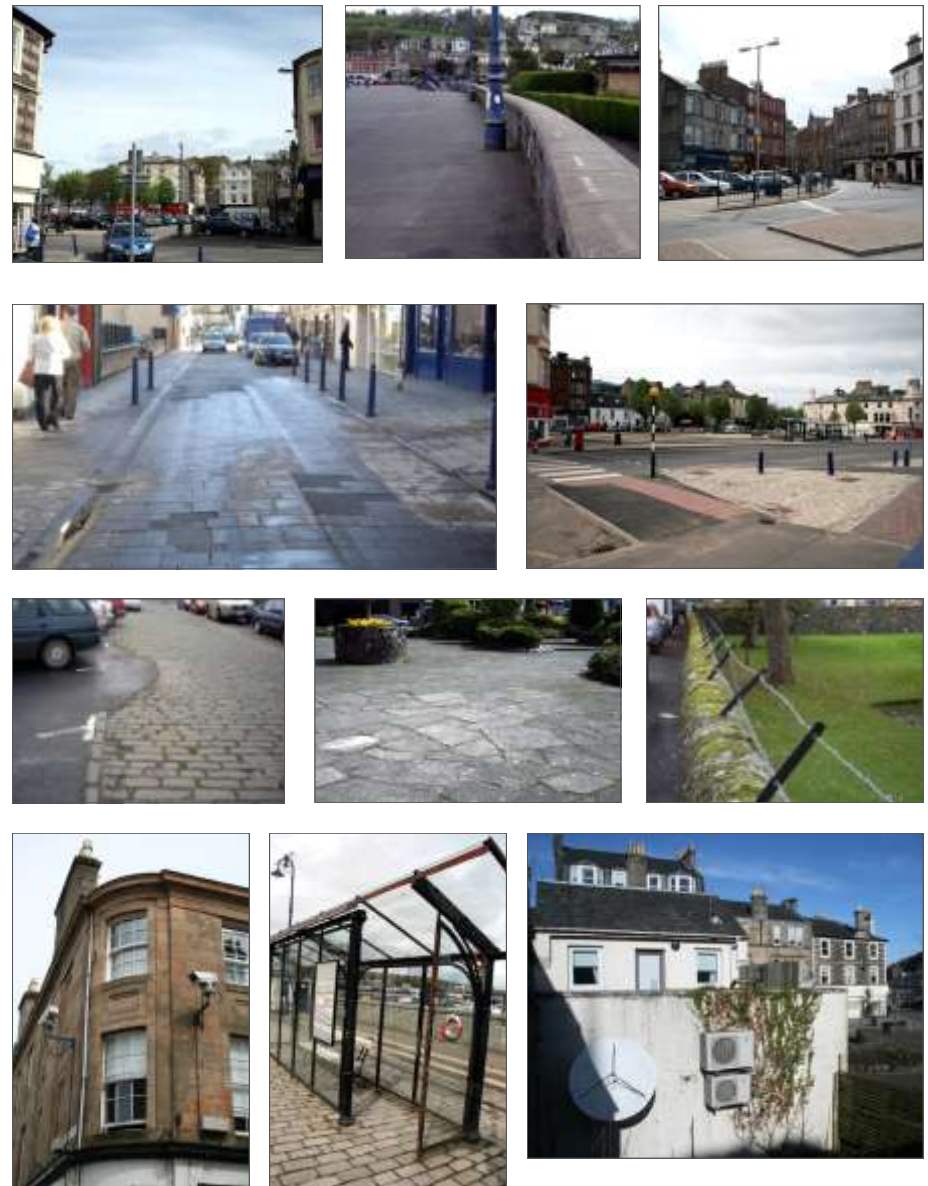
Negative Feature	Area of Character Area affected
Connectivity	<p>Guildford Square: general improvements to connect between Montague Street and Albert Place (L).</p> <p>Seafront: flood defence works present a visual and physical barrier between the shore and the town (C).</p> <p>Foot of High St/Montague St: further opportunity to create more physical permeability and visual connectivity.</p> <p>Foot of Bishop Street: improved pedestrian connectivity required (R).</p>
Public Realm	<p>Seafront: the muster area for the ferry is vast and intrusive.</p> <p>Maintenance: special surfaces (original and new) are not properly maintained, and care has not been taken in the repair of surfaces in correct materials; in particular Albert Quay; Montague Street (L).</p> <p>Some areas have a mix of materials e.g. Albert Place (R).</p> <p>Landscape improvements would benefit key open spaces: Guildford Square; the Market Cross; foot of High Street; Bishop Street junction.</p>

Street Furniture etc	<p>Seafront: improvement required to the welcome sign on Mid Pier; bus shelters require maintenance.</p> <p>All areas: surveillance cameras; satellite dishes, alarm boxes etc; often poorly positioned in particular on listed buildings and prominent corners.</p> <p>Safety measures: barbed wire around the castle, and a nearby pub, is not only a physical and visual barrier but it is also dangerous.</p>
