HELENSBURGH TOWN CENTRE

DRAFT CONSERVATION AREA APPRAISAL

& CONSERVATION

STRATEGY

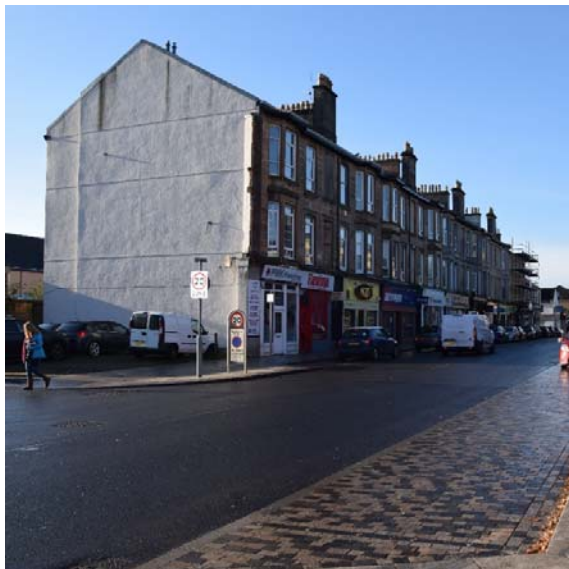
One of the principal characteristics of the town centre street pattern is the various corner conditions to the urban block. At the intersection with Maitland Street however there is a gap site. The row of tenements to East Princes Street lack a suitable termination and transition onto Maitland Street and as a result present a blank gable to the street which negatively impacts on the streetscape.

View West from gap site at corner of Maitland Street and Princes Street. The row of tenement lacks a suitable termination. This diminishes the integrity of urban block and corner condition.

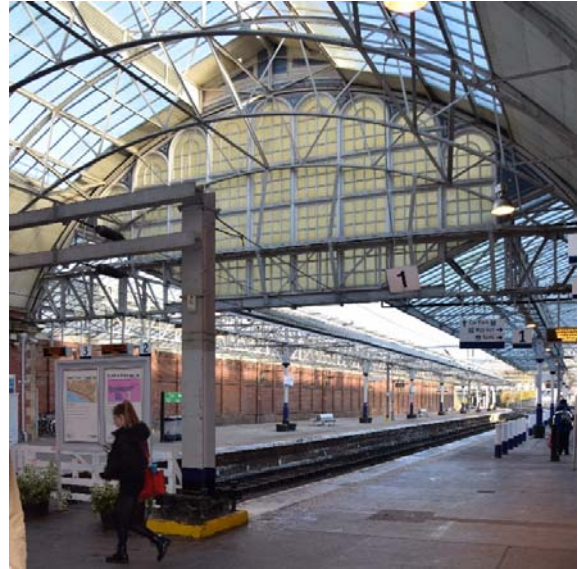
Helensburgh Central with its barrel-vaulted and pitched roof glazed canopies to platforms.

The train station (Category B listed) to the north side of the street is vital in informing the first impression of Helensburgh by rail. Of Victorian design built in 1899, it replaces an earlier building from 1856. Designed by James Carswell for the North British Railway Company Engineering Department the station as a public space contributes significantly to town centre character.

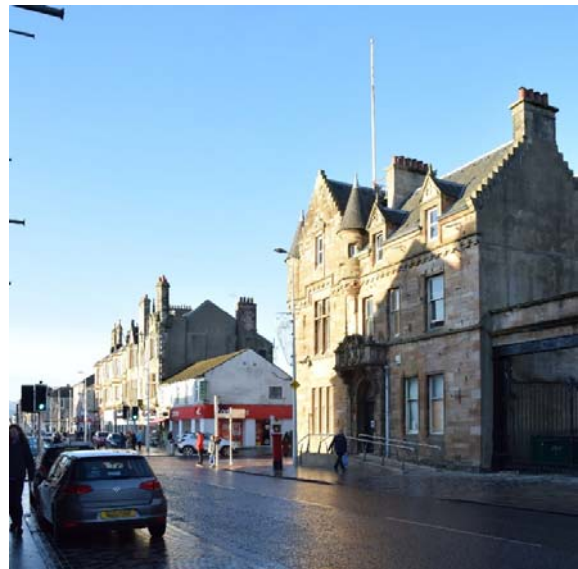
1 East Princes Street. Former Town hall. Scots Baronial style forming strong corner feature to cross roads.

Adjacent to the sandstone station office building is the 2 storey and attic Scots Baronial former municipal buildings (Category B listed) at 1 East Princes Street.

With its turreted and crow stepped form makes a handsome corner piece at Sinclair Street. Designed by John Honeyman in 1878 this building when read in conjunction with the 2 storey, 4 bay Renaissance style of the station office provides a strong node and orientational point.

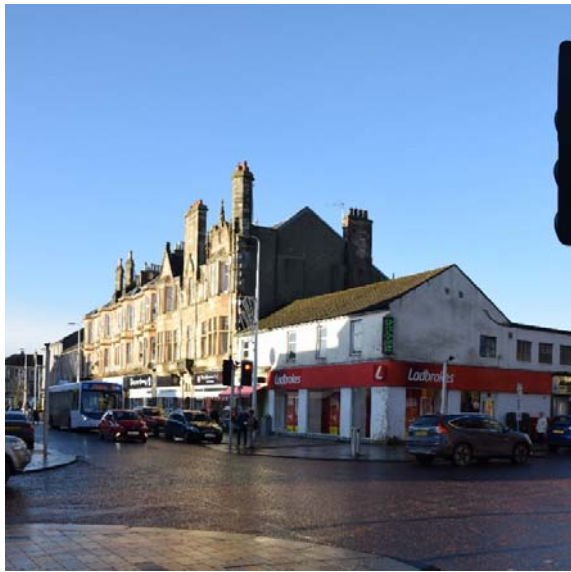
The projecting ashlar stones at the gable indicate that 8-12 is incomplete. The original intention was for this building to continue around the corner onto Sinclair Street with a grand bell capped tower. This would have required the demolition of the adjacent early 18th C building to the corner. The buildings have very contrasting aesthetics and the terrace reads as incomplete. The blank gable of the tenement is prominent in terms of streetscape.

8-12 West Princes Street. Striking tenement in Jacobean style with its varied skyline and prominent chimney stacks. The building has an impressive scale on Princes Street and makes a significant contribution to the street scape. Adjoining to the west is William Tait's well-proportioned tenement.

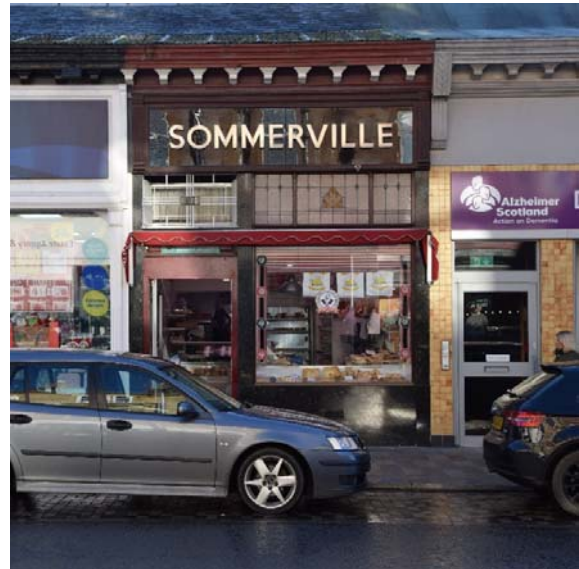
Across the street is a single-storey row of originally 9 bungalow shops, possibly of interwar period. Unfortunately, most of the traditional shops have been lost replaced with modern type with only one shopfront at nr 21 surviving intact. Some of the high level dentilled cornices to the row survive. This row of shops has an impressive shopfront scale and is distinctive in terms of character and streetscape.

Late 19th C, traditional shopfront to 21 West Princes Street. Mostly original with some later modern additions. Part of bungalow terrace row of shops. Shops either side have been replaced with modern designs.

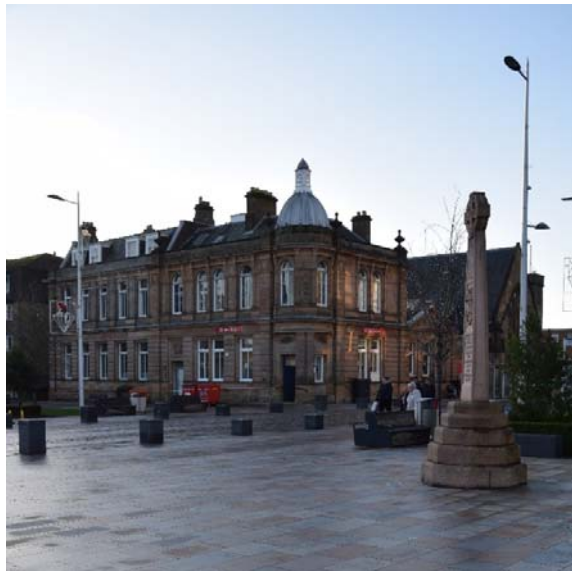
18 Colquhoun Square, W W Robertson, 1861. Late Victorian former post office with elongated cupola provides a strong corner feature and prominent visual marker.

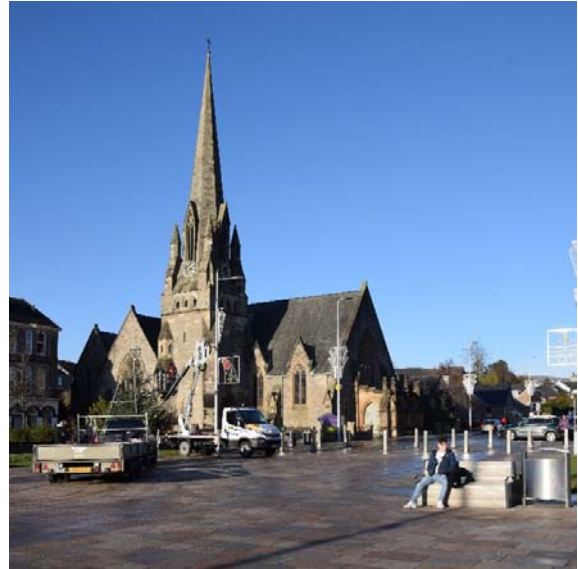
West Kirk an important visual marker on Colquhoun Street with its 3-stage tower with broach stone spire. J W and J Hay 1853.

To the north of the square, two prominent buildings form the enclosure and also the entrance sequence to Colquhoun Street. To the west sits the West Kirk (Church of Scotland) (Category B Listed) which is an important visual marker to the square with its spire which adds verticality and alternative scale. The diagonal view of this from the opposite corner of the square is particularly significant.

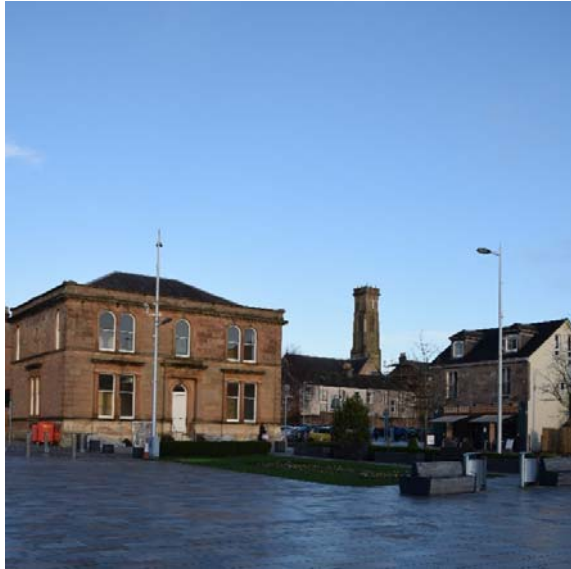
Open internal corner to north east side of Colquhoun Square. This affords long distance views towards tower of former St Columba Church.

Also, on the north eastern edge between 30 and 34 Colquhoun Square there is another view into the internal backcourt of the blocks. The rear elevations of the tenements to Princes Street are visible. Elements such as the projecting turnpike stair turret to the rear of 30-34 add a different character and variation to the streetscape. The back court is separated from the square by a tall rubble boundary wall which maintains the square's sense of enclosure at this point.

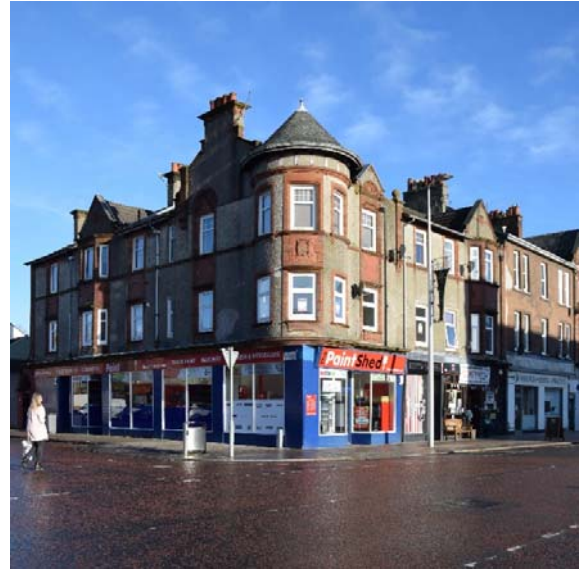
A L-shape three-story tenement at 74-78 of grey harl with red sandstone dressings with a squat turreted corner providing a robust termination to the end of the Town Centre area.

Continuing west down Princes Street the north side of the street again provides an unbroken terrace of four tenements with continuous ground floor retail until James Street at the edge of the town centre. A L-shape three-story tenement at 74-78 and 18-20 James Street (Category B listed) provides a robust termination to the end of the Town Centre area.

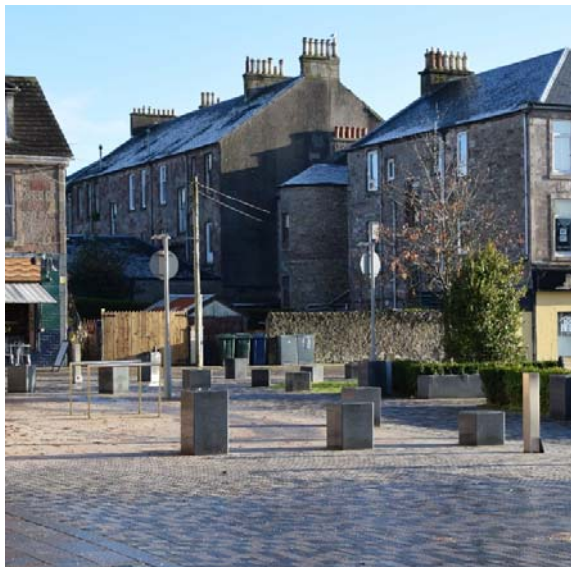
North east side of Colquhoun Square. Gaps in frontages offering views into interior spaces of the block and rear facing elevations.

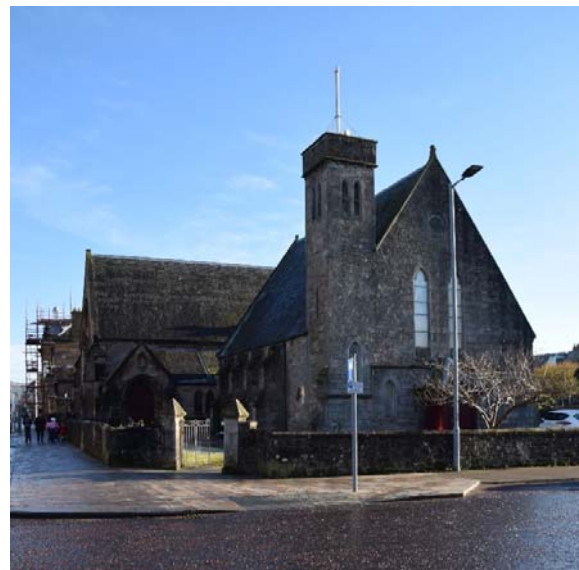
Helensburgh URC Church at the corner of Princes and James Street. The boundary wall is important in providing enclosure to the church grounds and maintaining the consistency of urban block reinforcing the grid iron street pattern.

Opposite this is the mid-19th century Helensburgh United Reformed Church (URC) (Category B listed) constructed in cream and pinkish sandstone rubble by John Honeyman. The church grounds are bounded by a mid-height rubble wall that maintains the block boundary with pink ashlar gate piers to the corner. The church was converted to a hall following the construction of a later church building built in 1883 in a cream sandstone behind and at right angles to the original building.

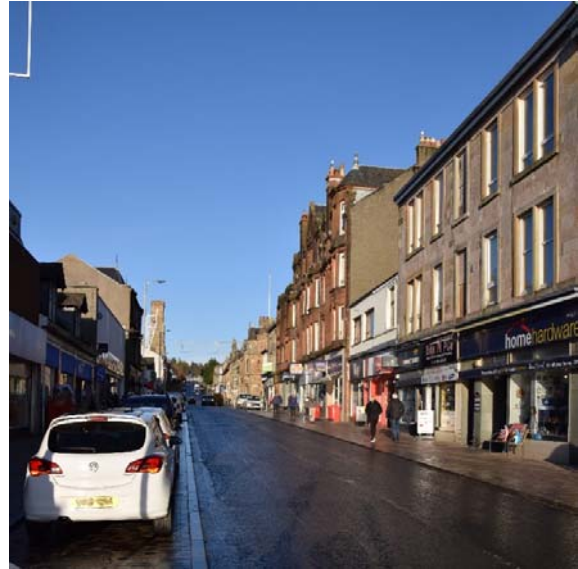
View north up Sinclair Street with variety of building scale. The spire of St Columba Church provides an important visual marker.

The two sides of the street have noticeably different building scales with the east side of the street being occupied by tenements and civic buildings of scale.

The west side is formed by predominately low rise single and two storey buildings. This is interrupted by one-off tenements that bookend the northern end of the town centre area at King Street and at the cross roads which reintroduce scale and variety to the streetscape.

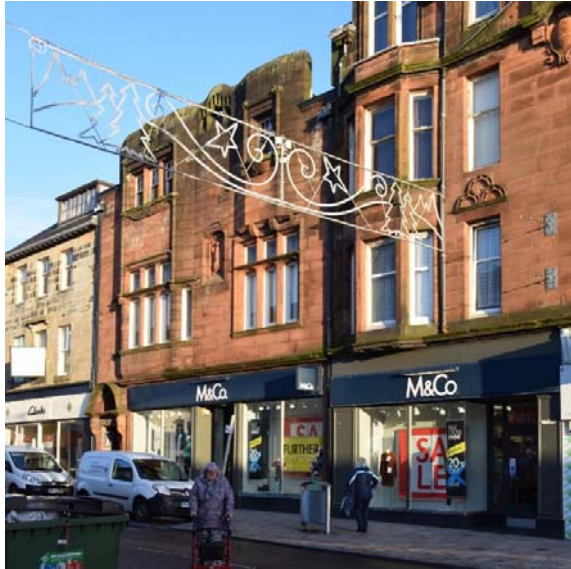
38-40 Sinclair Street. Former Helensburgh and Gareloch Conservative Club. Elegant asymmetric elevation with highly distinctive parapet and exquisite carved masonry.

Particularly prominent in street scape terms is the Art Nouveau style building of the former Conservative Association Headquarters at 40 Sinclair Street (Category A listed) and the 3-storey and attic muscular tenement of 22-34 (Category C listed). Charles Rennie Mackintosh worked for John Honeyman and Keppie at the time of construction in 1895 and it is widely considered that building details including the elegant stone carvings, ornately carved tree on the breaking eaves parapet and the roof glazing are consistent with his style.

Both buildings are built in red sandstone and their four-storey height with their breaking and varied skyline make a significant contribution to streetscape being of city scale with distinctive frontages and reflect that Helensburgh in the late 19th century would have had a wealthy population benefiting from close links to Glasgow.

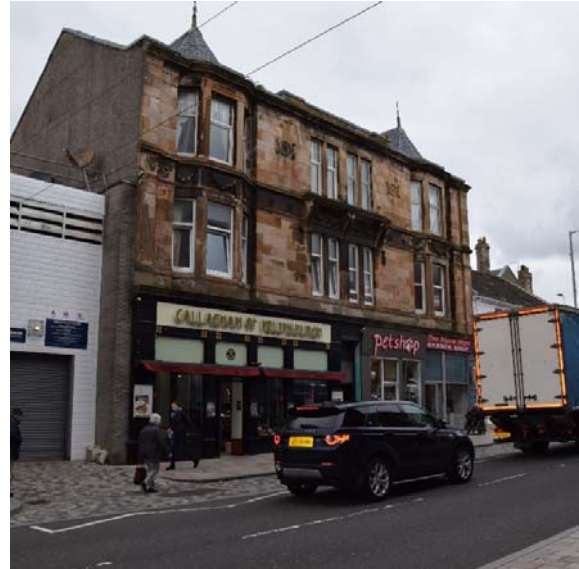
33-41 Sinclair Street. Dated 1878. The tenement is important in re-introducing scale to Sinclair Street and pairs well with the buildings opposite bringing a cluster of decorative listed buildings. The tenement with its canted roofs and decoration elevates it beyond a standard Glasgow tenement.

Opposite the former Conservative Association Headquarters, the three-storey blonde tenement of 33-41 (Category C listed) reinjects scale to the west side of the street when entering the town centre area from the north viewing towards the Firth of Clyde. This tenement with its canted slate roofs, decorative masonry details of consoles, capitals and carvings elevates it from a standard tenement and pairs well with the listed buildings opposite.

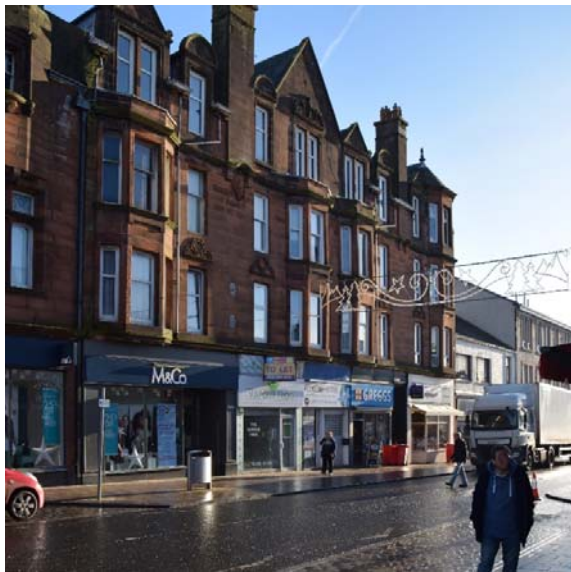
22-34 Sinclair Street. Frank Burnet and Boston, 1899. 3 Storey and attic with strong street presence featuring Scottish 17th century details and broken skyline. The stone for the building is originally from Maybole Castle, Ayrshire.

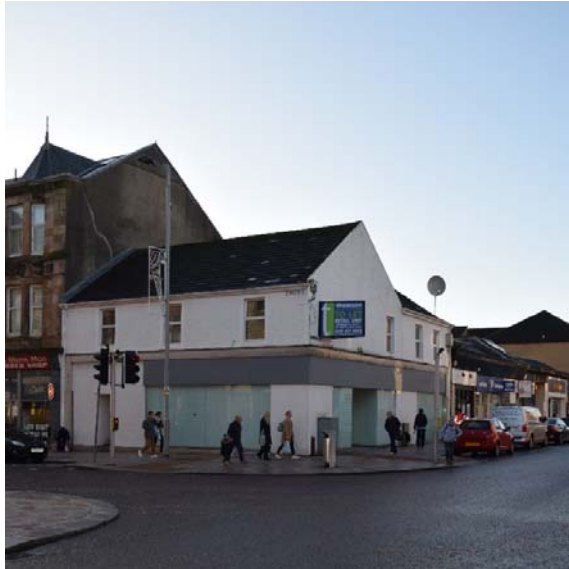
43 Sinclair Street. Paired with nr 45 below.

At the cross roads the buildings are generally two-storey and self-effacing with the exception of the Scots Baronial municipal buildings (former town hall). The two buildings on the west side nr 43 and 45 while plain in the context of the highly expressive tenements that form their back drop are early 18th century vernacular buildings. Their appearance has been altered by extensions, modern alterations and materials and loss of features such as gabled chimney stacks. They contrast with the neighbouring buildings being rendered. The two corner buildings form a good pairing having similar form but orientated differently with 43 having its gable to Princes Street and 45 its gable to Sinclair Street. Nr 43 was previously an inn according to NLS maps of 1860.

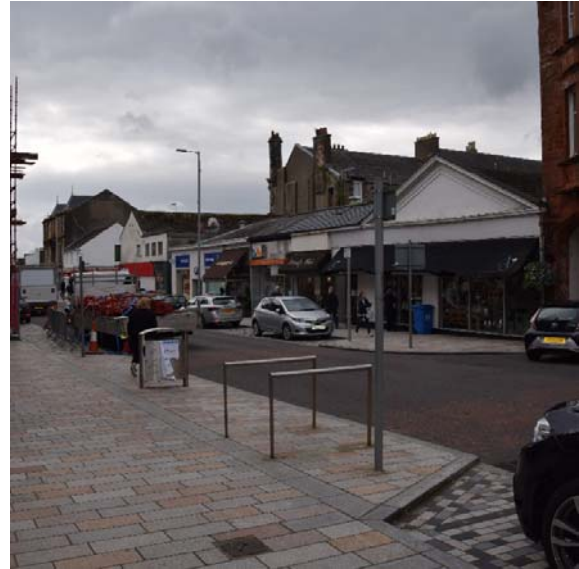
Transition from two storey corner buildings on Sinclair Street cross roads to bungalow row of shops. These are much altered with altering style, proportion, signage and use of materials. The original design intent for a designed row has been lost.

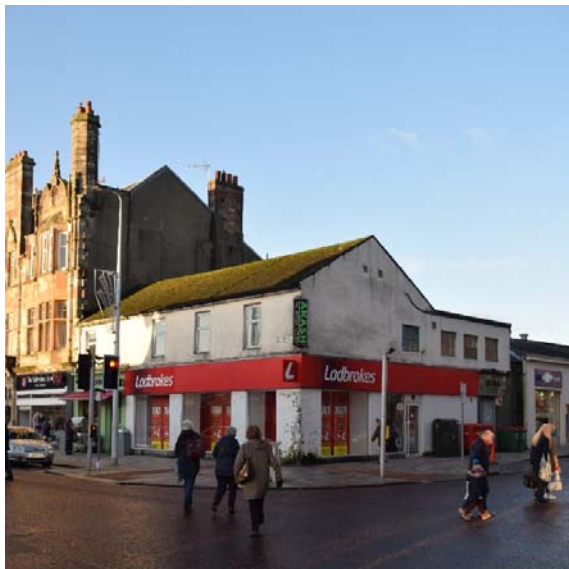
45 Sinclair Street. Pairing of two-storey early 18th Century vernacular buildings at an important cross roads in the town centre area. These are low scale and plain but very visible in terms of streetscape. Both have undergone modernisation and contrast with the decorative masonry large scale tenements neighbouring.

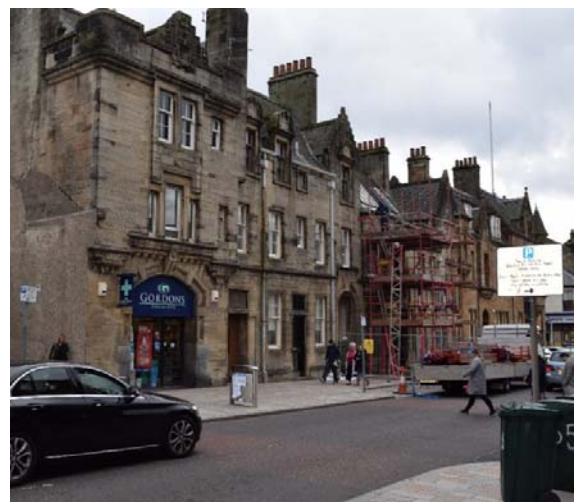
48-52a Sinclair Street. A N Paterson's 1906 addition originally comprising the Police Office and Fire Station. Continuing the Scots vocabulary of the former Town hall but with a modern interpretation

the two buildings make a significant contribution to streetscape with its variety of forms, details, and varied skyline. The use of a contrasting grey sandstone clearly demarcates the different timeline of construction.

Across the street at 48-52 is the later 1906 Police Station extension to the Scots Baronial burgh buildings (category B listed). It contrasts with the earlier building with the use of a grey sandstone but continues the Scots vocabulary albeit with a modern interpretation. This building is highly distinctive in terms of streetscape with a variable rhythm to the eaves level that together with its freer fenestration brings together the disparate building scales of Sinclair Street. The rear elevation of the building is also distinctive with its tall chimneyed doocot and expressive stacks.

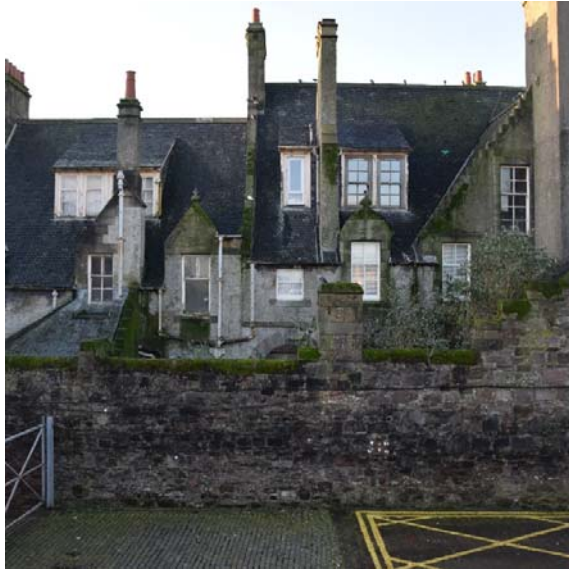
Rear of 48-52a Sinclair Street. Highly distinctive rear elevation in an Arts and Crafts style.

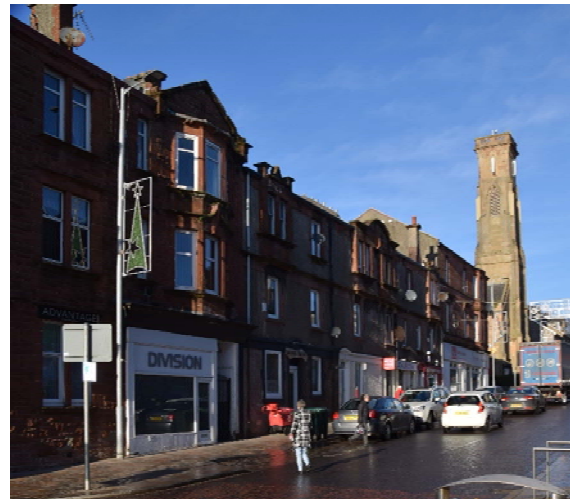
View north. Group of three tenements at end of town centre area. These provide a good grouping with the spire of St Columba Church and all differ in design offering variety benefitting the streetscape.

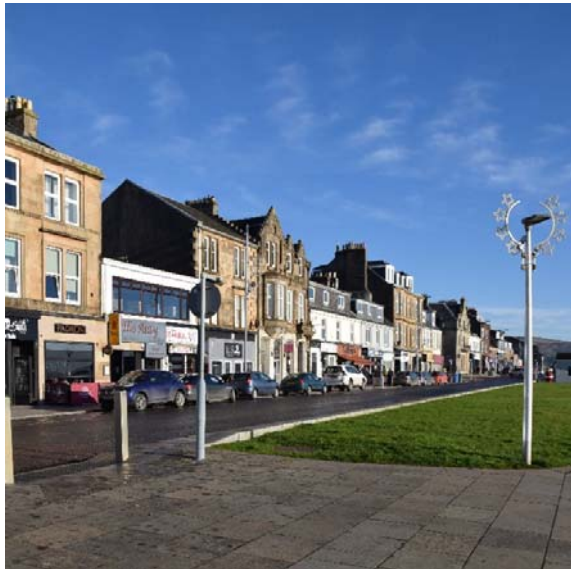
View east along West Clyde Street. Over time the single dormers have been modified creating full length dormers which has had an intrusive impact and much altered the roofscape and character of the buildings. The street has a consistent ground level appearance that contrasts well with the variety at eaves level created by different building scales and forms.

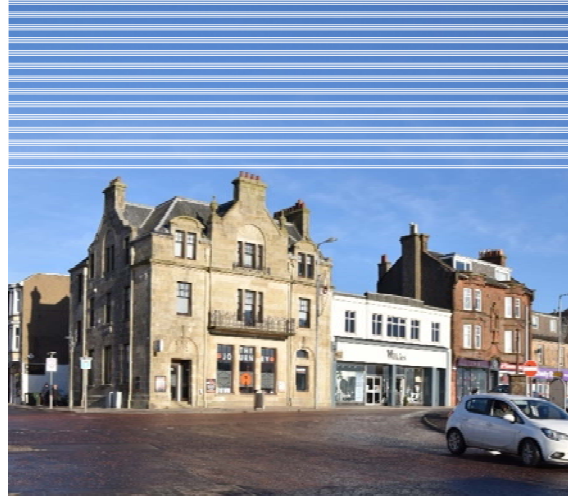
24 West Clyde Street. A N Paterson and Stoddart, dated 1928. The corniced apex stacks to both gables are highly distinctive and give the building a varied skyline and interesting form. The building was originally built for the National Bank of Scotland.

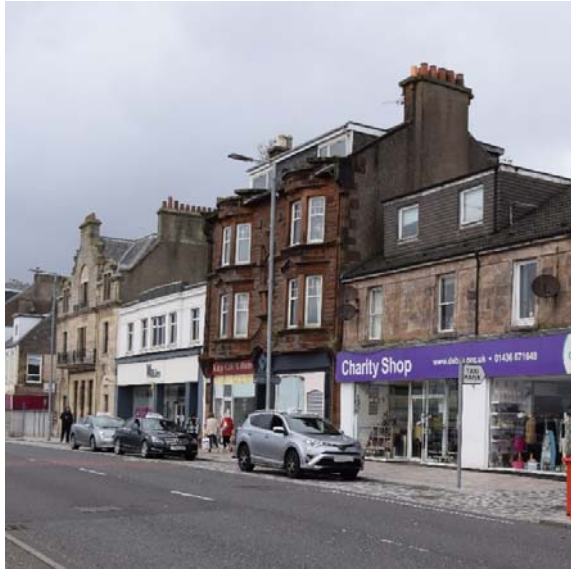
18 West Clyde Street. T and J Low. 1909. 3 Bay Glasgow style tenement with dated keystone, full height bowed tripartite oriels flanking and corbelled stepped bowed parapet with breaking eaves.

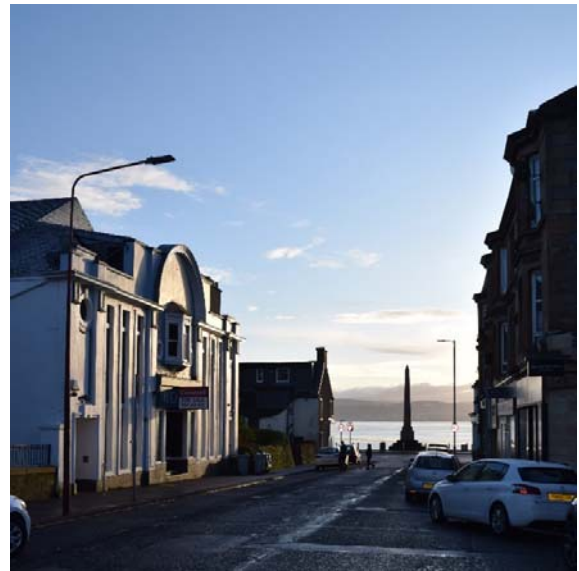
Erected in 1872 in memory of Henry Bell the obelisk forms the termination to James Street. The former Art Deco cinema on the east side of the street makes a significant contribution to streetscape.

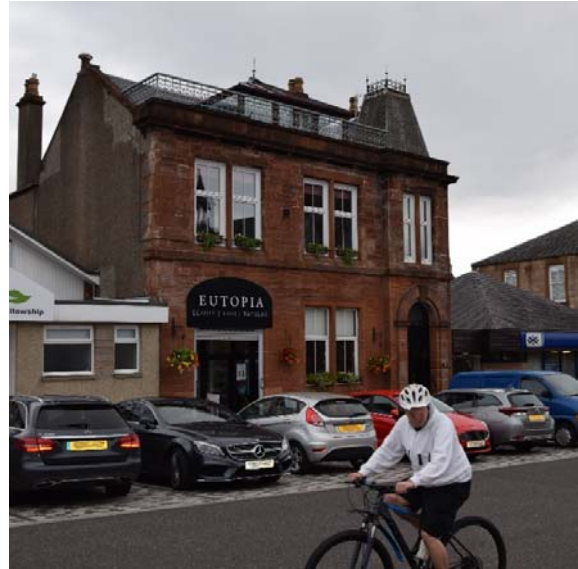
The north side of Colquhoun Street has a different character to the rest of the town centre area featuring traditional buildings with modern one-storey extensions of varying quality. These extensions affect the setting of the buildings and are inconsistent in terms of detail, materiality, scale and form. Generally, they do not enhance the streetscape and in some cases affect the setting of the traditional buildings. Looking north from the two buildings that form the entry to the square, the town centre character starts to deteriorate and it is considered that this part of the street does not have the special character of the town centre area.

North side of Colquhoun Street. The single storey extensions affect the setting of the traditional buildings and are not positive in terms of streetscape.

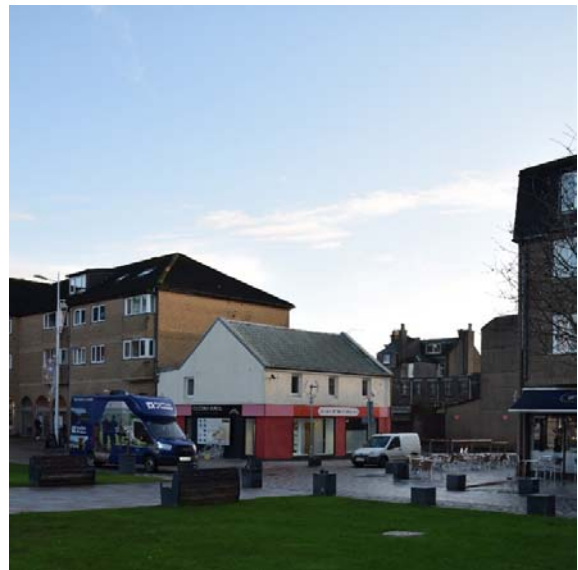
South side of Colquhoun Street. Variety in building scale surrounding Colquhoun Square, blend of 18th and 20th century buildings in close proximity.

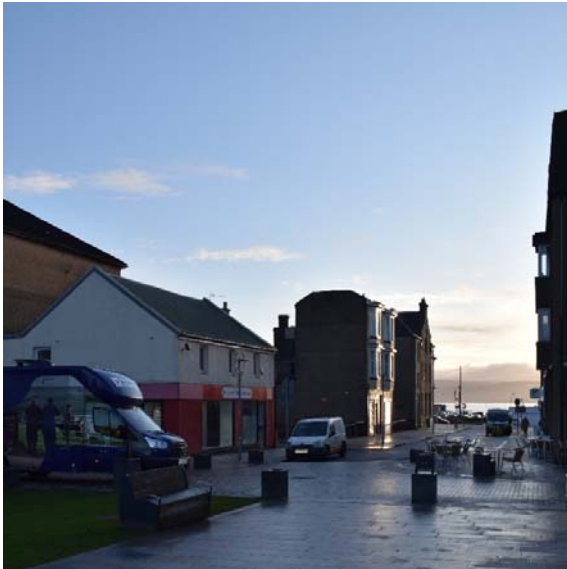
View down Colquhoun Street towards Firth of Clyde. The continuity of building line so distinctive to Helensburgh is eroded to this street due to the prominent gaps between buildings.

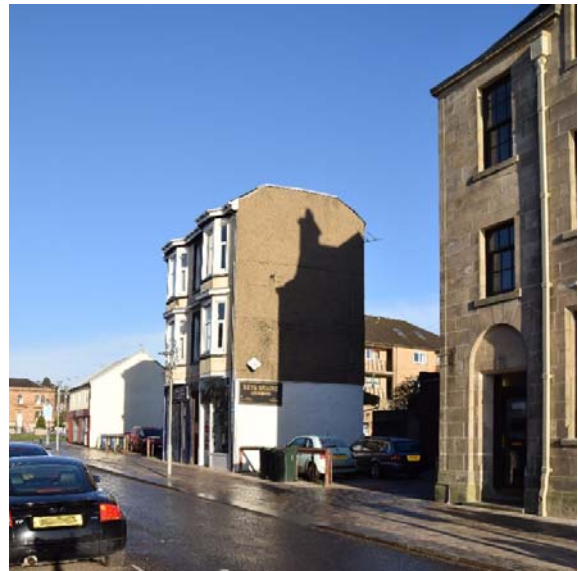
8-12 Colquhoun Street. The loss of the adjoining buildings results in the tenement feeling disconnected from the block and the blank gables are visually intrusive and illustrative of loss of building fabric. Nr 20 on the corner of the square is an early vernacular building of plainer aesthetic and reduced scale compared to the later 19th c development.

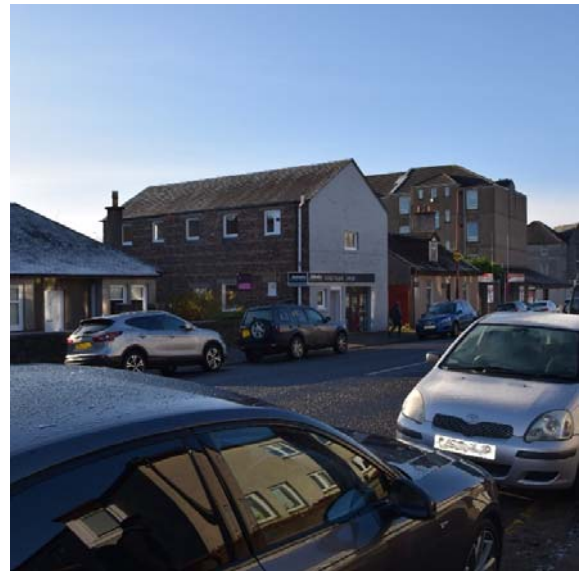
King Street provides the northern enclosure to the blocks that form Colquhoun Square. As the street moves west from Sinclair Street the scale, density and consistency of building line begins to deteriorate. Between Colquhoun and James Street the buildings changes from tenement to single storey bungalow properties situated either hard to the street or recessed. These domestic buildings are typically set between later new-build developments of lesser quality. Considered as a full streetscape neither block has the characteristics of the town centre area with little active frontages, lack of uniformity or significant buildings or distinctive frontages that make a positive contribution to street scape.

Deterioration in the character of town centre area with low rise residential set amongst low quality new build, commercial development. The uniformity of street pattern and building line is lost affecting the street scape.

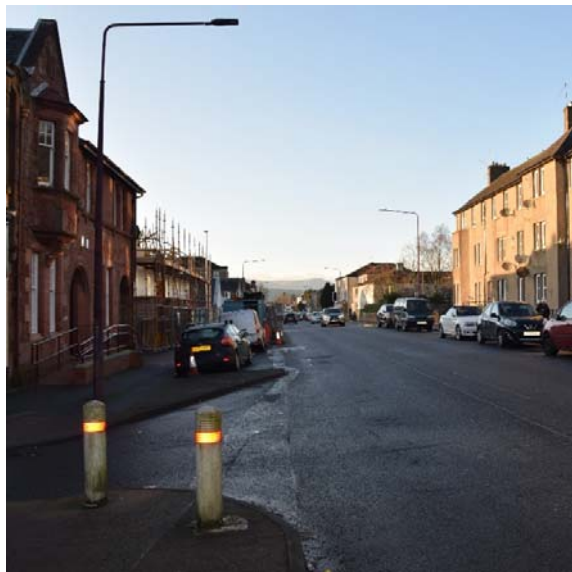
View west down Kings Street showing predominately residential dwellings and change in building typology and scale. The red sandstone listed building of 25-27 is visible to the left-hand side.

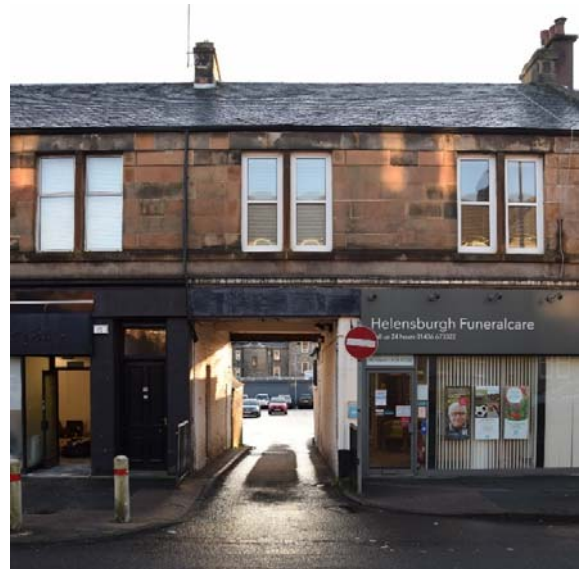
Pend to King Street forming the exit to the principal car park behind.

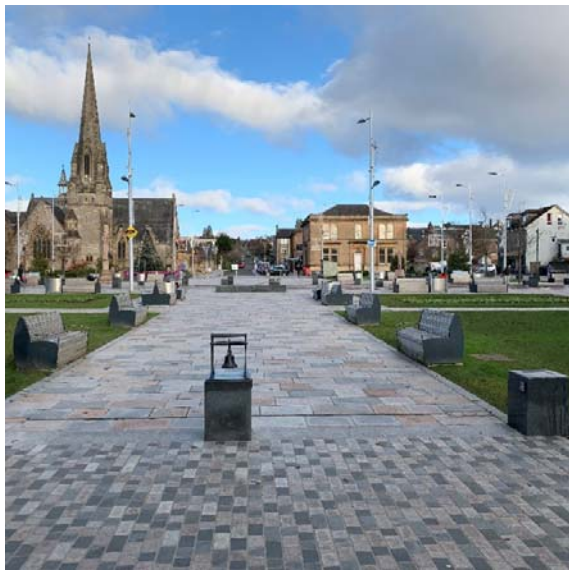
Public realm works to Colquhoun Square.

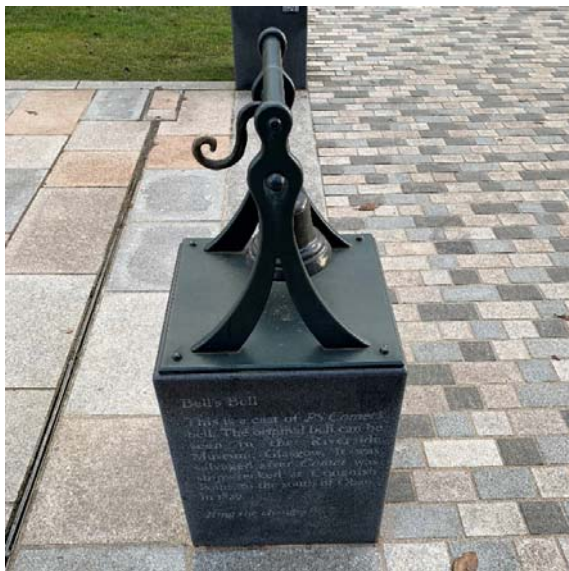
Bell's Bell museum plinth installed as part of outdoor museum.

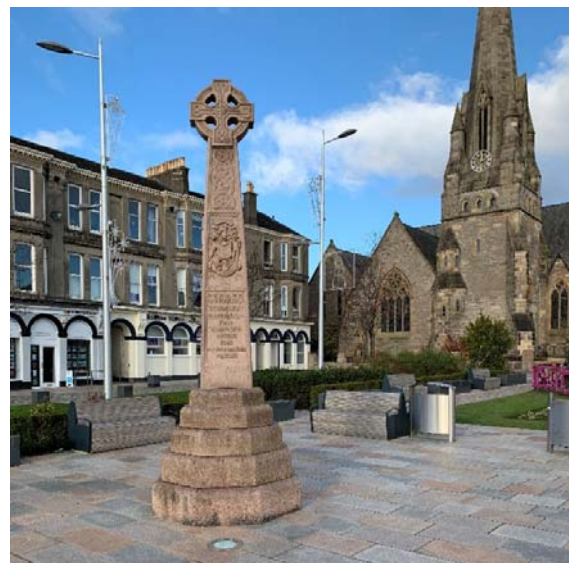
Celtic Cross statue (category B listed) celebrating the centenary of the burgh. 1802-1902.

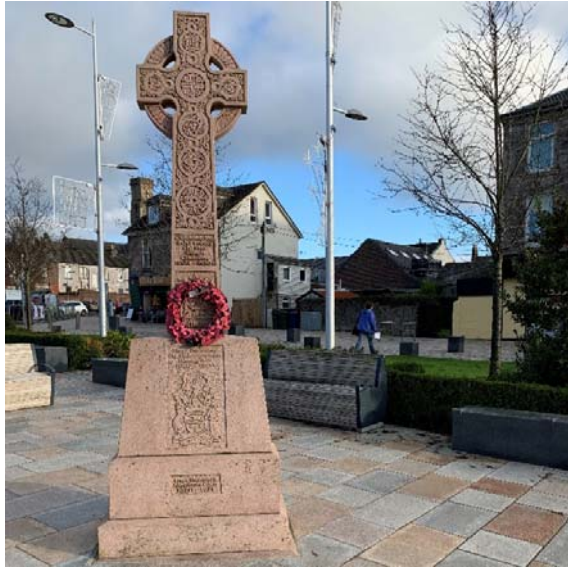
Celtic Cross statue celebrating 200 years of the burgh charter 1802-2002

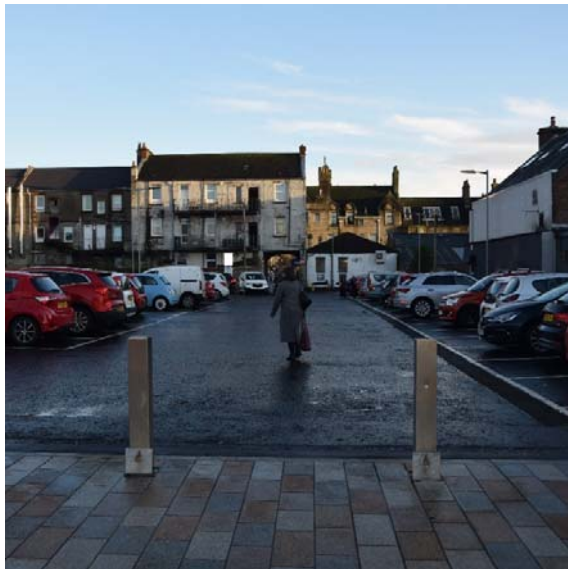
Car park installed to rear court. Views of the back elevations of Sinclair Street and King Court. Accessed through pend from Sinclair Street. Car parks in the rear courts keep the main shopping streets relatively free of cars improving the space for pedestrians.

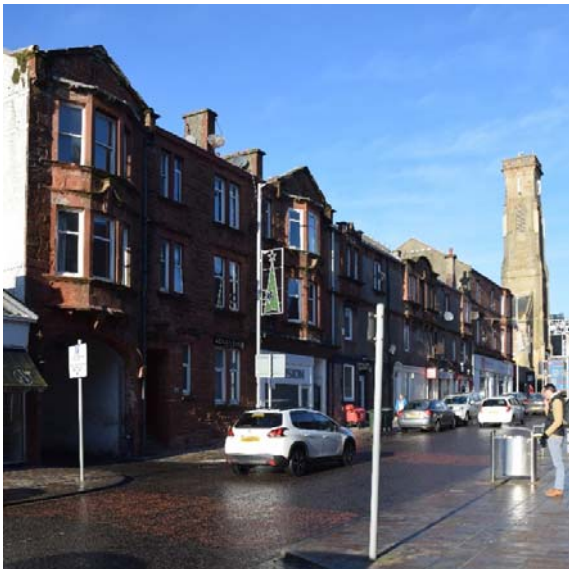
High quality public realm improvement works completed 2014.

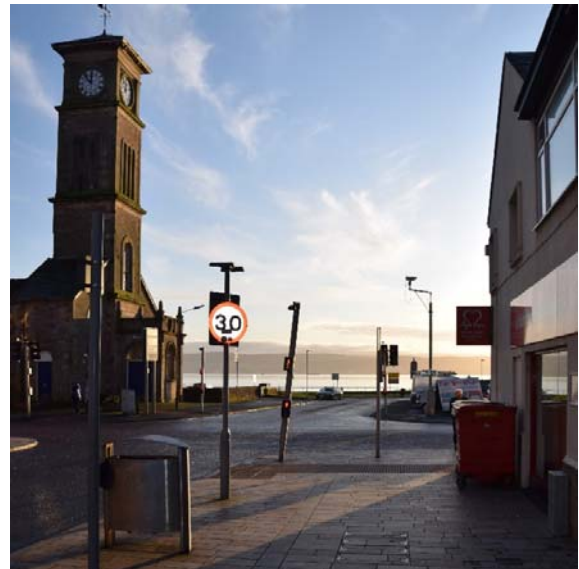
Waterfront: The land reclamation to the pier area at the foot of Sinclair Street and Colquhoun Square has altered the connection of the town centre to the water. The increased land mass reduces the body of water visible which in turn reduces its impact. Furthermore, the high number of cars and array of signage add various obstructions in the foreground which are distracting and deteriorate the view and connection to the water.

View south over land reclamation to pier and car park. The connection of the water to the town centre is diminished by the increased land mass and visual obstructions of cars and signage.

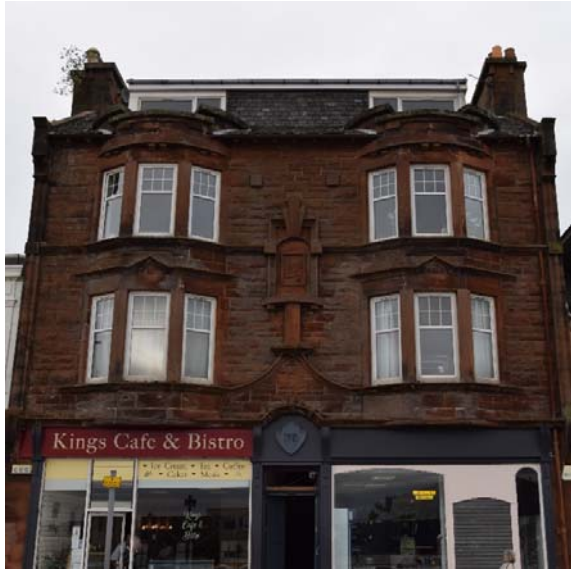
17-19 West Clyde Street (Category B listed). Typical building failures include vegetation growth, failure of roof details and repairs. Significant stone repair and structural intervention is required with movement evident to canted window bays.

The poor condition of the building fabric is a result of a lack of regular maintenance and repair. This is exacerbated and underpinned by a number of local and specific issues:

- The severely exposed West of Scotland coastal location (accelerating decay and increased effects of climate change).
- Multiple ownership with variable factoring agreements (complicating implementation of repair works).
- No planned maintenance or inspection regimes.
- Accessibility for basic maintenance / repair operations (access to rear elevations, high level).
- Economic factors (high cost of repairs relative to property values within the town centre area; changing demographic profiles).

Once a building descends into disrepair it can become increasingly complex and expensive to rectify. In some instances, poor quality, partial or inappropriate repairs have been made. In other instances, buildings have been vacated, threatening the building's ability for reuse and repair.

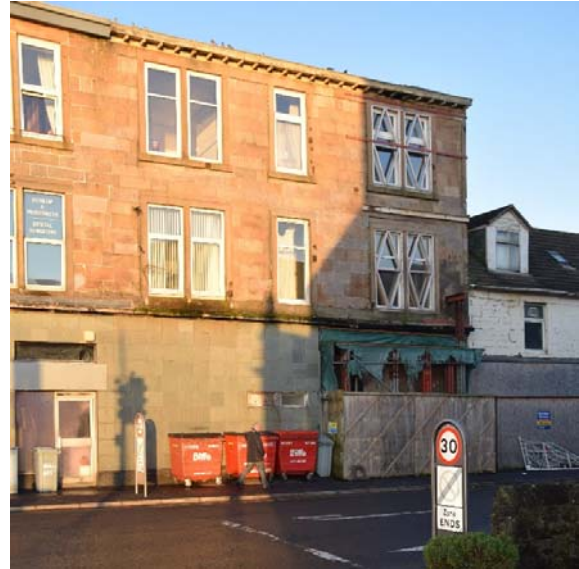
5-7 East Clyde Street. Building subject to emergency notice from Argyll and Bute Council. Works include doughtakings to gable, propping of internal pen check stair and propping of shop lintel.

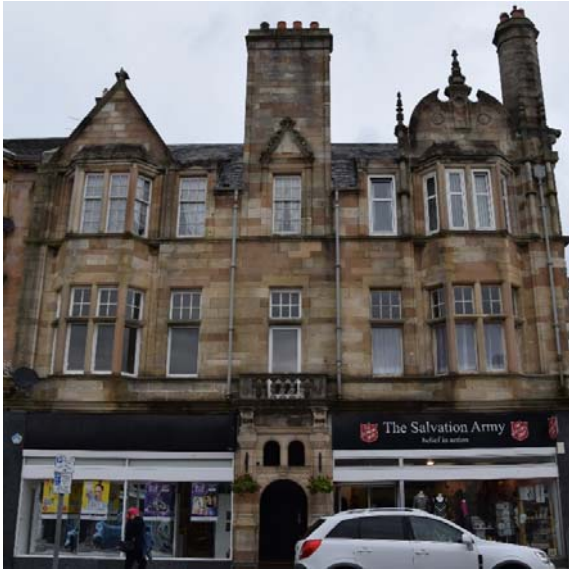
8-12 West Princes Street. A good example of traditional timber sash and case windows and a demonstration of their importance to the overall building character, in this case Jacobean with its original 6 over 6 and 6 over 1 glazing patterns formed with astragals. One flat has replacement modern Upvc casements which have a vastly different aesthetic with larger, double frames due to being a casement type. This begins to alter the character of the listed building.

Existing sash and case windows should be repaired whenever possible. Repairs should be on a like for like basis and can include effective draught proofing measures. Re-glazing with slim profile double glazing units, manufactured specifically for sash and case windows, can in many cases be successfully incorporated into existing frames. Such overhaul, carried out by experienced contractors can extend serviceable life for modest cost. Replacement of historic windows will only be acceptable where it can be demonstrated that they have deteriorated beyond practical repair. In such cases the replacement windows should replicate the historic design, in terms of proportion, section sizes, astragal arrangement, profile and material. Details such as the presence of horns and the method of glazing fixing (putty), paint coatings and colour should be considered. The use of externally visible proprietary trickle vents and dry glazing beads should be avoided.

Where previously inappropriately replaced or altered the reinstatement of windows in keeping with the character of the building will be encouraged and supported.

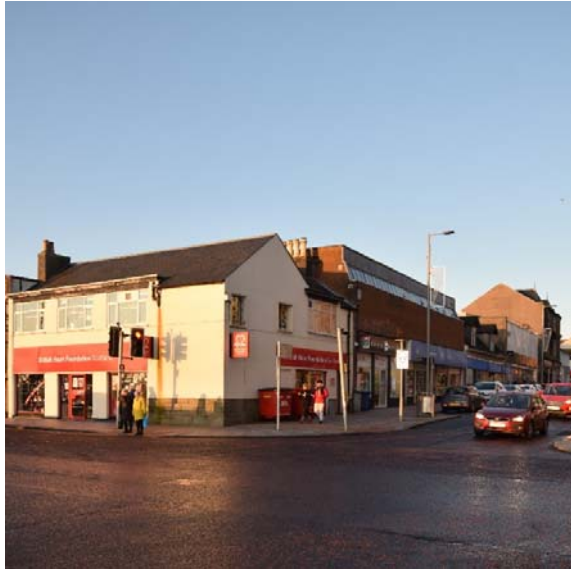
2-5 West Clyde Street to the corner of Sinclair Street and the adjoining building at 7-13 Sinclair Street are prime candidates for future redevelopment considering the long term enhancement of Helensburgh.

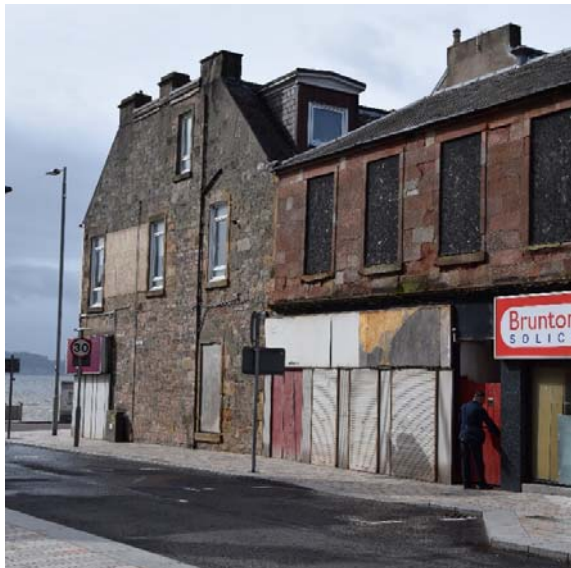
The vacant ground floor shops to 1-5 Colquhoun Street has a negative impact on the perceived quality of the area. The vacancy to upper levels indicates to visitors that this isn't a High Street issue of not being able to let the unit but a much wider condition issue.

The general fabric of the building is in very poor condition and it would be reasonable to assume that unless a programme of necessary repairs is instigated, it will not likely be occupied at any time in the coming years. The external fabric requires attention to address water penetration issues, considerable stonework repair, window refurbishment (or wholesale replacement), and possible structural intervention to the supporting

structure of the shopfronts. A programme of repair with a structured maintenance plan would safeguard the building's future and greatly improve the streetscape. In conjunction with the building repair, consideration should be given to a shopfront replacement programme to reinstate high quality, traditional shopfronts to this important linking street.

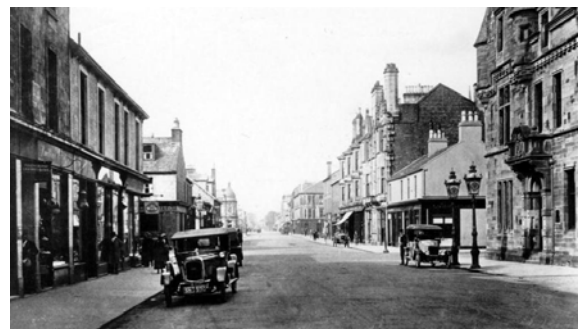
Archive image of Princes Street looking west towards cross road intersection with Sinclair Street. The buildings of 43 and 45 can be seen with their original arrangement.

The location of these buildings on the cross roads of the town centres two principal streets present an opportunity to enhance this key townscape area. Significant enhancement would be achieved through a programme of fabric repair. There is also an opportunity to enhance further through appropriate fascia and shopfront replacement. Archive images provide precedents for previous shopfront treatments.

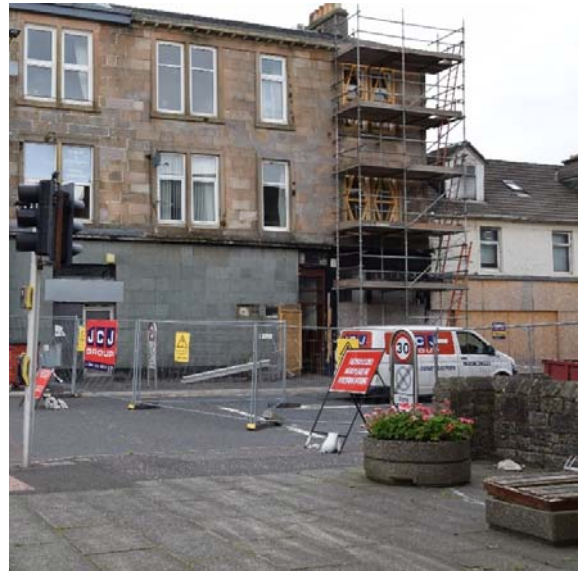
- *First floor Stonework at junction of front elevation and east gable in dangerous condition.*
- *Rear raised attached ancillary block in dangerous condition.*
- *Pencheck stair in dangerous condition (temporary propping installed).*

5-7 East Clyde Street. A dangerous building notice has been issued on the building. Without a comprehensive fabric repair programme the building is in risk of full demolition in the future.

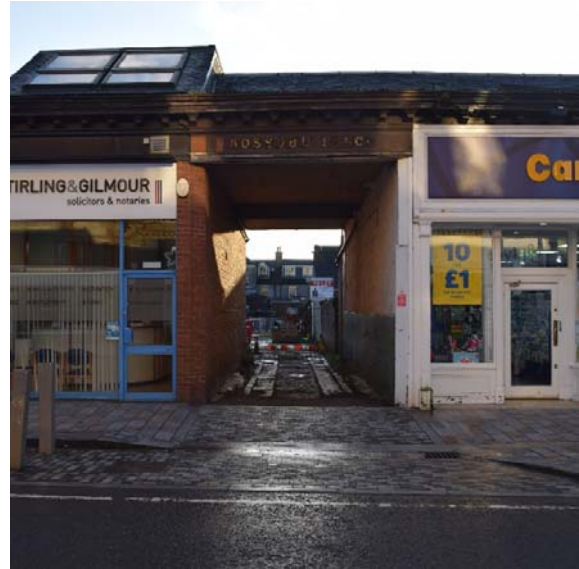
Pend to West Princes Street as part of bungalow row of shops. The rear courts are visible from the street and their appearance directly affects the character of the town centre. Consideration should be given to how these are used.

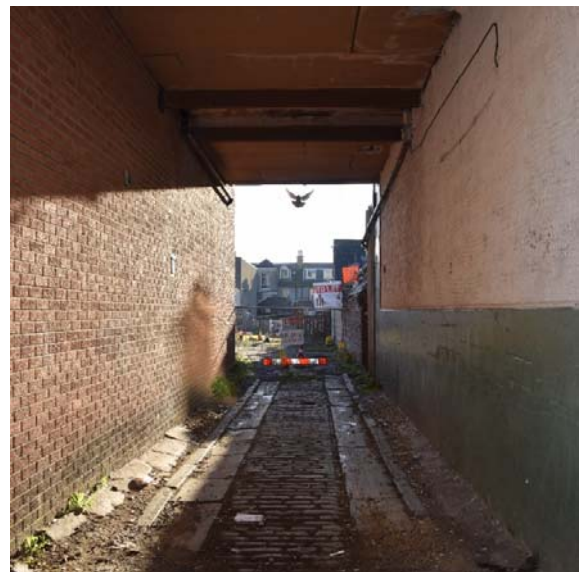
View from within the West Princes Street pend towards rear court. This pend contains cobbles and remnants of an earlier road network which could be conserved and enhanced. The overall perception of the pend could be enhanced encouraging positive development of the internal courts.

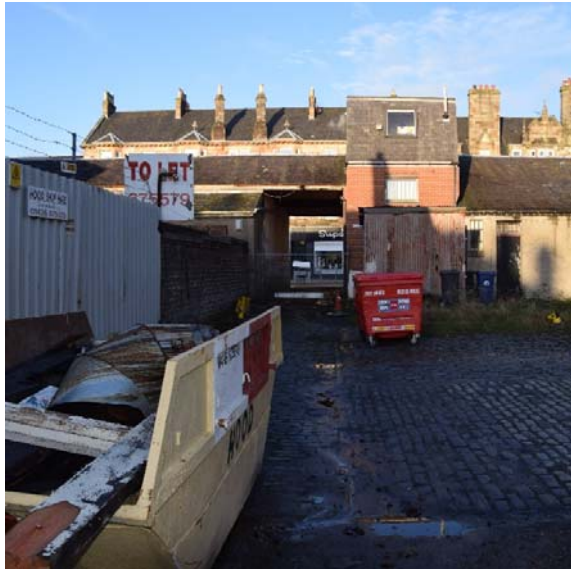
View of back court area looking north. Poor level of amenity and lack of any active management.

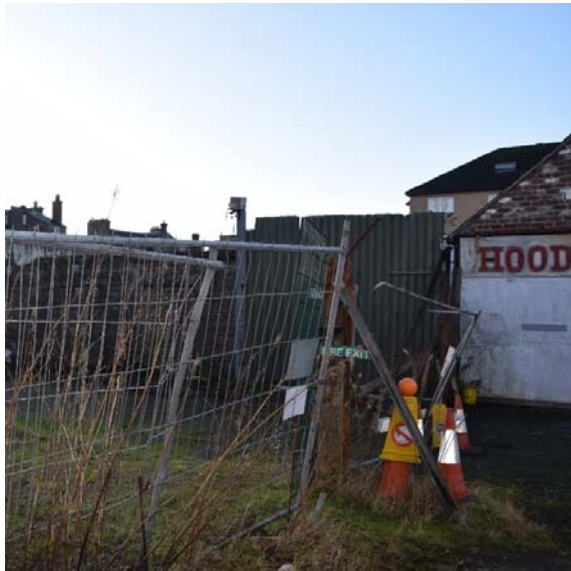
Ad hoc Heras fencing separating adjoining areas.
