Ardfern Slip A816 – rock stabilisation and emergency by-pass scheduled to open mid-December, opening of main A816 still to be confirmed

Loch Awe C30 – rock/soil nails and stabilisation

Glen Lean – B836 – Temporary Bridge

Lochgoilhead – B828 Slope stabilisation and bridge works

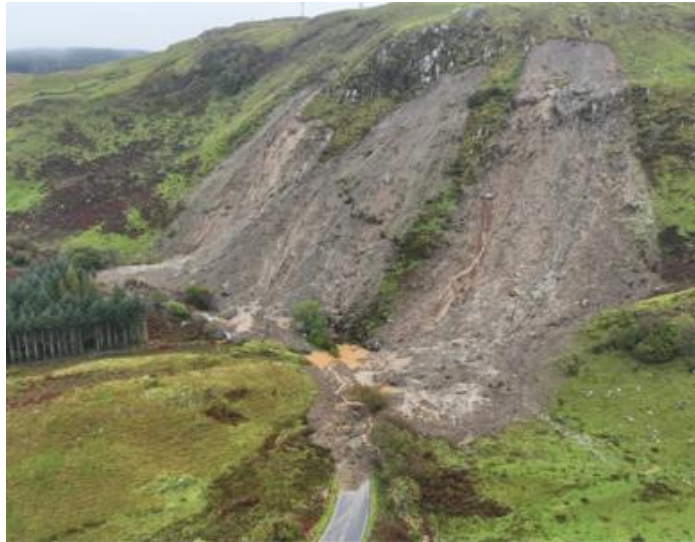
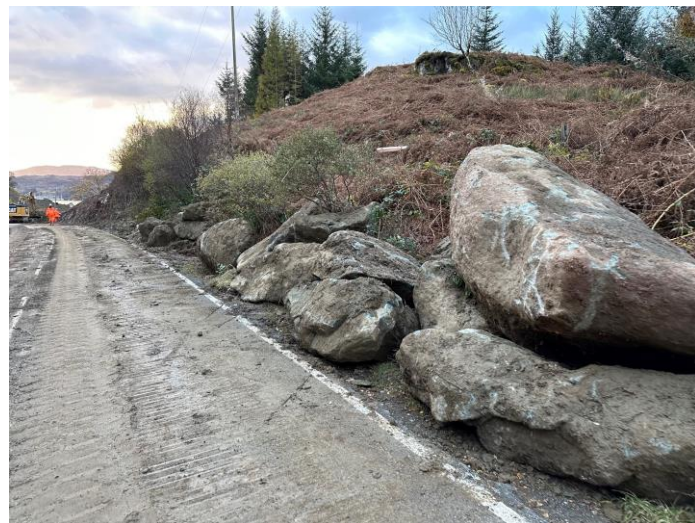
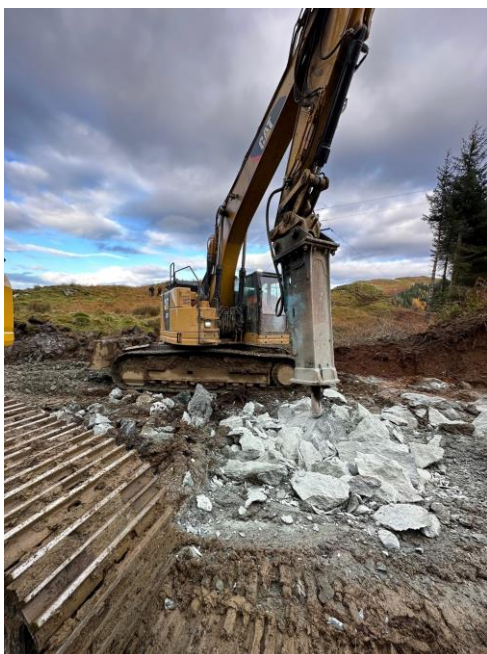
Top image showing the extent of the landslip and debris flow from 7 October, middle image of typical rocks which been 'falling' from the hillside - these will be used in forming the bund to help to catch material from future flows and bottom image of a large rock being broken up using a hydraulic pecker attached to a large excavator.

Once the debris flow material is sufficiently cleared a bund will be formed at the side of the existing road which is designed to hold back

future debris flow material. Modelling work will be undertaken to forecast future slope flow and the bund will be built accordingly.

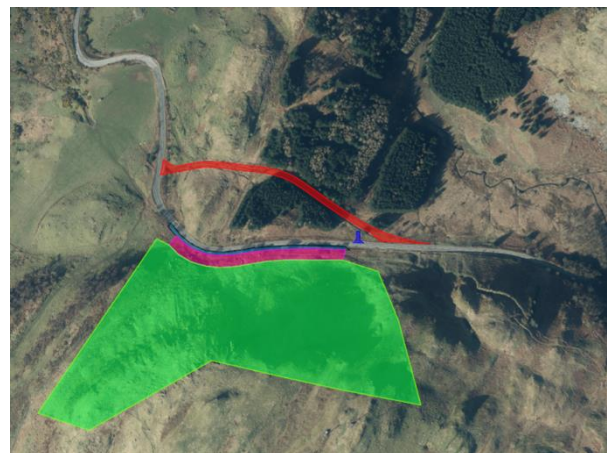
The image to the right shows the extent of the Ardfern slip in green (at least 3 separate slip events took place) the purple shading is the ditch/pit which would catch any future flow, the blue line is a bund to keep the majority of any future flow in the ditch and the red is the proposed emergency road which takes traffic away from the slip affected area and provides a safe alternative route during future weather events.

The likelihood of future debris flow events is so high that we are also progressing with an alternative emergency route as per the plan below. This emergency route will be used when weather conditions are such that the original road is not safe. The land agreement for the road is in place and works are underway. Archaeological

The land agreement for the emergency route has been completed and currently we are on target for the emergency route to be complete by 15 December with a caveat that extreme weather conditions may delay works on the ground. We anticipate the emergency route will be available before we are able to safely reopen the original road.

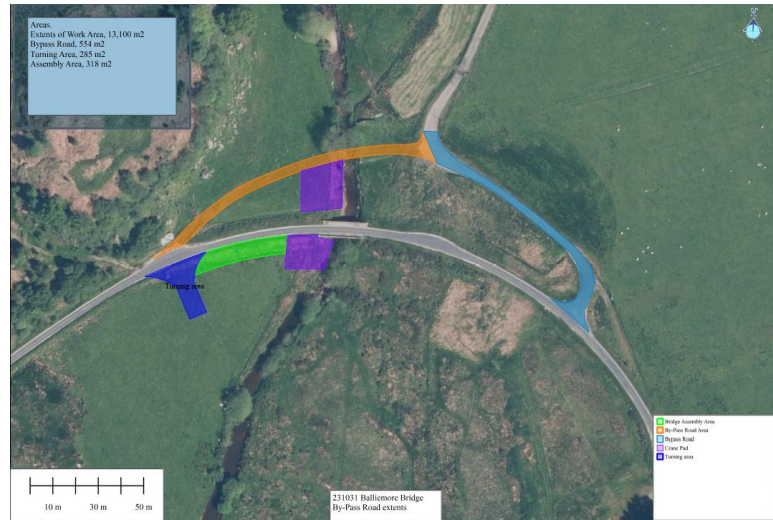
The image above shows where the temporary bridge will go which is to the north of the storm damaged bridge.

A temporary bridge is on target to be built on the alignment of the old bridge by 24th November. This will allow the Glen Lean road to be reopened whilst the bridge damaged in the October rain event is demolished and a new bridge rebuilt. This target date is subject to reasonable weather conditions and no other issues coming to light on site.

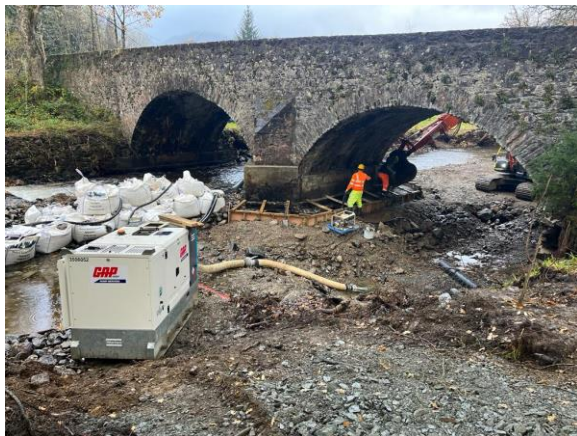
Emergency bridge works to deal with scour damage (water eroding the bridge abutment/foundation) have been completed and work is currently underway stabilising the embankment, which supports the road. There are a number of locations along the B828 where rock nailing and support beams are being installed.

Image above detailing diversion of river flow and over pumping to allow concrete to be laid to support the bridge structure with the concrete replacing masonry washed away with the force of the river.

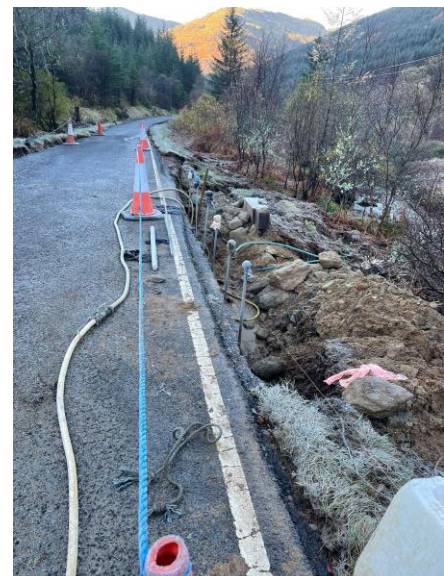
Bottom left image shows reinforced concrete edge beam being constructed to support the carriageway.

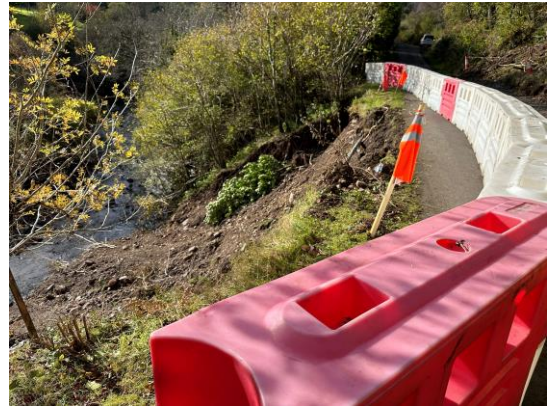
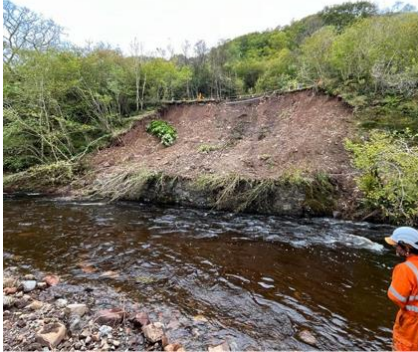
The damage to the Scammadale road embankment was due to exceptionally high river levels washing away the embankment. The repair to this embankment is complex and design works are nearing completion with site works commencing over the next couple of weeks. In the meantime we continue to liaise with the residents regarding vehicles over 3.5

Top image of barriers to keep traffic from the weak edge and right image showing the extent of the affected banking – note the road is at the top of the embankment and this shot was taken before the barriers shown on the right were installed.

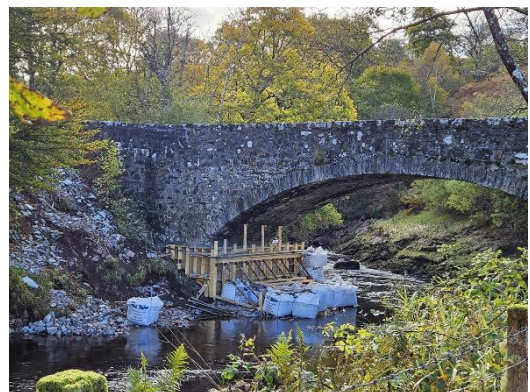
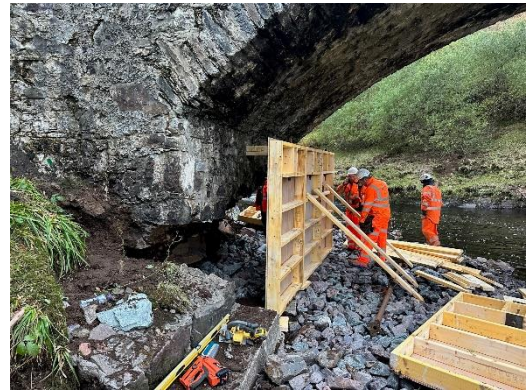
The bridge suffered significant abutment scour during the rain event. Extensive emergency works have been carried out and some rock armour protection work will be carried out in due course to the upstream side of the bridge. The initial works were carried out at pace in order to save the bridge from further scour damage to the bridge's abutment. Any further damage would have very likely resulted in the bridge being lost.

Top image showing the wooden formwork in place which supported the fibre reinforced concrete until it set. Bottom image on the right showing the formwork being erected. The carpenters in the shot help to give scale to the repair works.

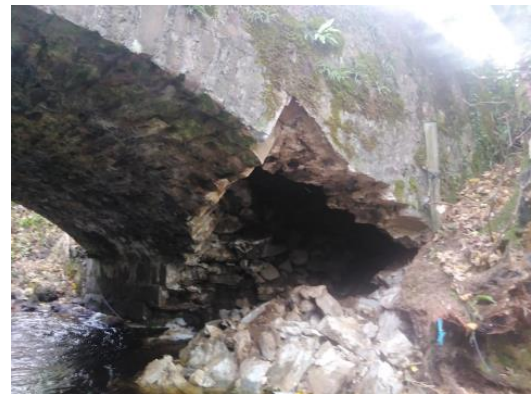
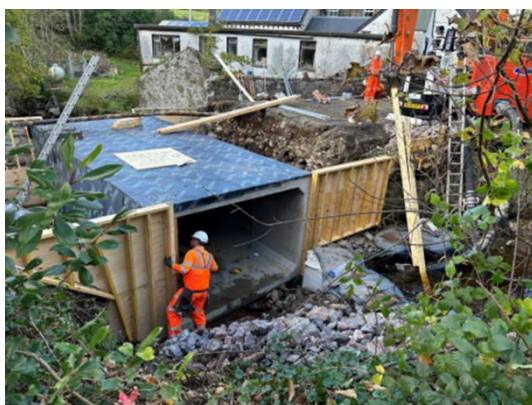
The initial emergency phase commenced on Thursday 19 October when a major defect was found on the bridge. The defect was so significant there was only one option – to demolish the bridge for public safety.

Top image showing the damage to the bridge and the bottom picture detailing the new concrete bridge sections prior to the reinforced concrete slab and surfacing being placed.

The initial plan was to demolish the old bridge and put in place a temporary ‘forest’ type corrugated steel pipe type bridge. However, we were very fortunate and found a number of concrete culvert/bridge sections in Highland which were the correct size and were available. This enabled a rapid construction phase which had the road open to 44 tonne vehicles in an impressive 2 weeks’ time period.

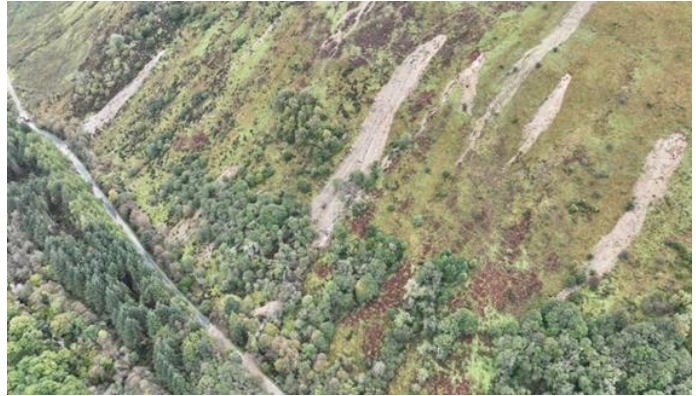
A contract has been put in place with a geological engineering expert for ongoing monitoring of the scars left on the A815. In addition to the monitoring the contacted works include advising on future flow mitigation measures – these at their most basic will be deeper ‘climate adapted’ drainage channels to intercept small flow events. *The image to the right shows*

some of the scars on the hillside above the A815 which are being monitored.
