Key for ROA Assessment Maps

North Kintyre - Site Reference Map

Rural Opportunity Area Assessments, North Kintyre Sites 1-7

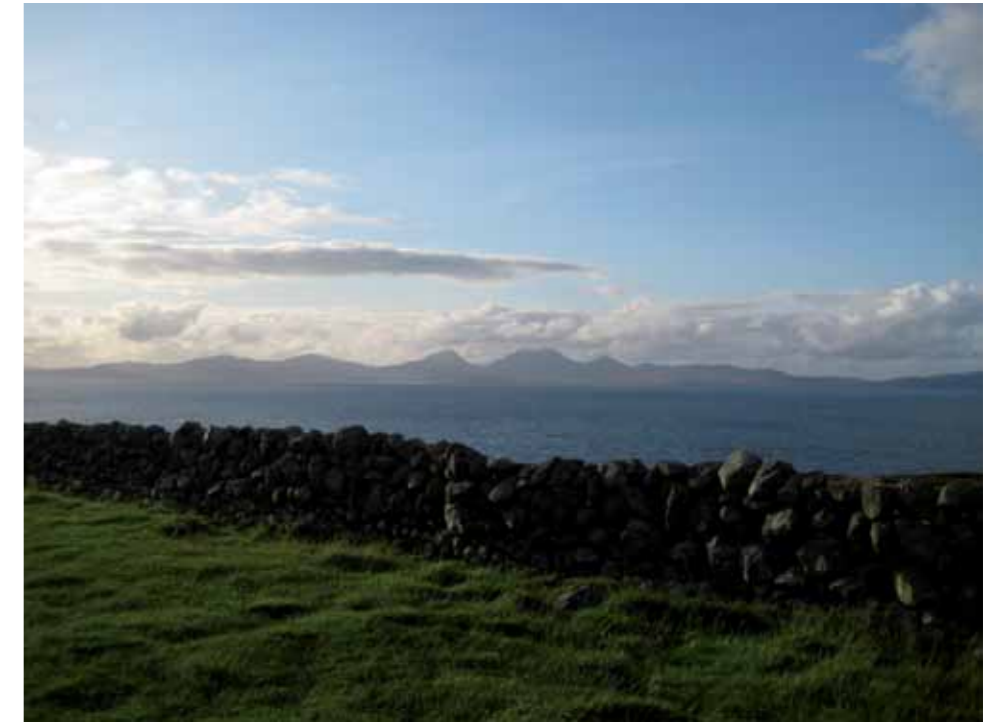
NKI -View from NK I to Jura

The site enjoys an elevated, coastal location overlooking the Sound of Jura with completely open panoramic views to Jura and Islay.

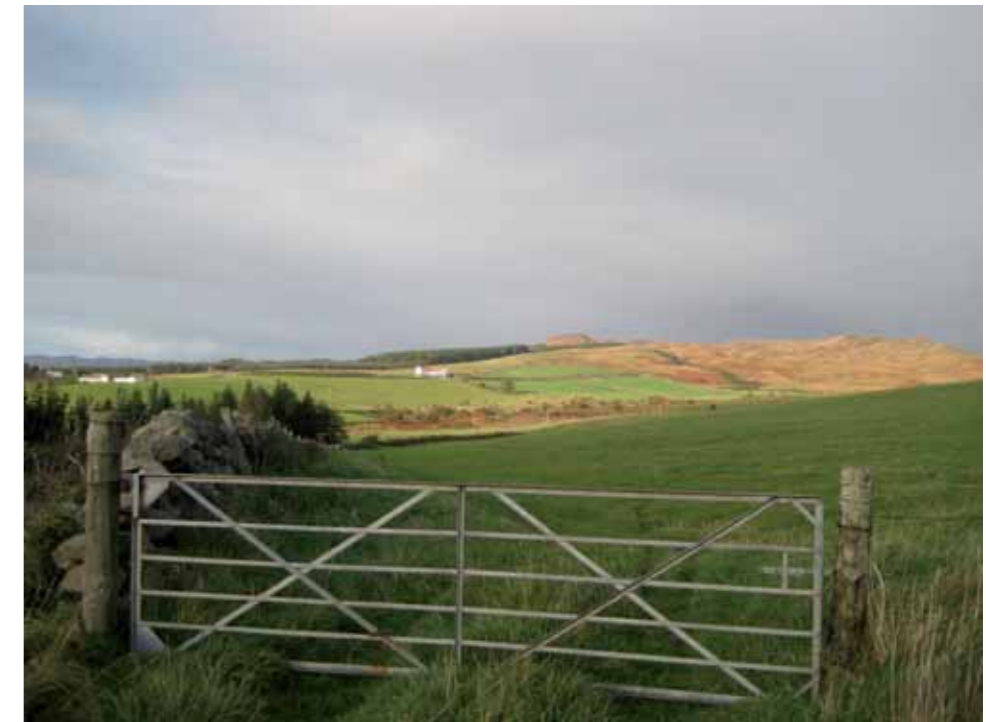
NKI -View north to Crear

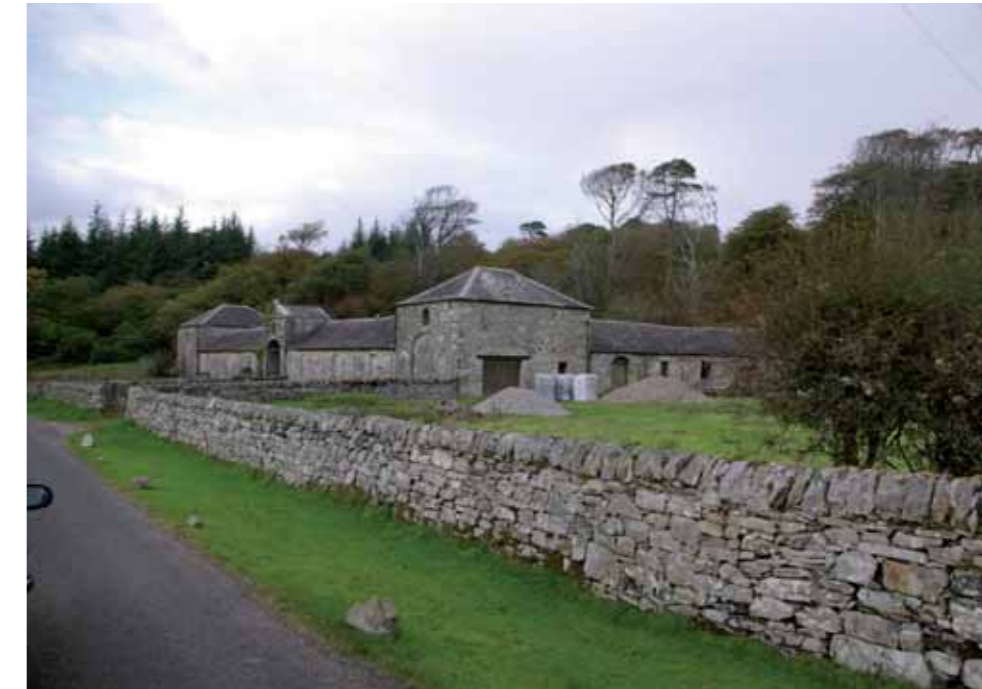
NK2 - Derelict buildings at Gorten Lodge

There are a number of properties reasonably discreetly tucked into the landform within the river valleys and clearings of the wooded foothills. The formerly grand Gortan Lodge is now derelict but still provides an attractive, architectural feature within the landscape.

- Redevelopment of the Gortan Lodge buildings;
- Development of 3 or 4 dwellings in the valley of Abhainn Learg an Uin, between the church and High Carse, providing that it is set into the landscape at lower levels and tucked in amongst trees;
- The area at Tigheata presents an opportunity to create a clustered development of 4 to 5 properties (in addition to the existing development) as it is sheltered, enclosed and any development would not affect the wider landscape or views out. It is also a natural place for settlement (in a valley, route junction, riverside) and would follow the pattern of existing development in the area.

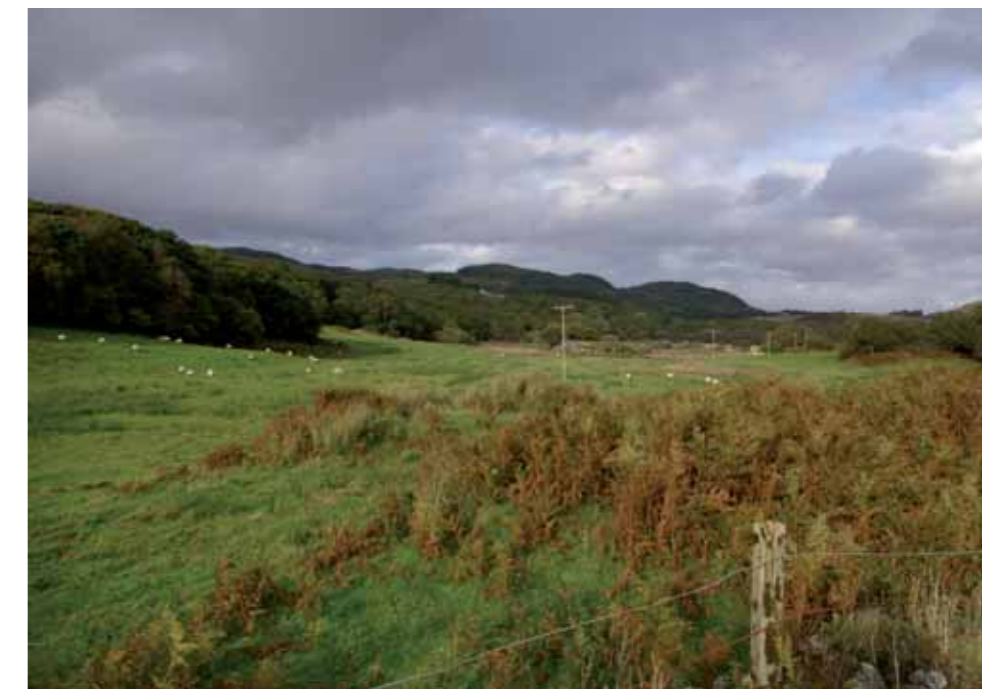
NK2 - The view north west to Kilnaish

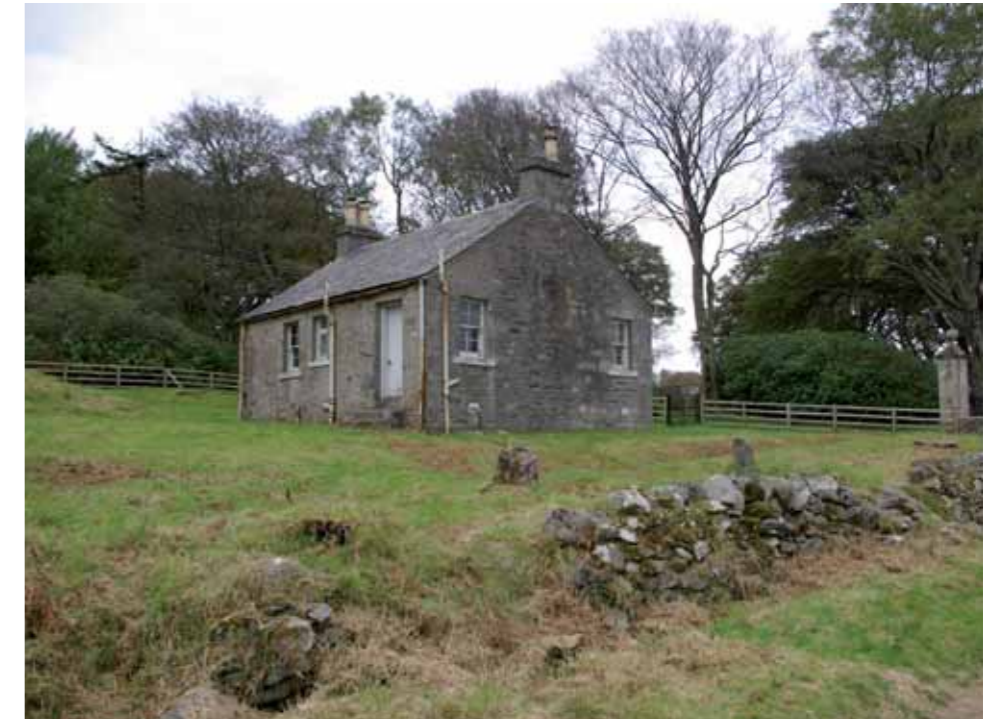
NK3 - Bruach Bhan

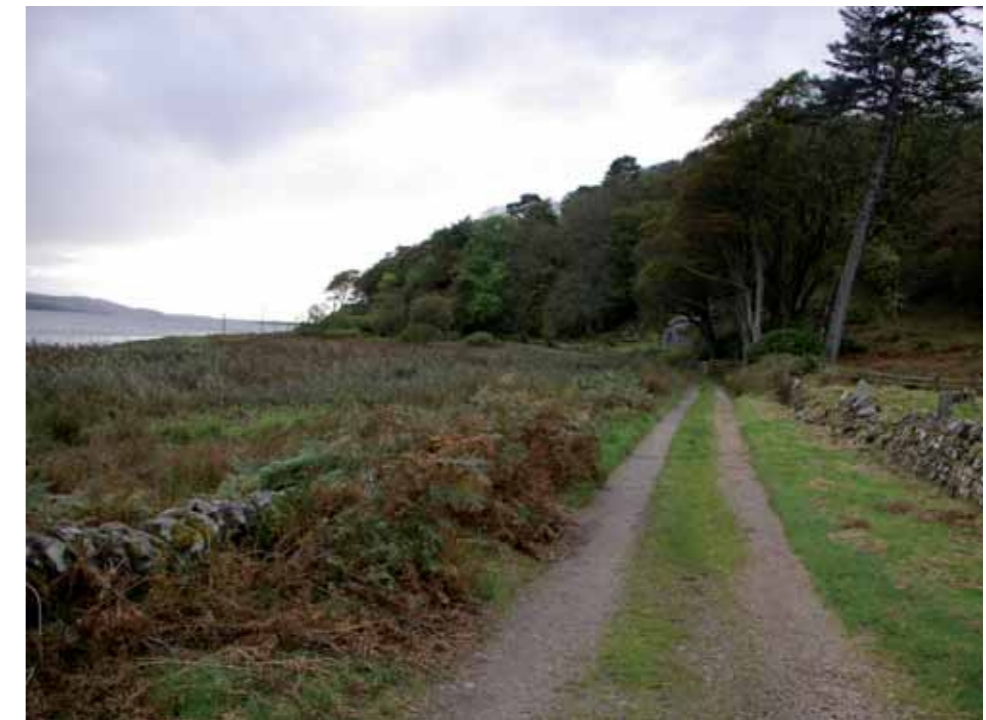
NK3 - Approaching Ardpatrik House

Ardpatrik House is set back from the coast surrounded to the south and west by landform and on all sides, except the east with mixed woodland. A framed view, over a formal lawn, of the loch is afforded between the trees. The Home Farm, other cottages and out buildings are tucked away, out of site amongst the trees and landform

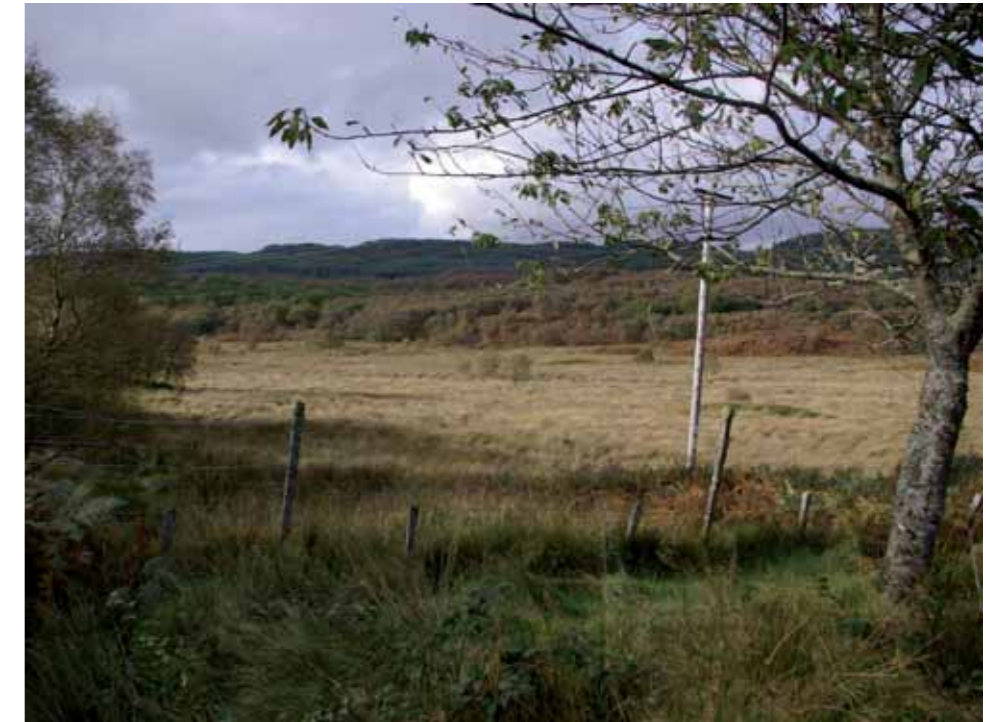
NK4 - North of B8024

- The area to the north of the B8024 could accommodate some development in the lower levels, next to the road, utilising existing tracks for access;
- Development could be tucked within the woodland along the access track, extending southwest towards Auchan;
- Development could be considered to west of woodland where trees and landform would 'anchor' / ensure a positive setting within the landscape.

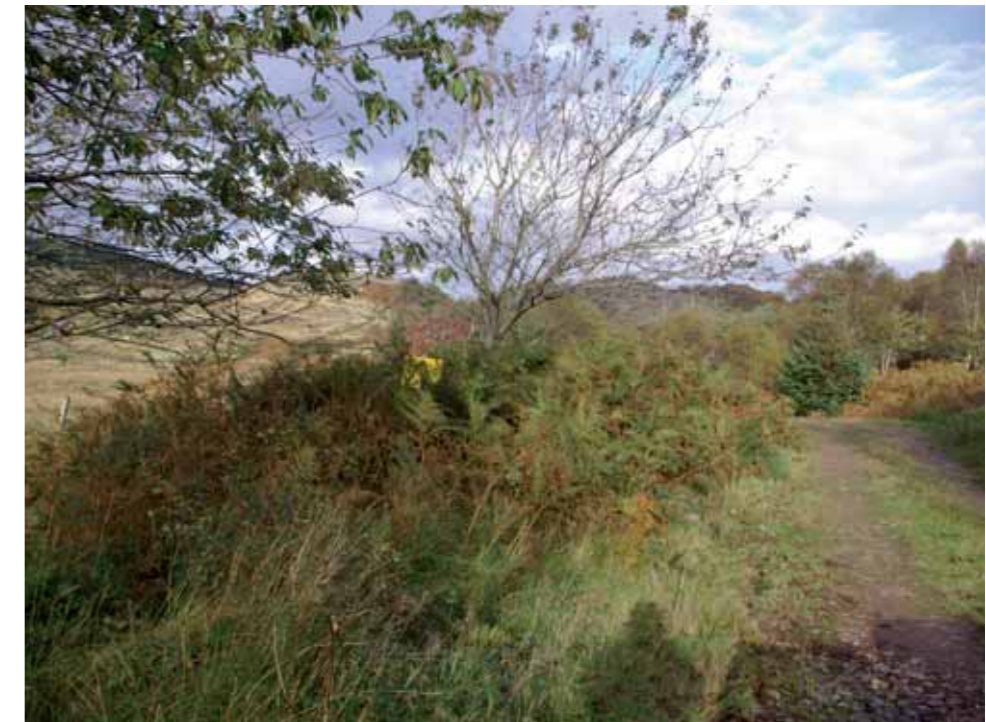
NK4 - View north east along the track leading to Cnoc Mhic Bhreatuinich

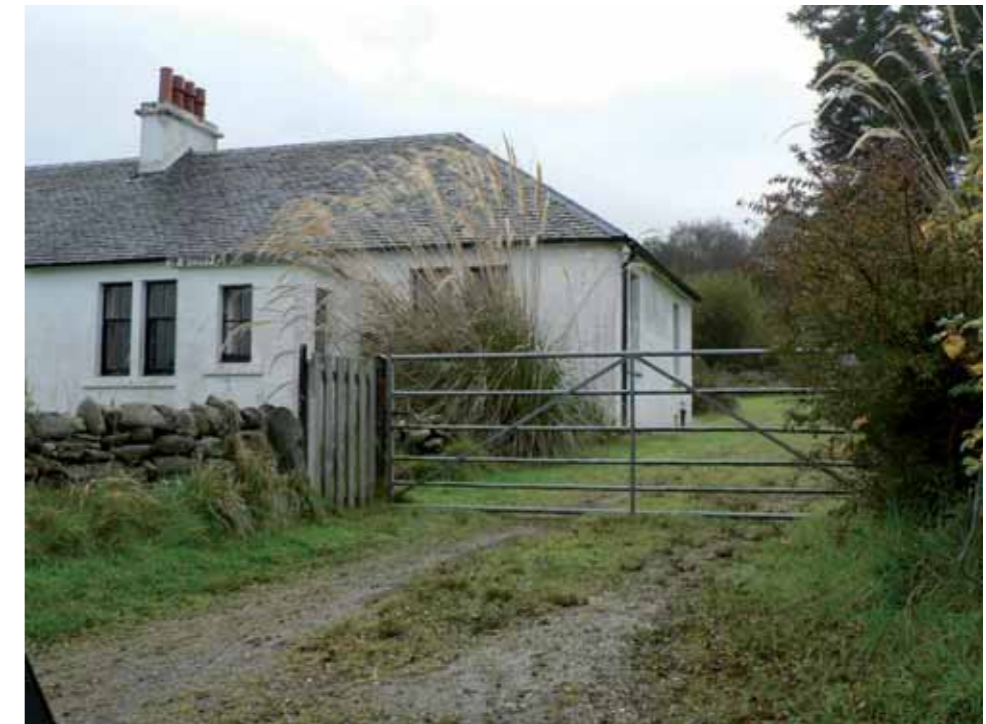
NK5 - Loup House

- There are opportunities for a small number of new units within this ROA. They should be located on the lower flat fields between Corran Farm and Loup House where the steeply rising ground will provide a backdrop;
- Further opportunities exist for several units in the wooded area around the property at Portachoillan if set back against the rising ground and away from the lochshore;
- The elevated open ground at the centre of the site in the vicinity of the current farm building reconstruction should ideally remain free

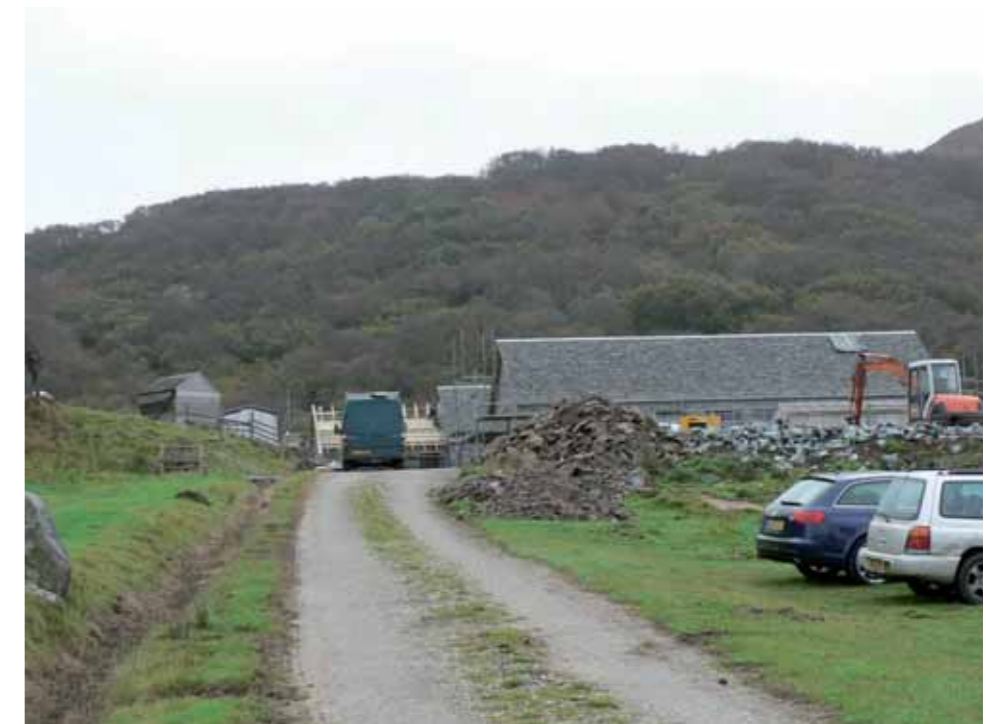
NK5 - Existing buildings and extensions under construction

On the steeper slopes there are open fields with native woodlands and existing buildings are individually located, not clustered. There are farm buildings currently under reconstruction/refurbishment on the upper open slopes at the centre of the ROA which command panoramic views to the north and west. There is only one single track road system through the area. There are no overriding landscape characteristics such as walls or hedgerows.

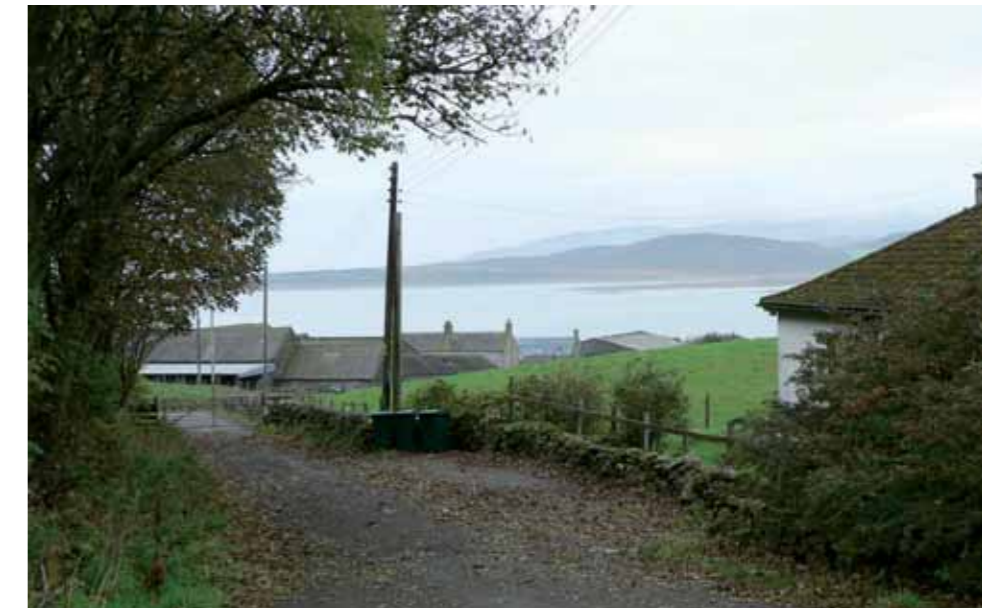
NK6 - View to Stewartfield

The site is a small area immediately west of the A83, comprising a few fields used for grazing sheep, to the north and south of Stewartfield Farm. This is a predominantly agricultural landscape with a block of mixed coniferous and deciduous trees immediately adjacent to the road. The larger coniferous woodland to the south at Dun Ronachain forms a dominant backdrop to the views to the south.

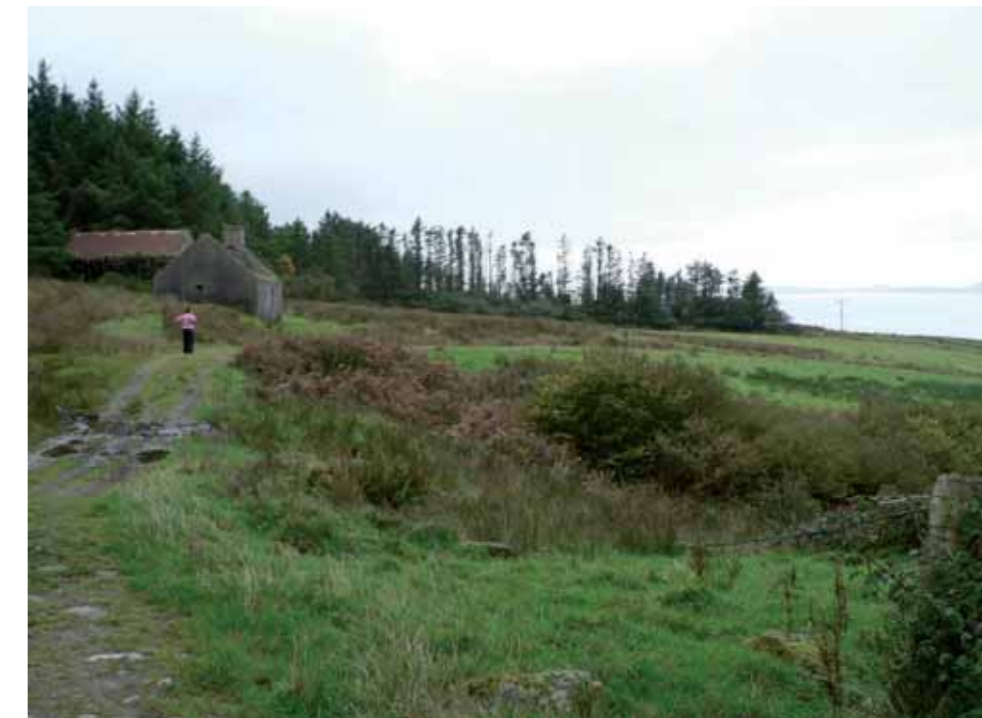
NK7 - View of upper fields

- The steeply sloping scrubby areas to the northern end of the ROA adjacent to the road should remain undeveloped to preserve the fine views and avoid physical impacts on attractive wooded slopes;
- The upper convex slopes of open fields should also remain undeveloped as they are highly visible and climatically exposed with no woodlands or landform features to create shelter or screening.
