**TITLE: A83 KENNACRAIG TO CAMPBELTOWN - ROAD CONDITION**

## APPENDIX A

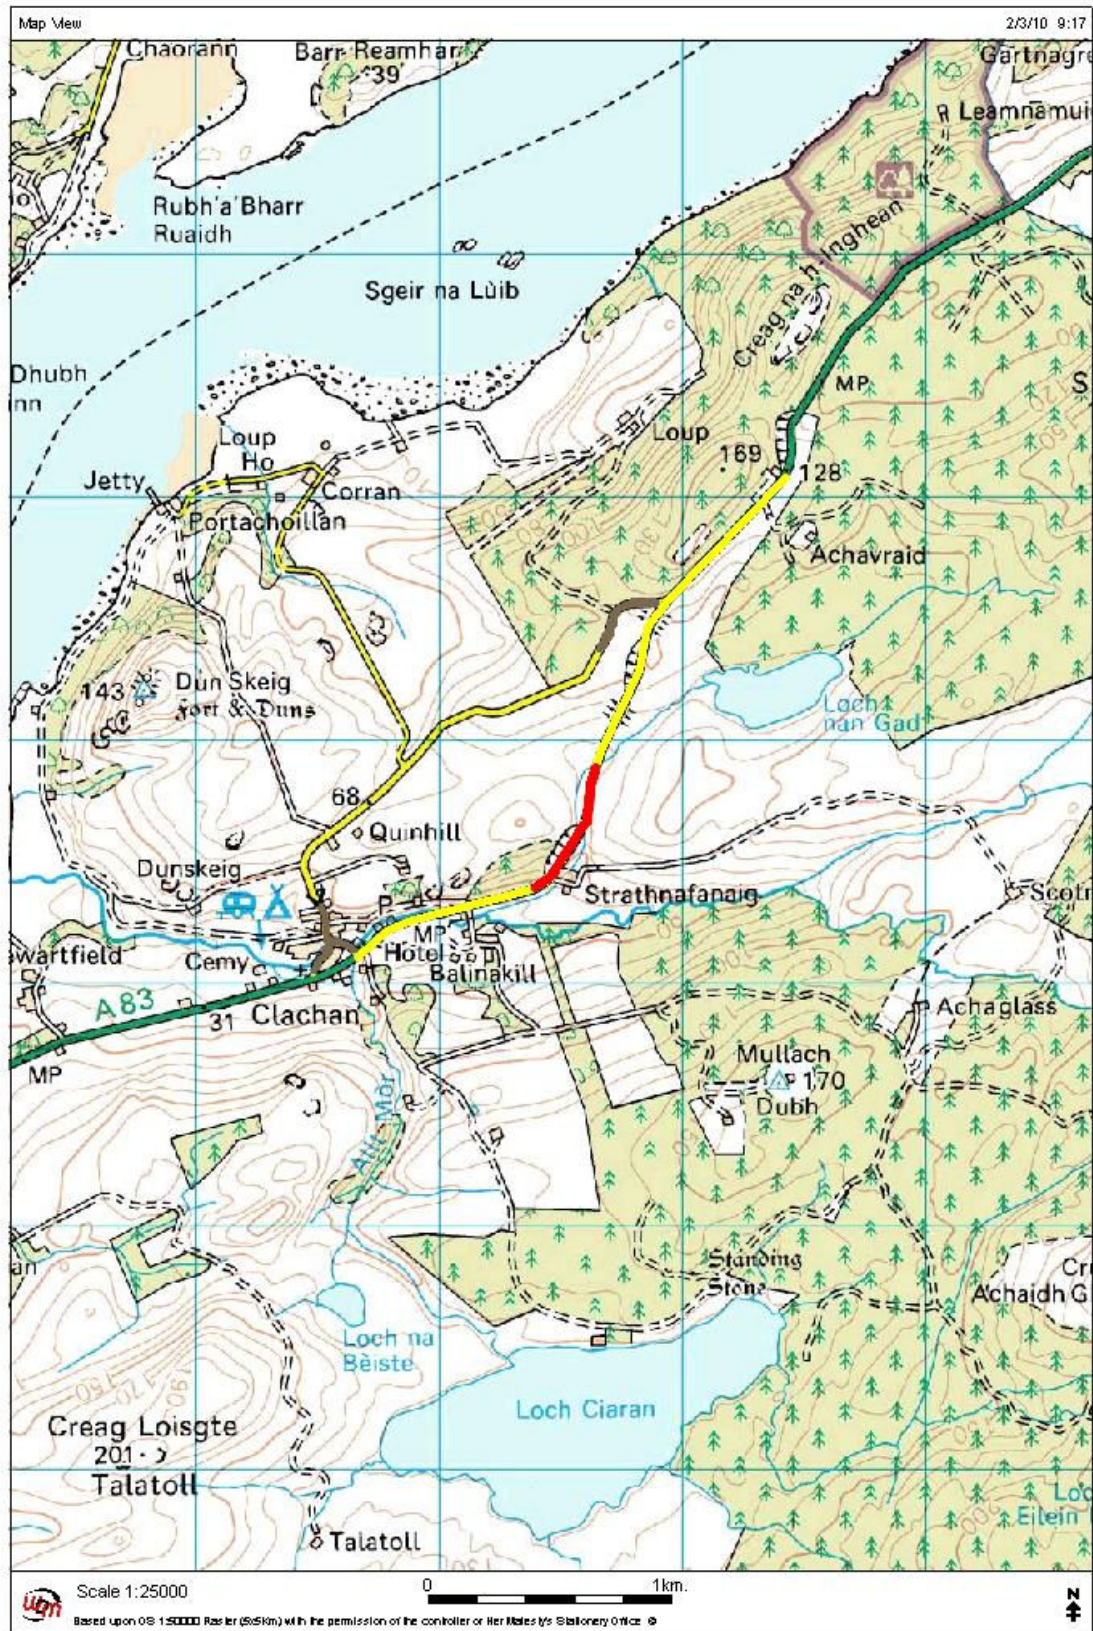
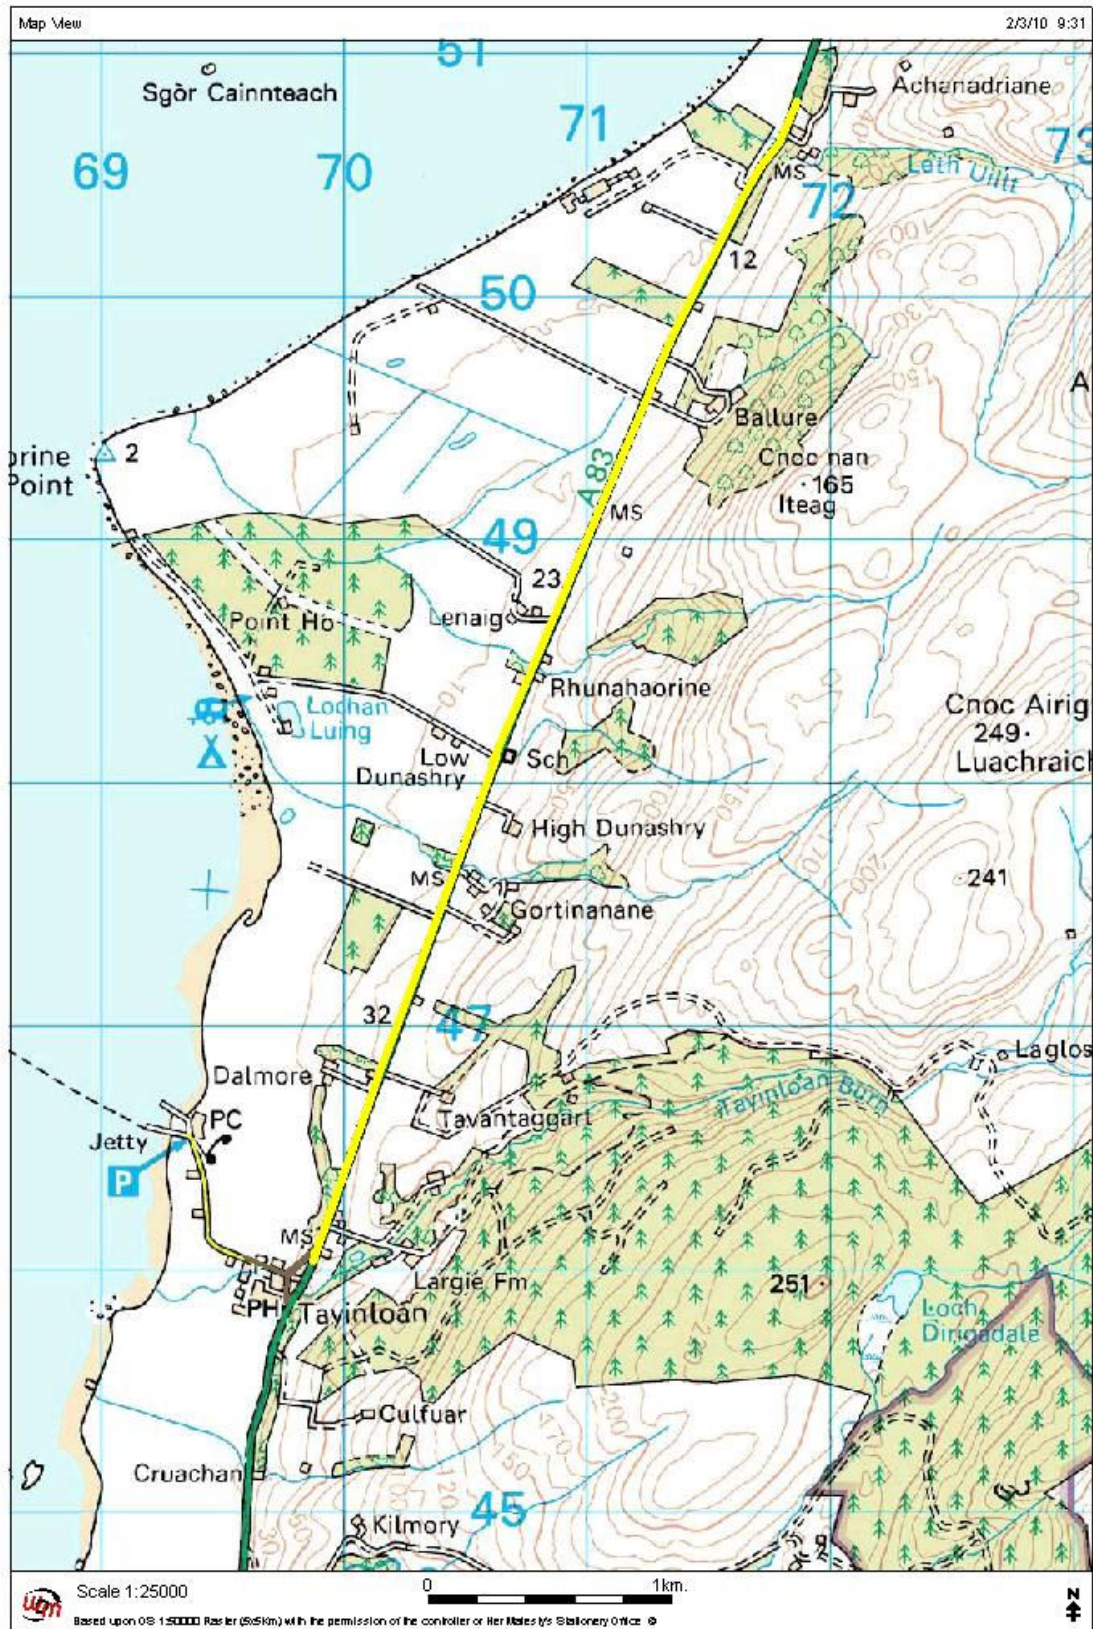
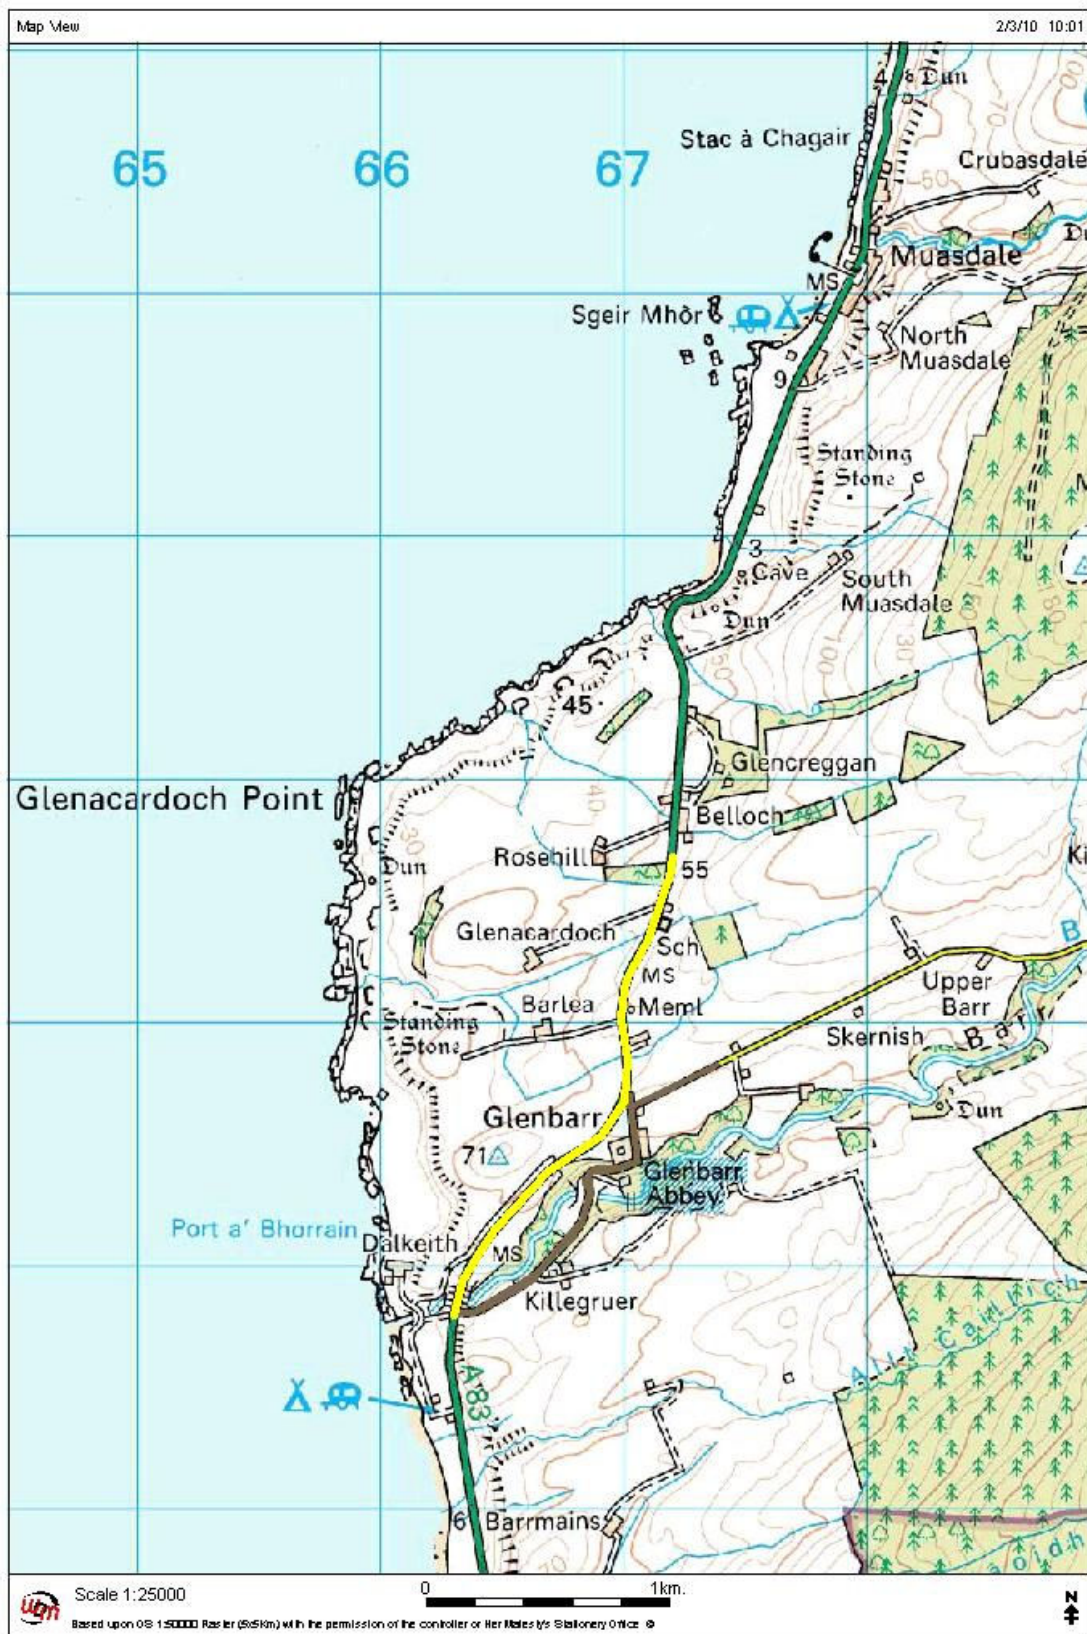
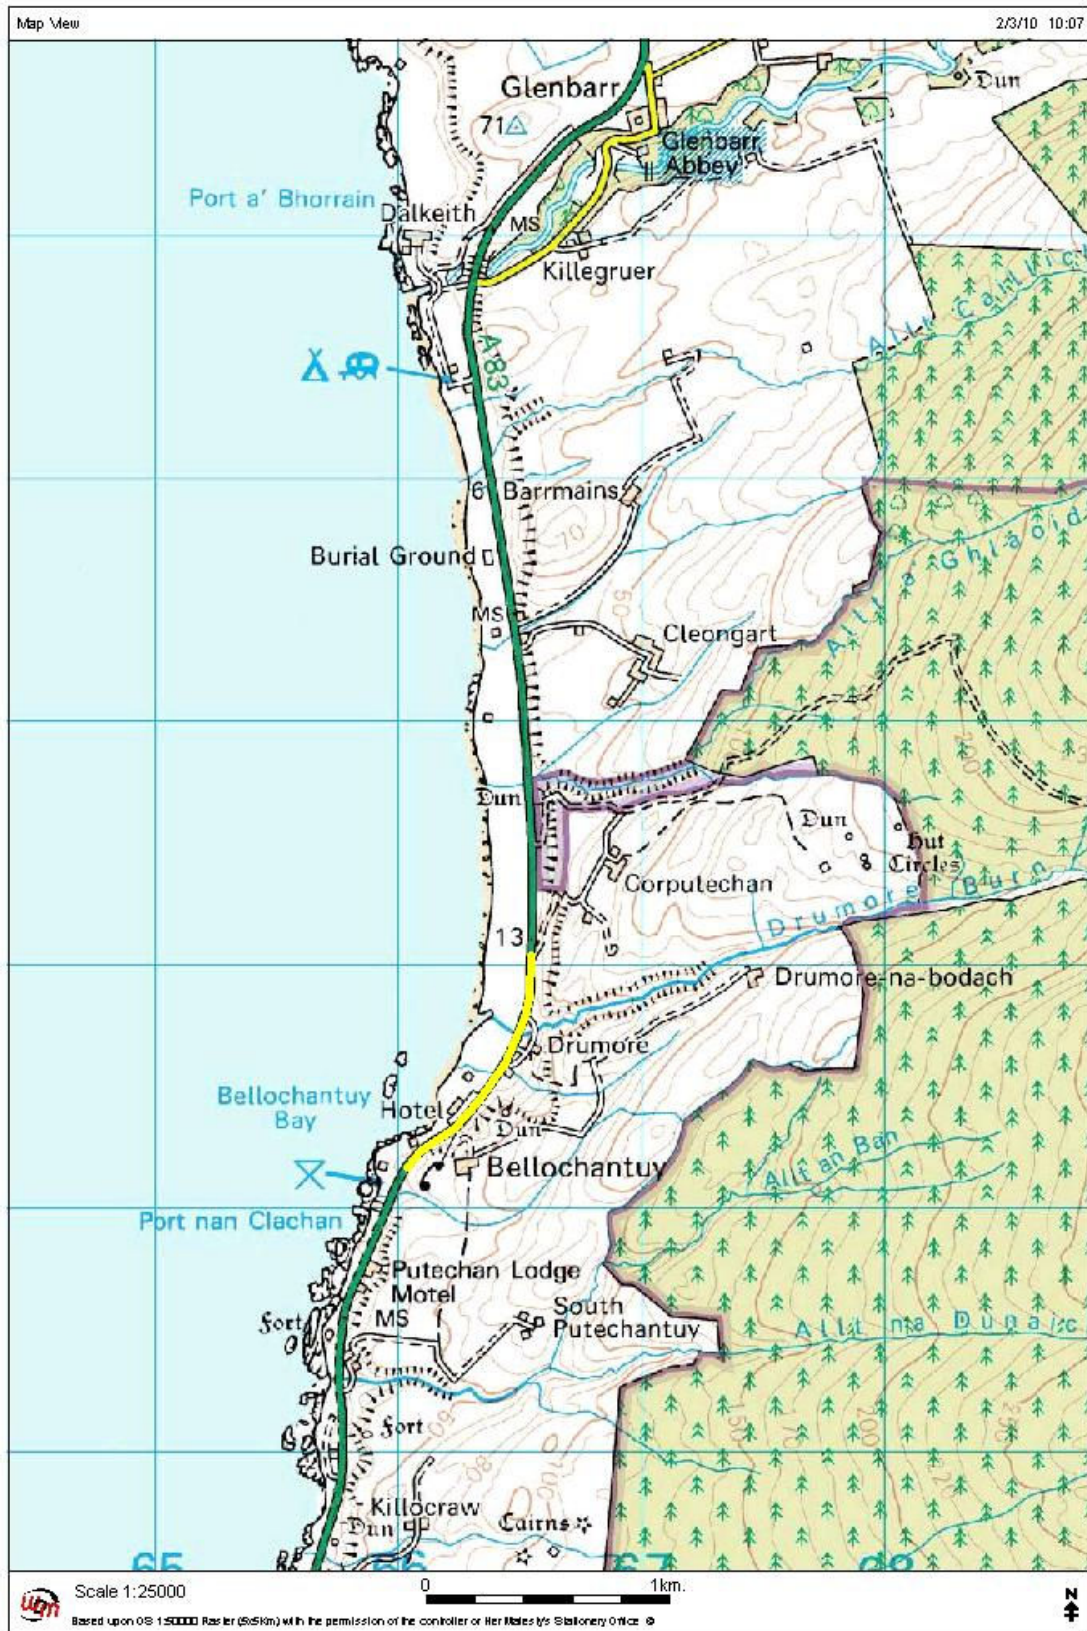
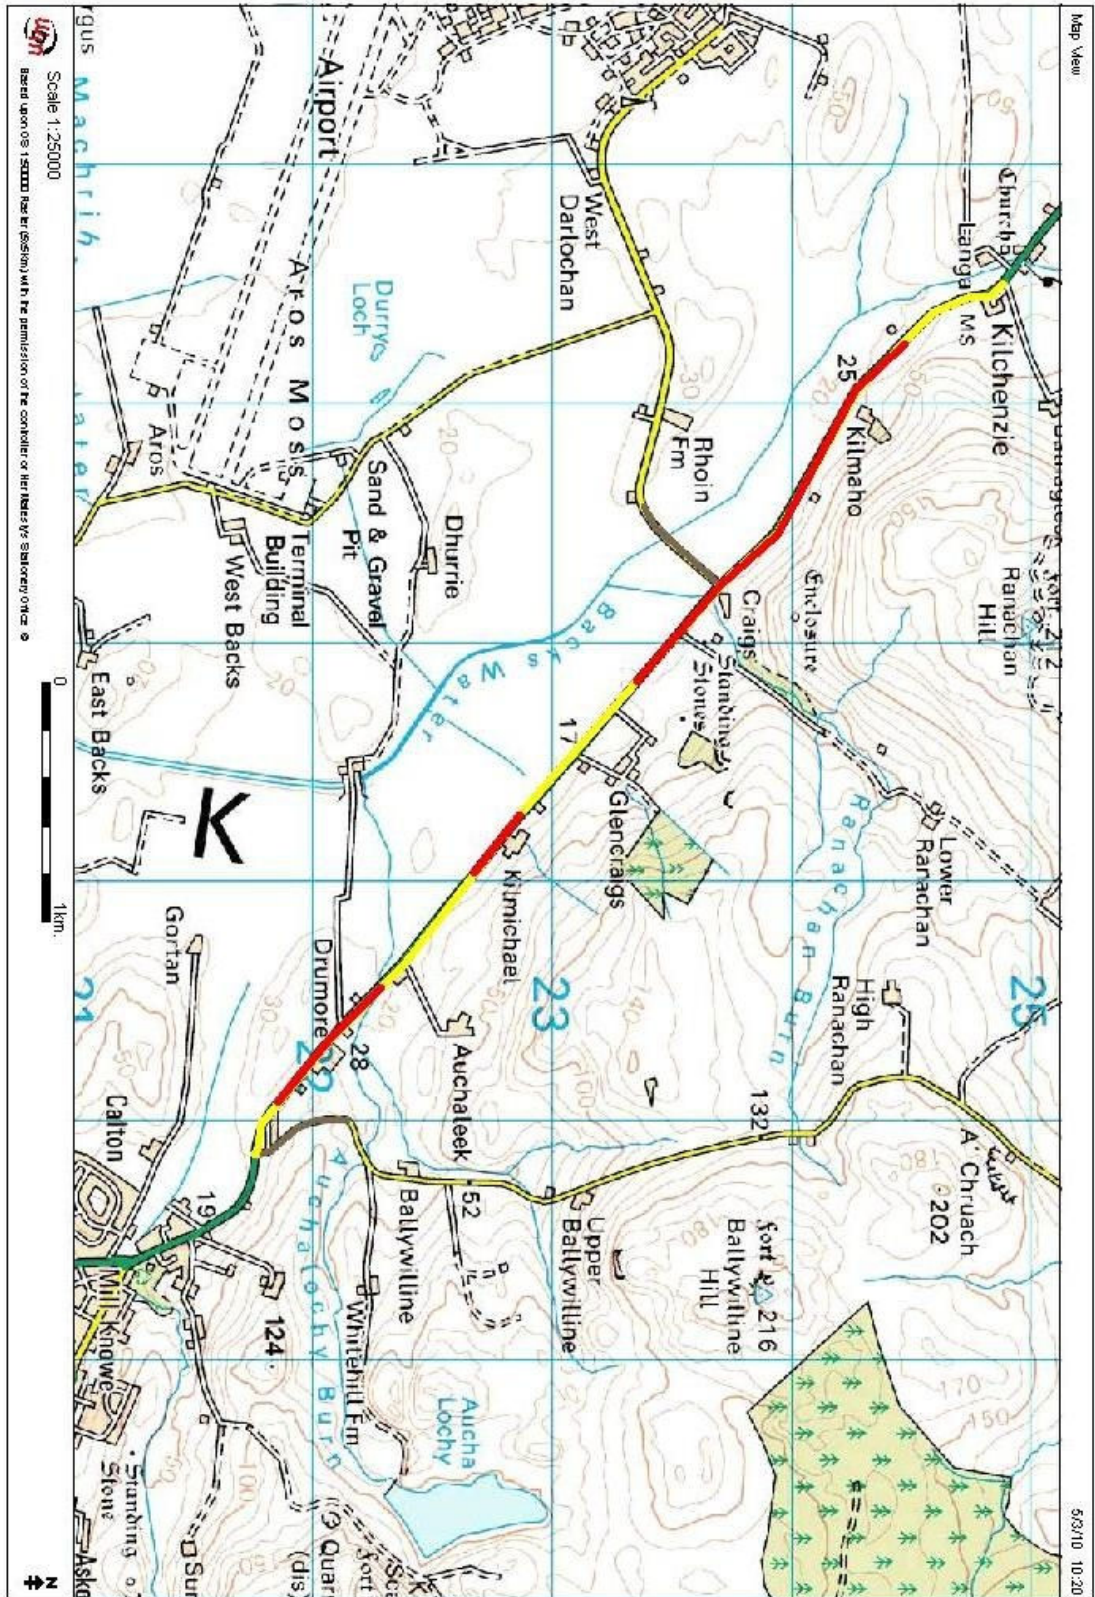
## **APPENDIX A**

- 3.2 The attached report, in Appendix A, identifies 5 locations on the A83, between Kennacraig and Campbeltown, which are considered to be showing the worst signs of deterioration.

- The overall section length requiring treatment is 5,200m - highlighted in yellow on the plan in Appendix A.
- The existing surfacing is a mix of old surfacing and permanent and temporary repairs.
- Repairs have been carried out to the drainage along this section with further work required prior to carrying out surfacing work.

- This 2,200m long section is highlighted in yellow on the plan – Appendix A.
- The existing surface is generally surface dressing over old surfacing.
- The surface suffers from sporadic potholes with a few localised clusters. One main drainage issue has been highlighted north of the village access - formalised drainage will be installed this coming financial year. There are also longitudinal ruts in the wheel tracks at the south of Glenbarr which carry water down the hill.
- Most of these repairs will suit permanent patching works. This work will be carried out under the revenue maintenance budget. Whilst this section requires limited surfacing work, it remains in a better condition than other sites mentioned in this report.

- This 1,100m long section is highlighted in yellow on the plan Appendix A.
- The surface consists of surface dressing over old surfacing.
- Potholes have developed along the wheel tracks at several locations. These will suit repair by overlay or planing out ¼ carriageway & resurfacing with a mini paver.
- Again, as with Glenbarr, this site should remain in a better condition than other sites mentioned in this report. Work here will be carried out under the revenue maintenance budget.
