Dunoon Pier Strategy DRAFT

Structural Review

DUNOON PIER TIMBER PILE SURVEY September 2011

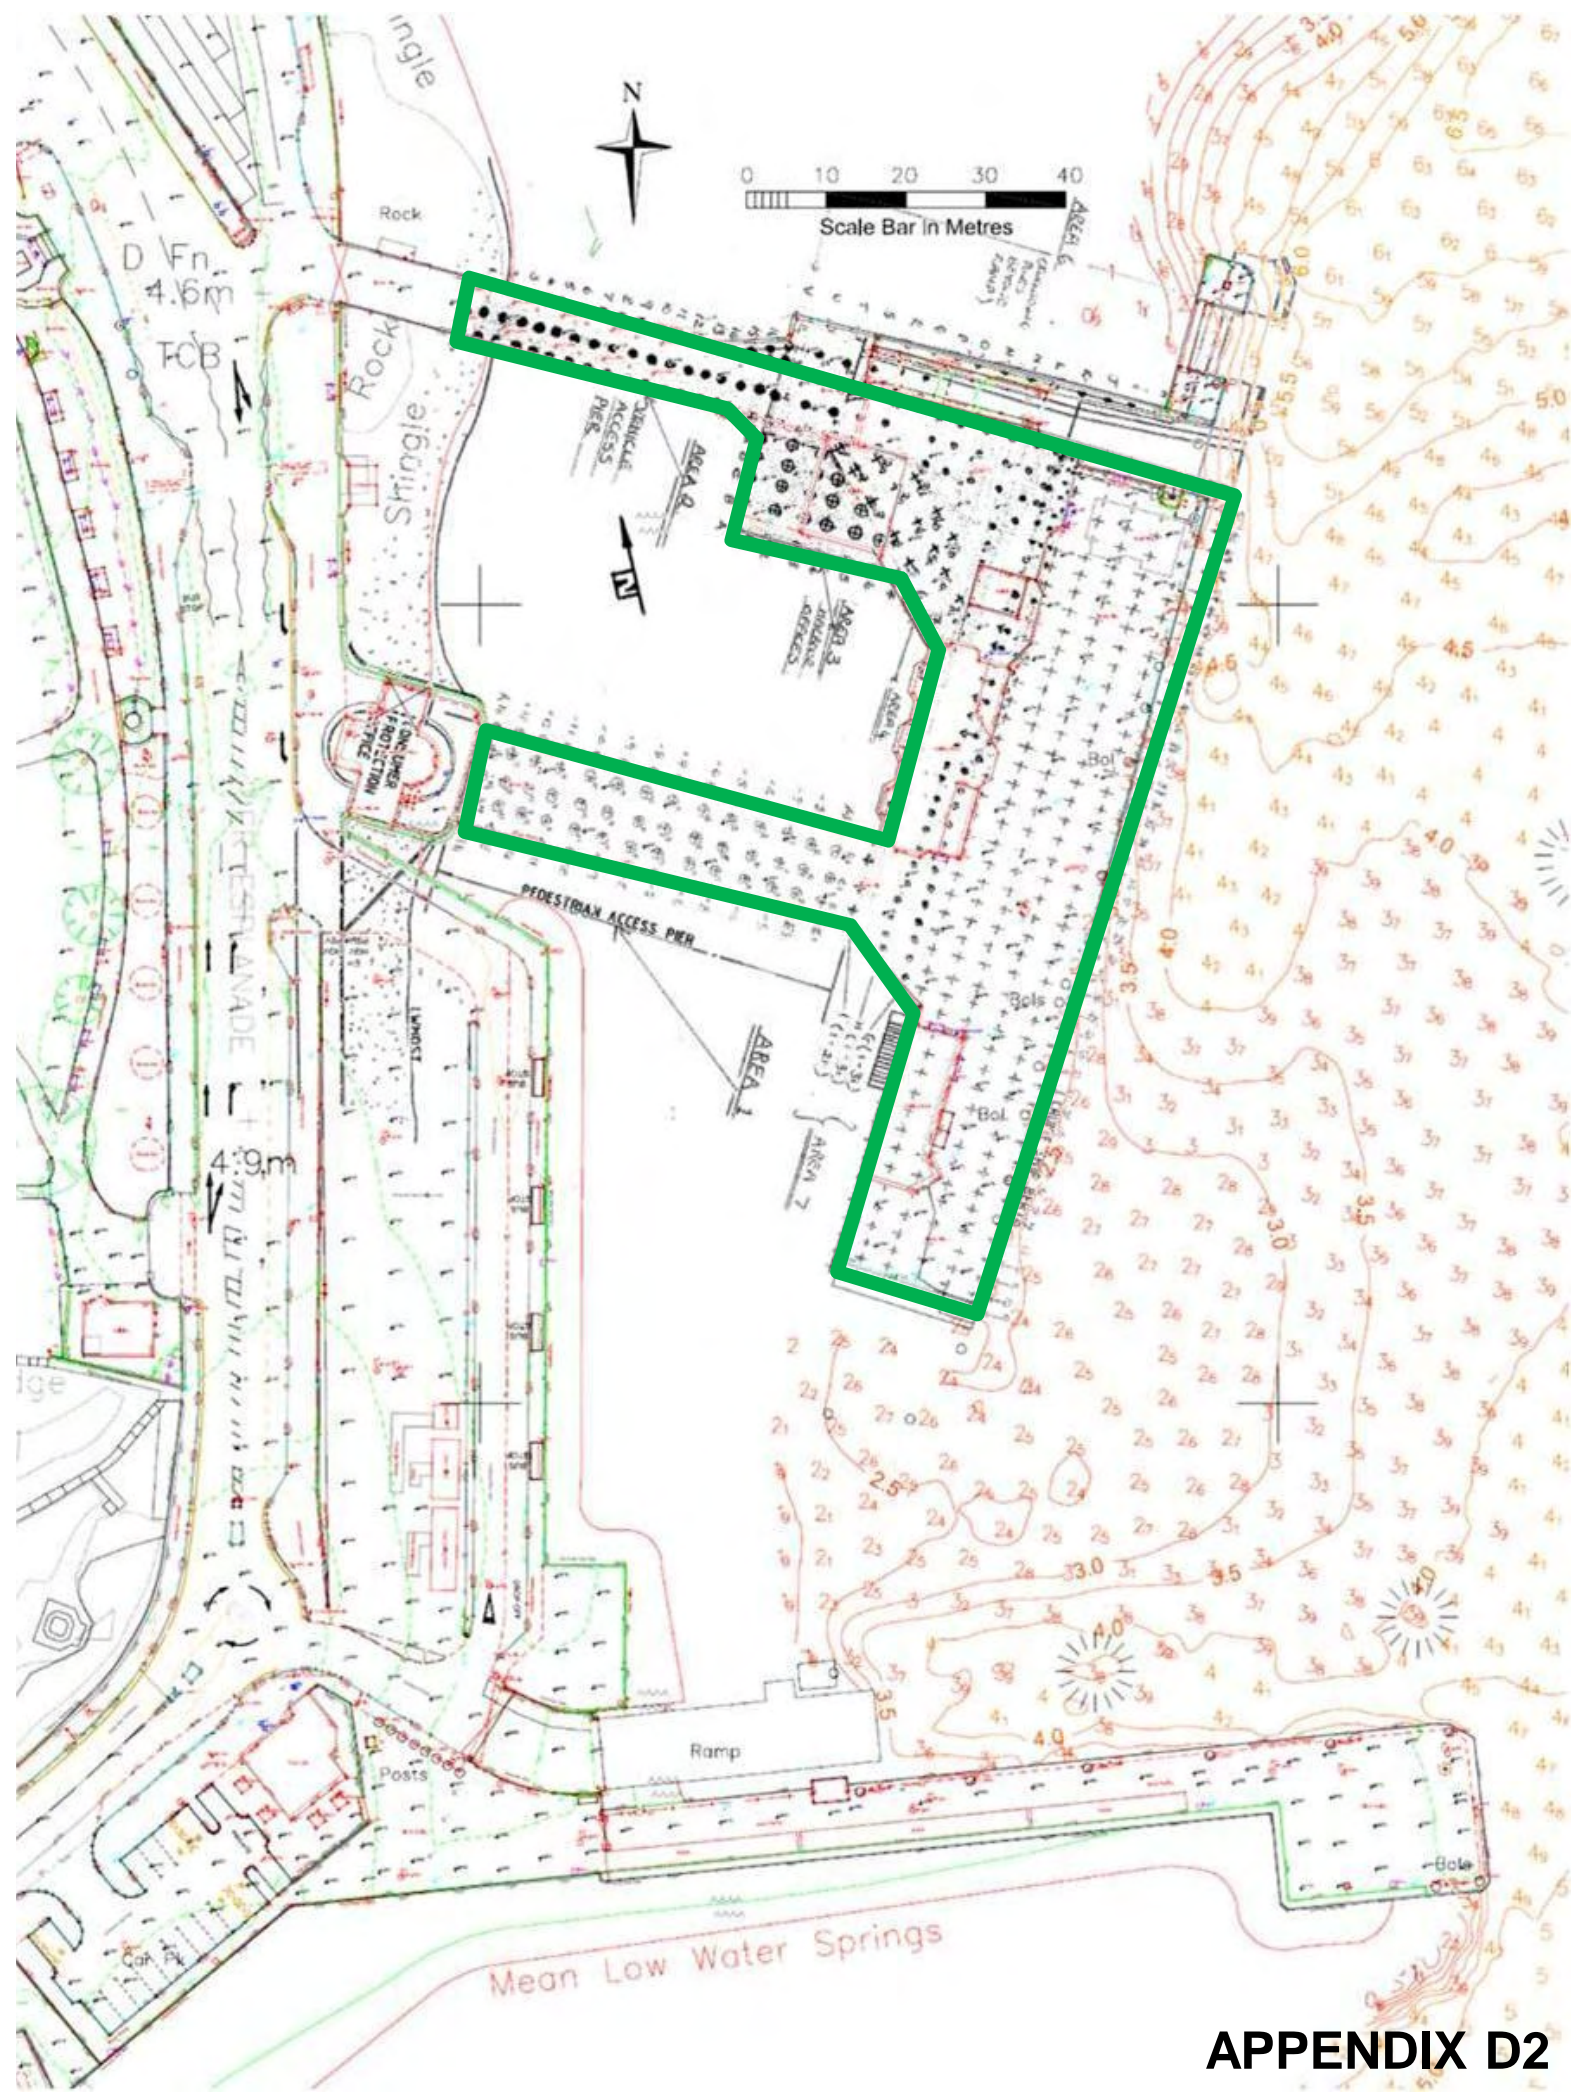
Timber Pier Restoration – Full Restoration

Diagram shows combined topographic survey, bathymetric survey & pile locations

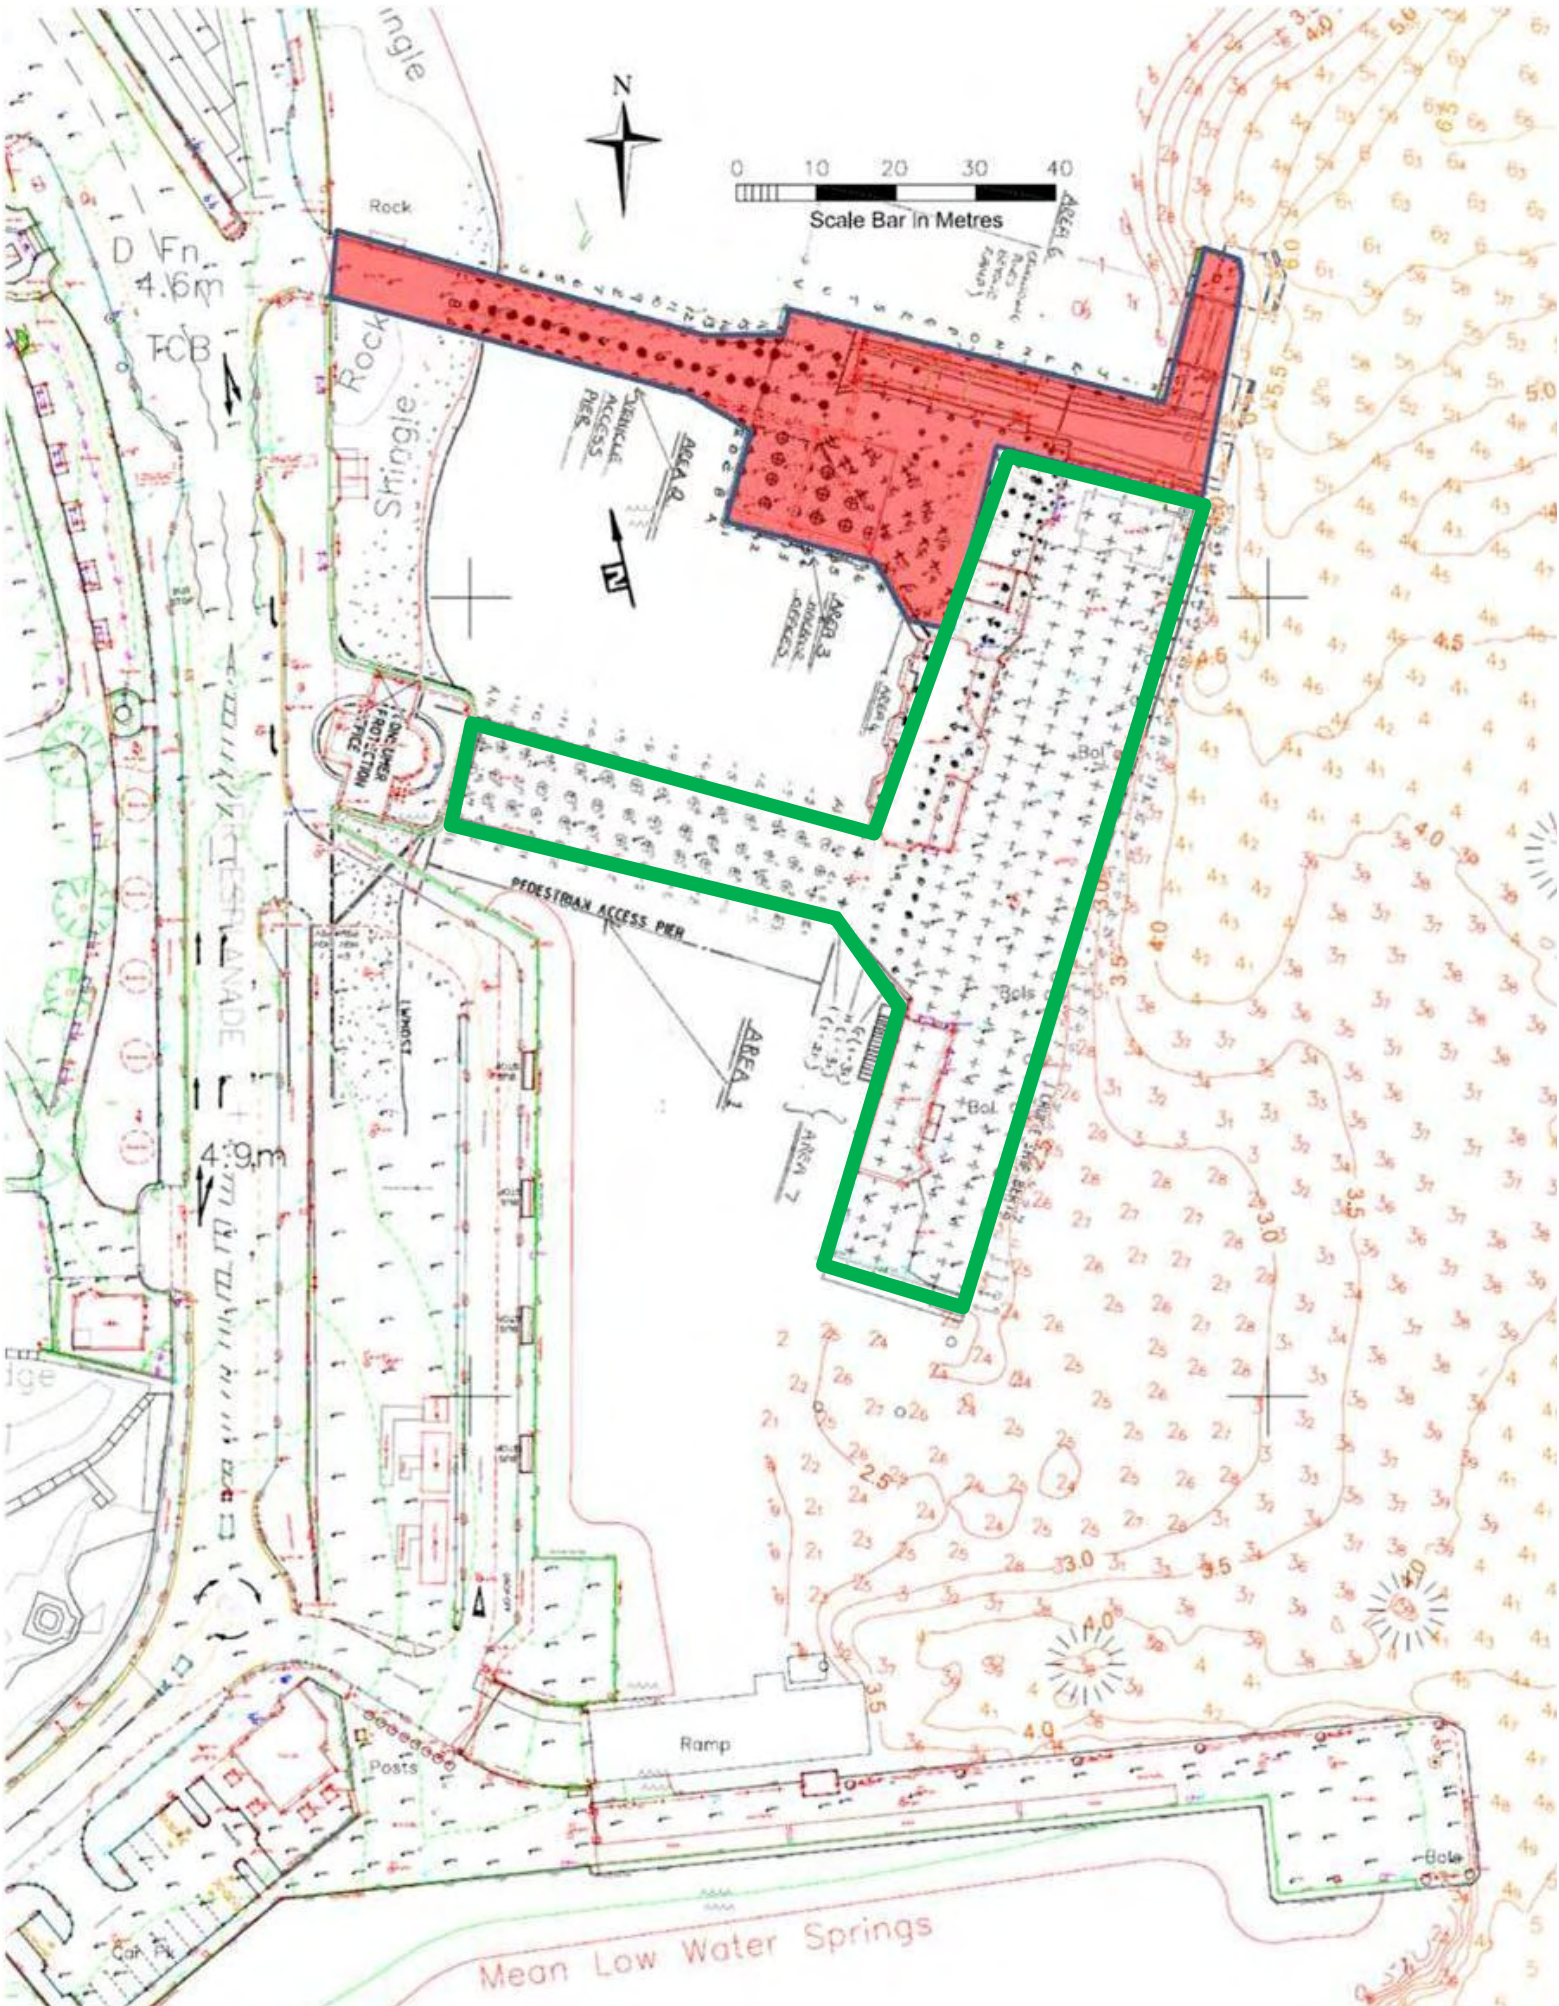
Timber Pier Restoration – Partial Retention Option 1

Removal of car access, link span and berthing dolphins

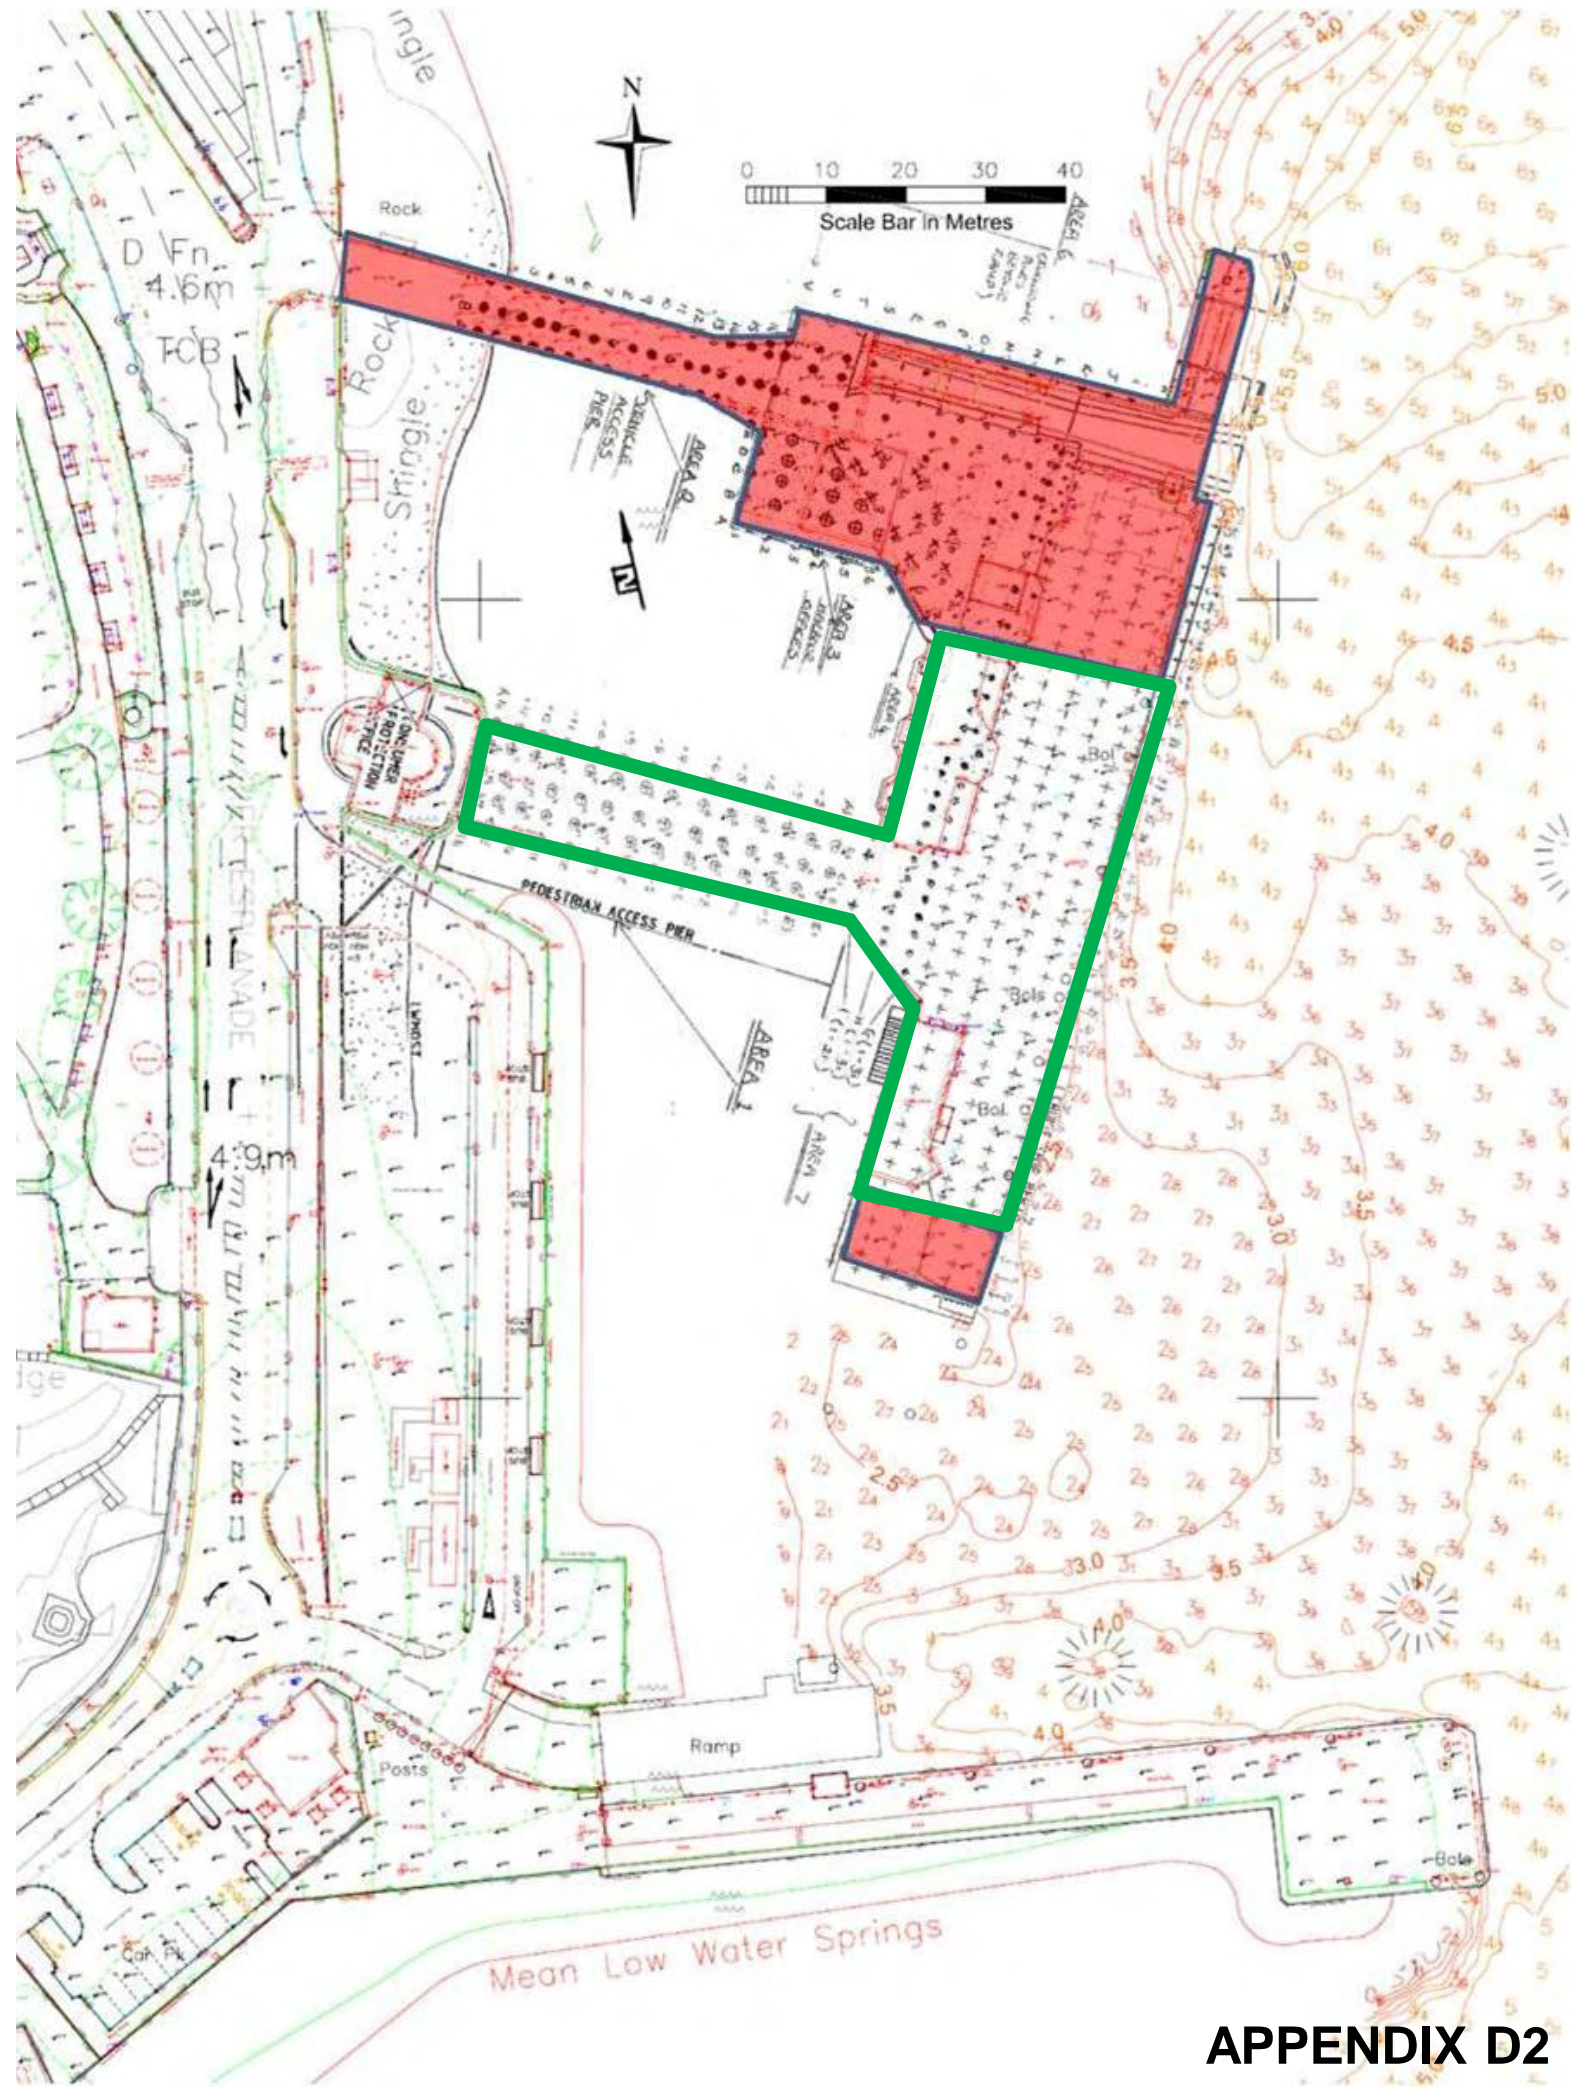
Timber Pier Restoration – Partial Retention Option 2

Removal of car access, link span, berthing dolphins, north end and west end

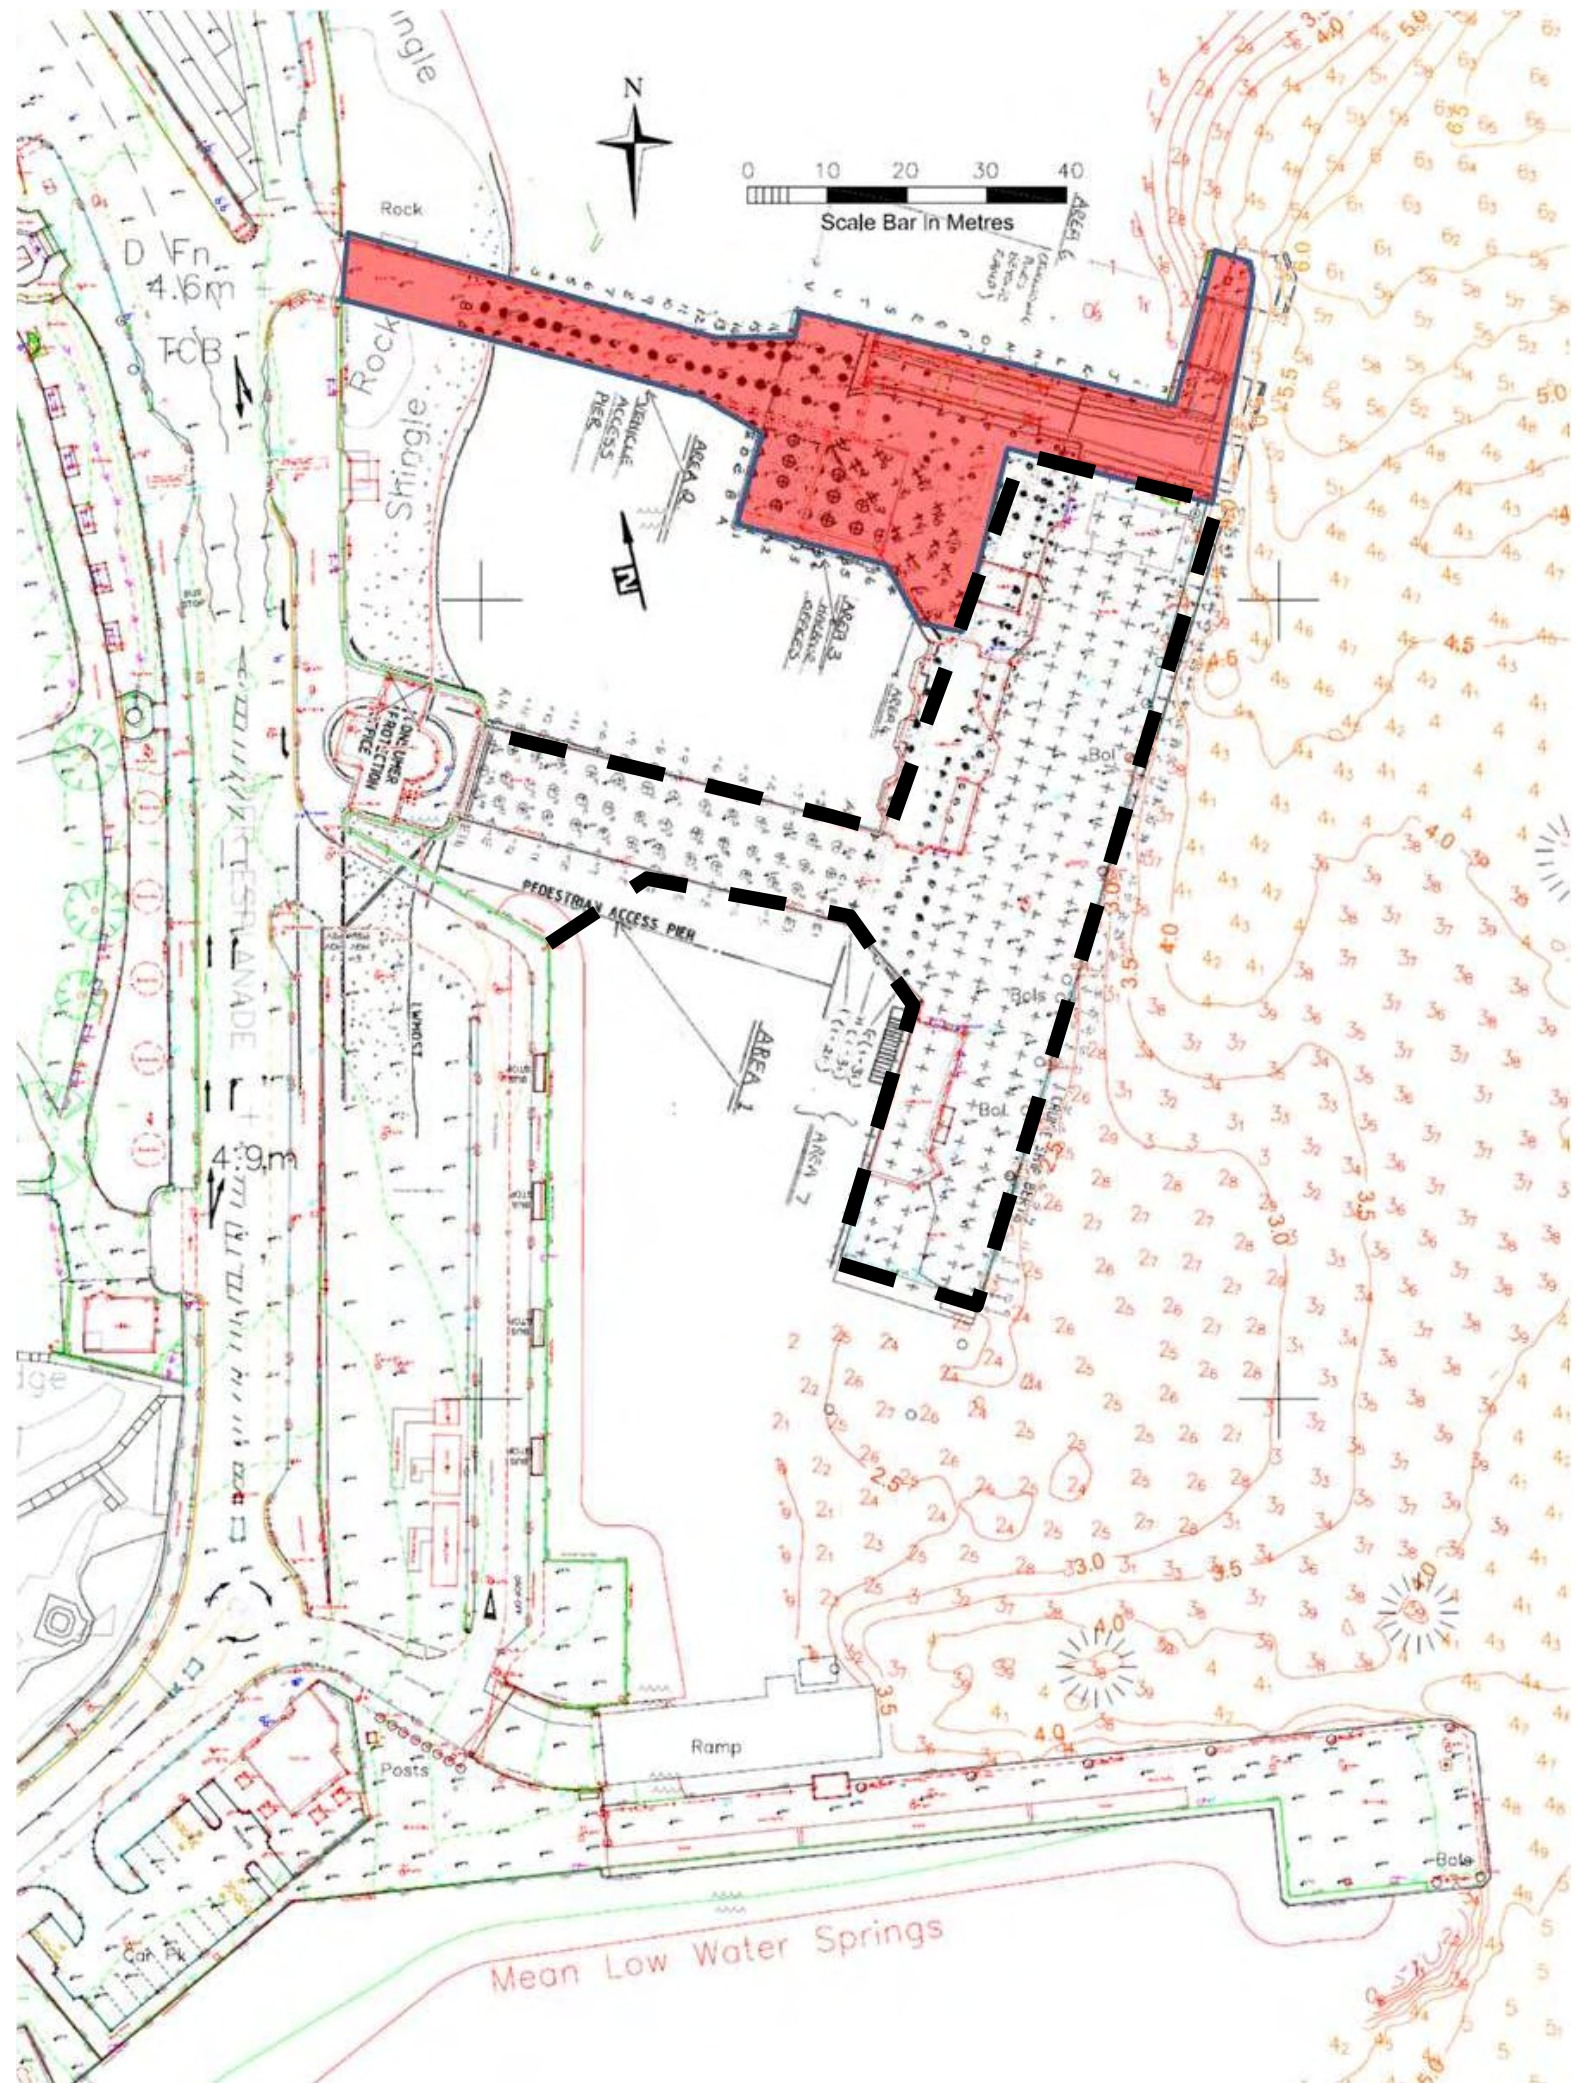
Steel Sheet Pile Option

Removal of car access, link span, berthing dolphins, north end and west end
