Port Riddell Condition Report and Initial Option Development

June 2023

Argyll and Bute Council
Kilmory
Lochgilphead
Argyll
PA31 8RT

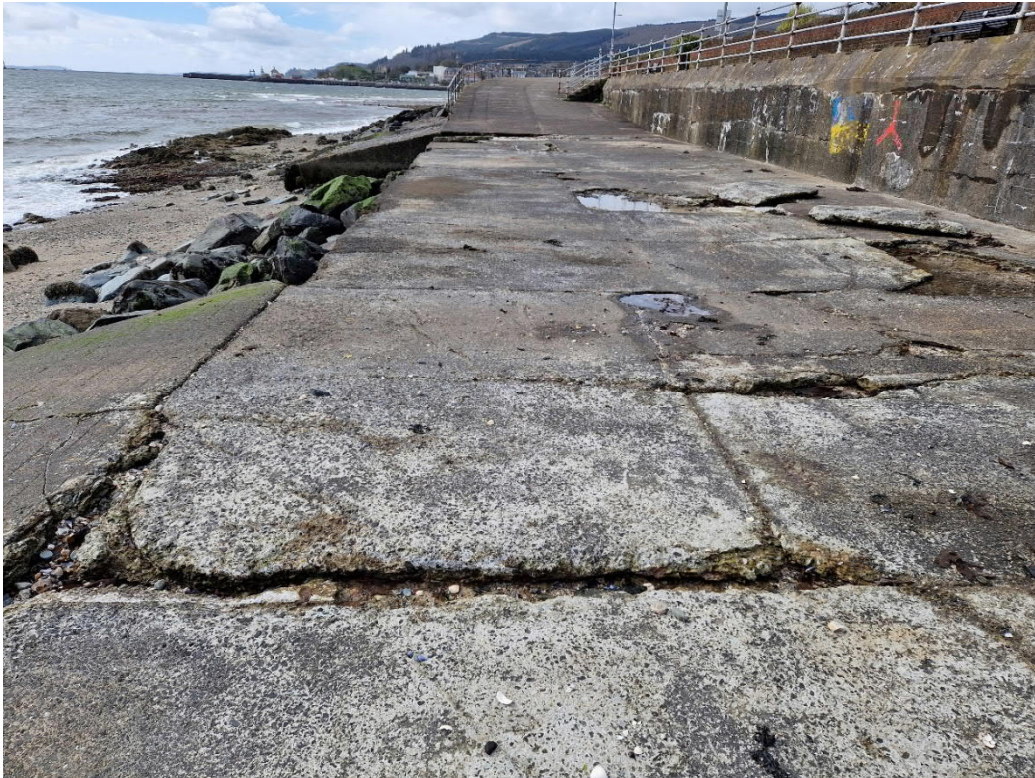
Figure 3: View of Parking Area and Access Ramp from Slipway

The concrete slab to the parking area is in poor condition with large areas of broken and dislodged concrete, rebar exposed and cracking of the concrete visible. These defects are observed over the majority of the surface and can be seen in Appendices B.2 and B.3.

At the beach, the seaward face of the concrete structure does not appear to be undermined; however, cracks, spalled concrete and voids are observed on the vertical face. The joint between the seaward face of the wall and the concrete slab to the parking area has widened over time, allowing seawater below the slab, potentially worsening the condition of the structure. This can be seen in the photograph in Appendix B.3.

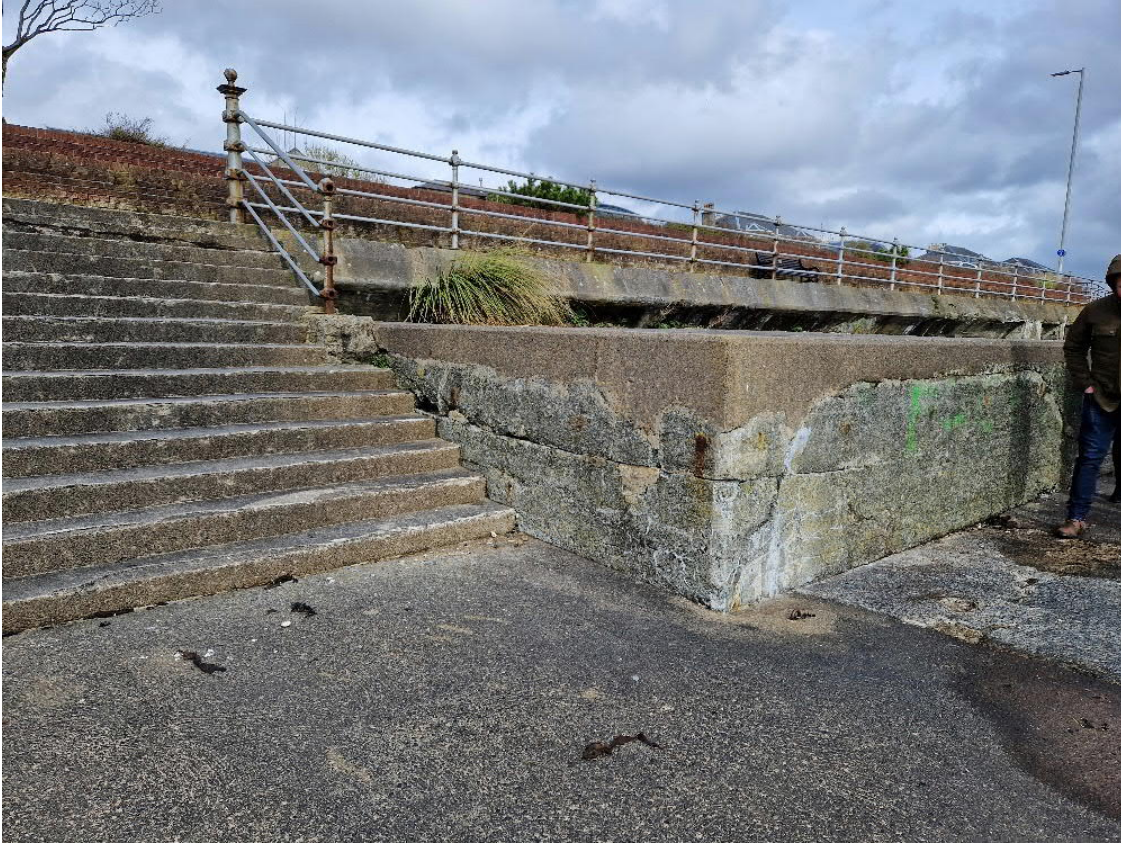
Figure 5: Historic Bathing Area

The parking area is bound to the east by the historic concrete bathing area / lido. The bathing area has been capped with a concrete slab, and potentially infilled. This can be seen below and in the photograph in Appendix B.6.

There are cracks present around the bathing area walls, some of which are potentially joints that have widened over time. Similar to the vertical wall at the access ramp, the structural form is unknown and could be masonry with a protective facing – with cracks following the bedding joints. Alternatively, the cracks could be associated with cold joints as concrete was placed in layers.

There are two drainage outfalls that discharge directly onto the concrete cap of the bathing area. This discharge then flows over the bathing area and down onto the walkway towards the Victorian changing rooms, leading to an accumulation of algae/marine growth at the top of the steps to the beach. This is shown in the photograph in Appendix B.11. This is noted as a health and safety hazard as the algae/marine growth is extremely slippery and makes the steps unsafe for use.

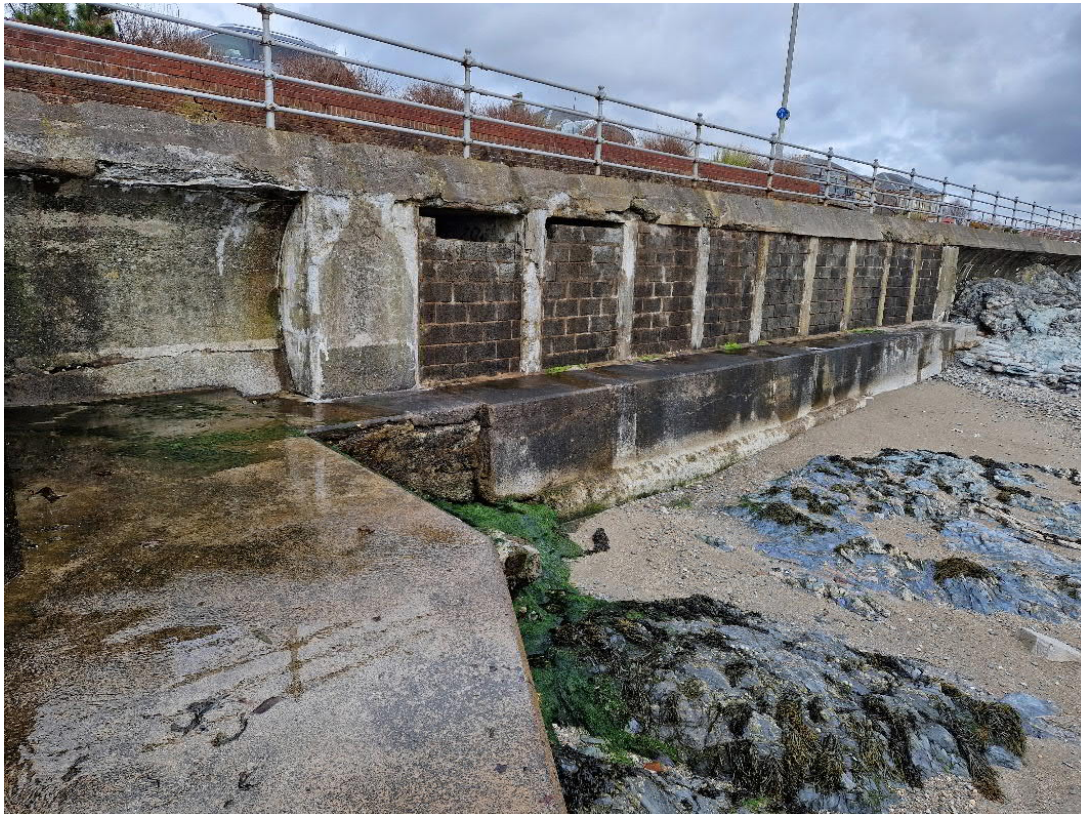
Figure 4: Victorian Changing Rooms and Walkway

The changing rooms are currently not in use and are blocked off with lightweight concrete blocks, therefore the condition of each of the changing rooms is unknown. However, the top row of blocks at changing room 1 is missing and the internal space could be viewed using a camera, as shown in photograph in Appendix B.12. Changing room 1 is approximately 1.5m wide x 1.9m high x 2.5m deep. The walls and ceiling of changing room 1 appear in fair condition; however, a render or painted surface has been used on the surfaces, therefore the condition of the blocks making up the structural wall is unclear.

The exposed edge of the concrete roof slab above the changing rooms varies in condition along the length. There are sections with spalling concrete, large cracks and portions missing, as shown in the photograph in Appendix B.10.

The walkway in front of the changing rooms appears in good condition with the exception of the corner nearest the steps down to the beach. This section appears to be undermined where the steps meet the wall and voids are present here. The voids were not measured due to the presence of large amounts of algae and seaweed on the steps making them unsafe. This is shown in the photographs in Appendix B.10 and B.11.

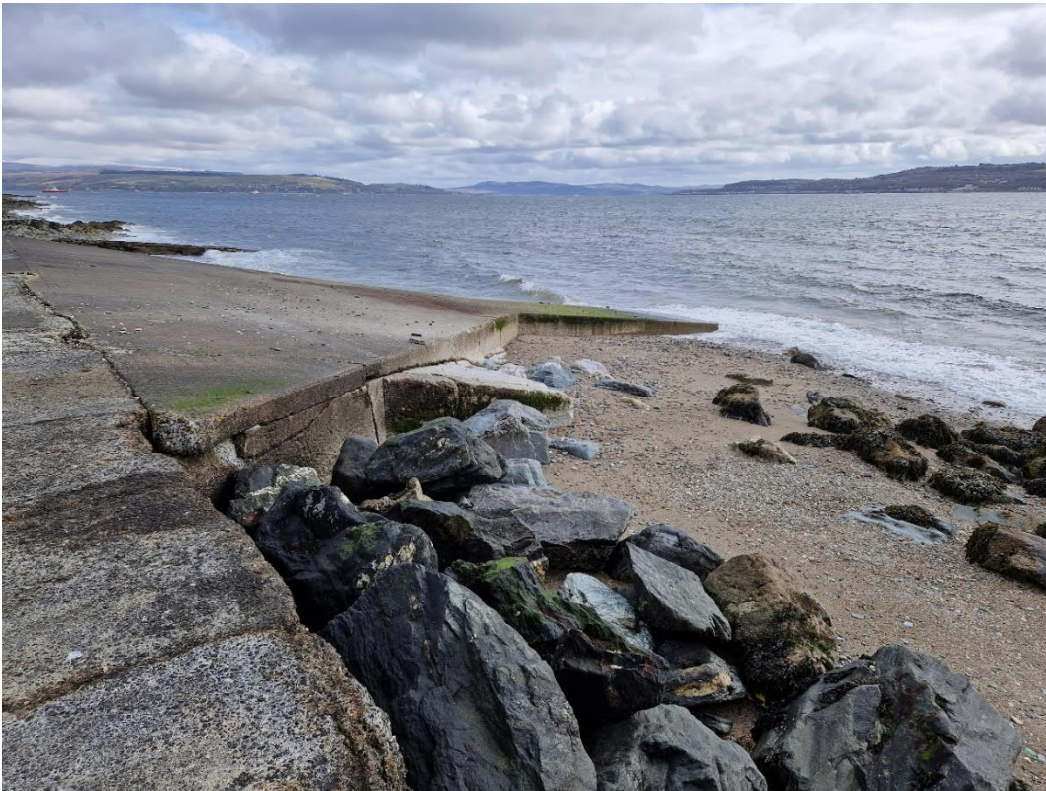
Figure B.8: View of slipway from in front of bathing area

The slipway appears in fair condition with no undermining of the structure visible on either side of the slipway or the apron during MML's walkover.
