## Helensburgh Pier

### Market Scoping Study

On behalf of **Argyll & Bute Council**

Project Ref: 332010810 | Date: May 2023

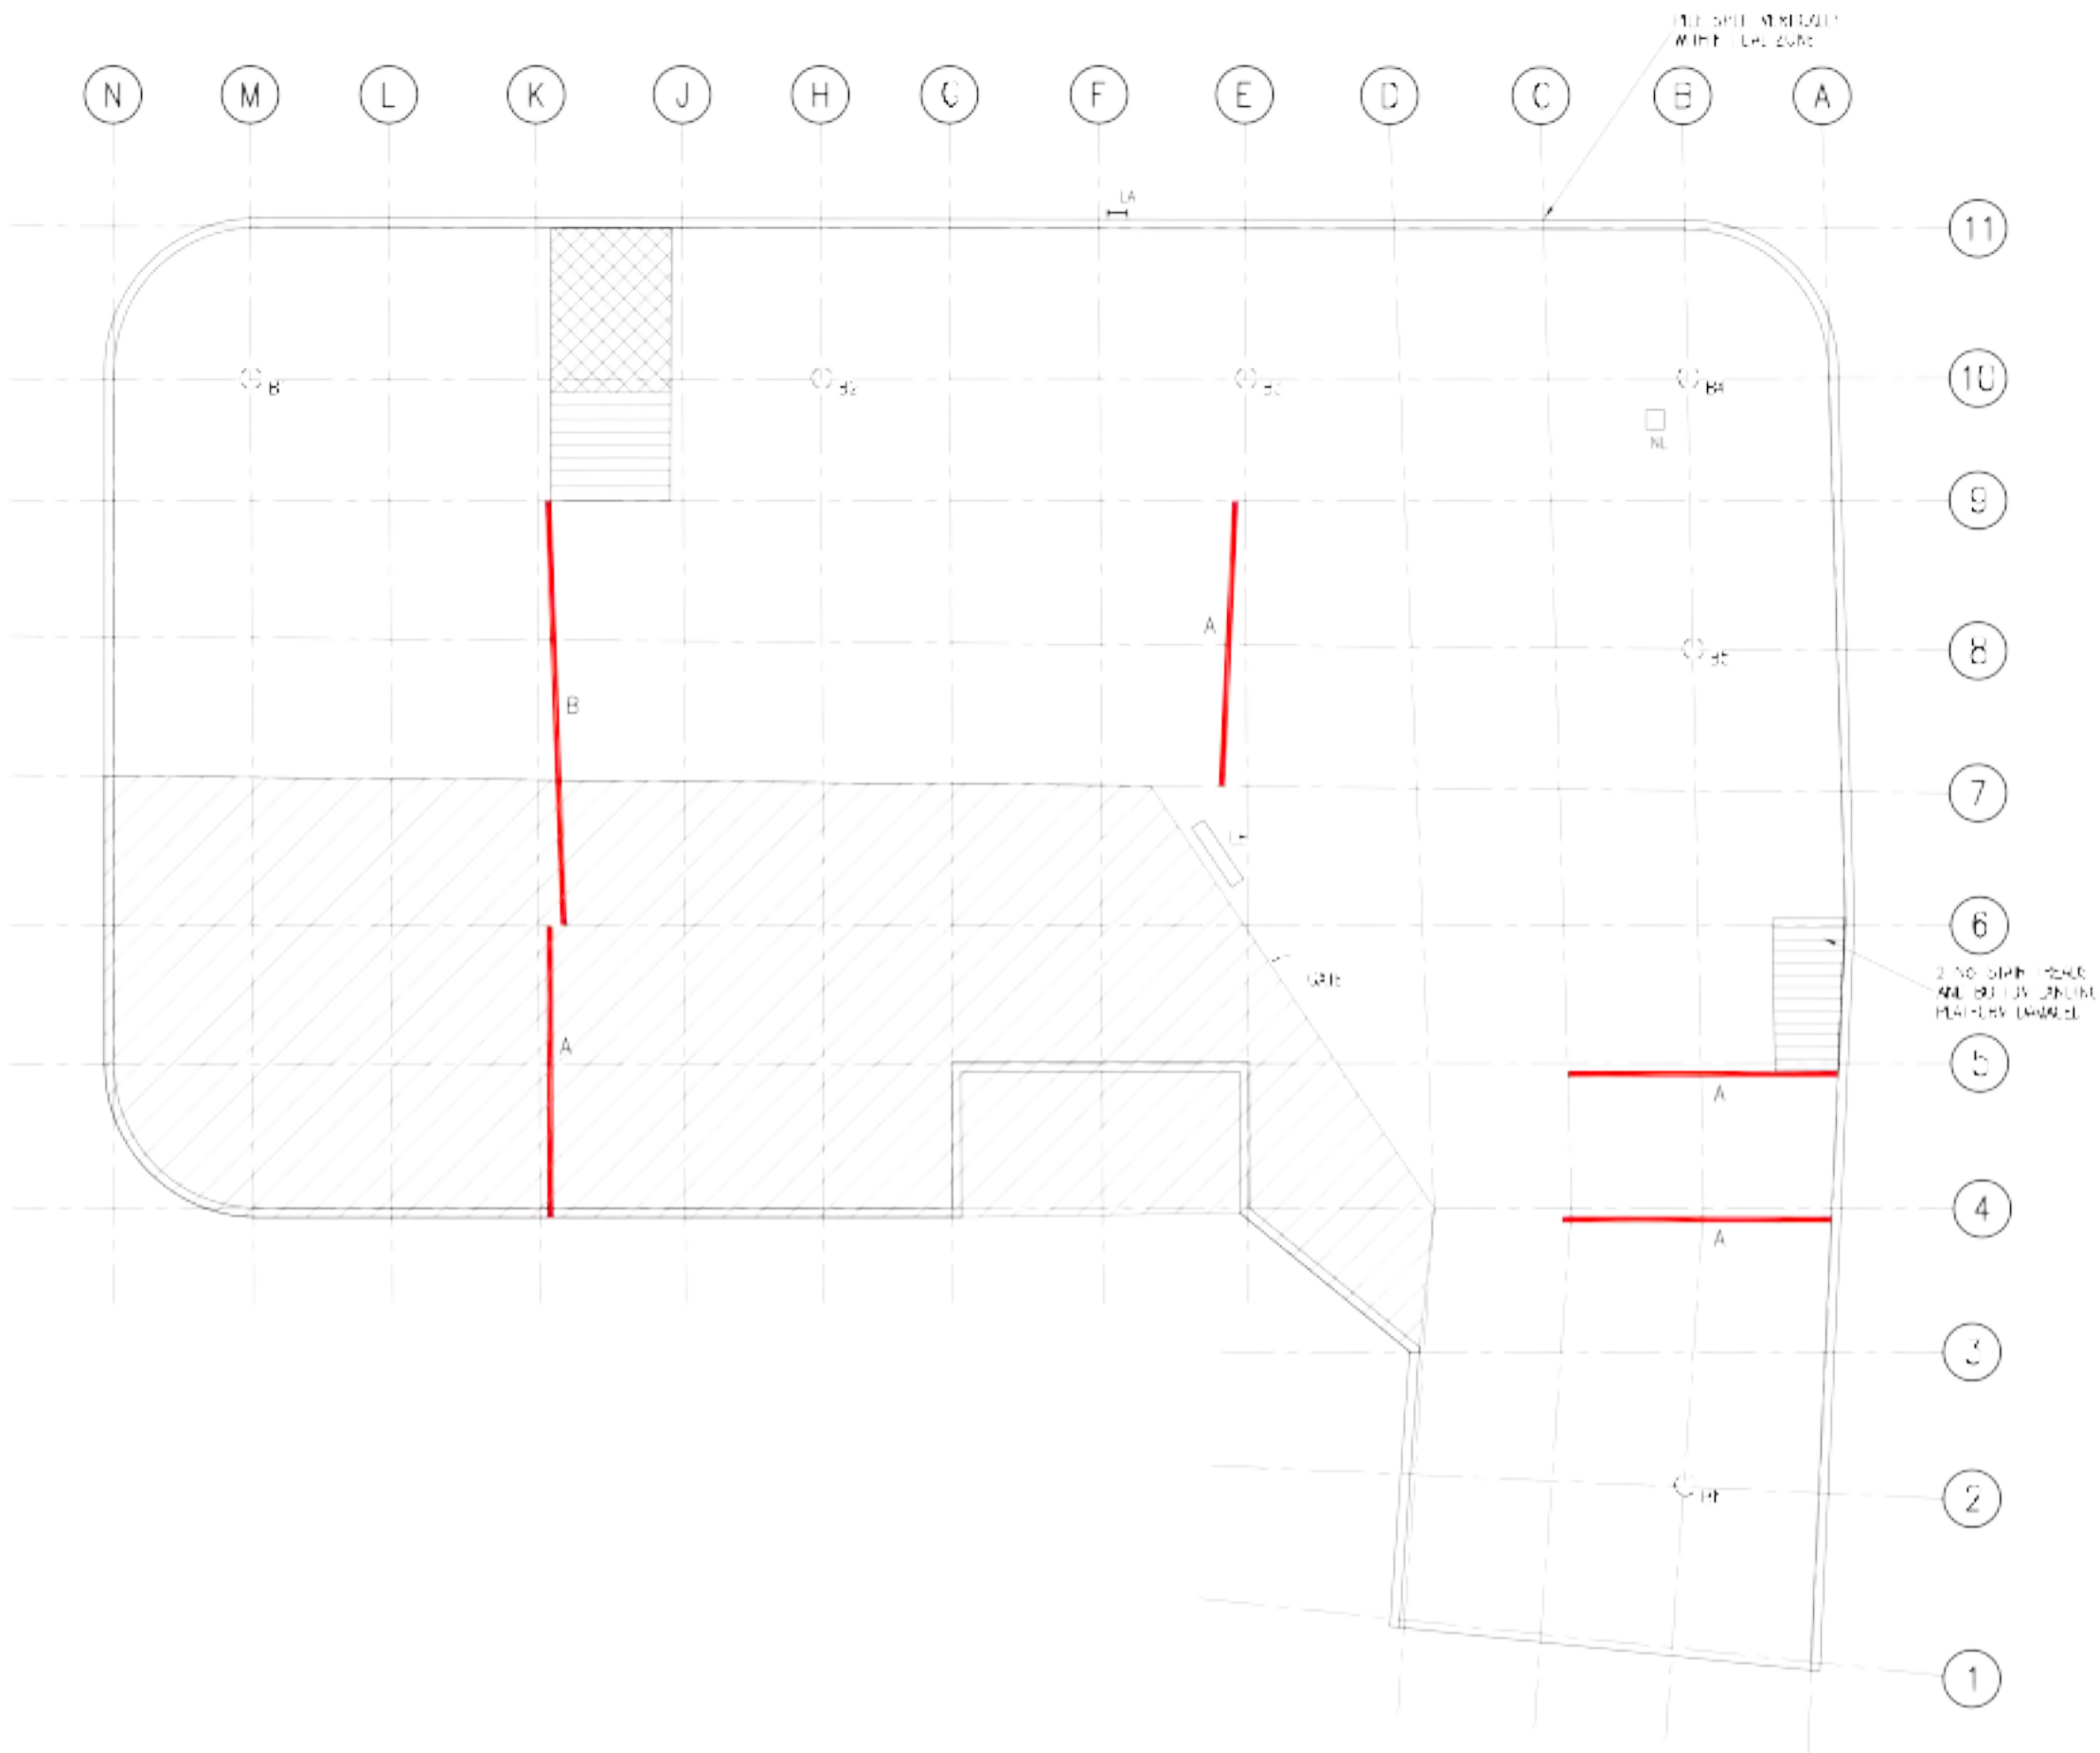
DO NOT SCALE	HELENSBURGH FIGURE 1	REV	1
DRAWING No

The timber pier is in a deteriorating condition, especially beneath the decking level. The timbers are showing various extents of erosion, loss of sectional area, pile C10 (refer to Figures 2 & 3) has a vertical split within the tidal zone, isolated timbers are either not connected or only connected at one end and there is evidence of timber repairs (including splicing) having been carried out.

A number of the bollards have not been properly secured to the timber structure i.e. some of the fixing screws have not been installed and there is localised damage to some of the connection plates. Refer to Figure 2 for details.

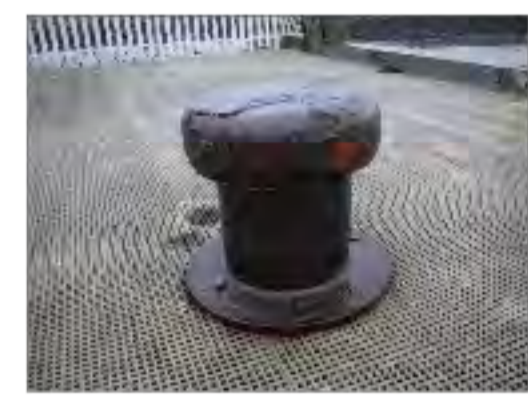
BOLLARD 1

BOLLARD REF	COMMENTS
B1	4 FIXING SCREWS IN PLACE. BOLLARD SITS ON TOP OF GRP FLOORING
B2	3 FIXING SCREWS IN PLACE. BOLLARD SITS ON TOP OF GRP FLOORING
B3	3 FIXING SCREWS IN PLACE. BOLLARD SITS ON TOP OF TIMBER DECKING BOARDS
B4	NO FIXING SCREWS IN PLACE. MISSING SECTION OF BASEPLATE. BOLLARD SITS ON TOP OF GRP FLOORING
B5	2 FIXING SCREWS IN PLACE. MISSING SECTION OF BASEPLATE. BOLLARD SITS ON TOP OF GRP FLOORING
B6	NO FIXING SCREWS IN PLACE. MISSING SECTION OF BASEPLATE. BOLLARD SITS ON TOP OF GRP FLOORING

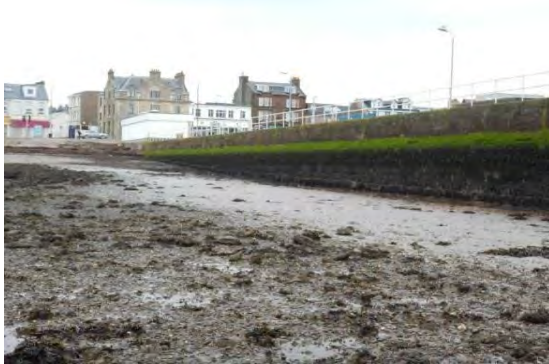
Showing north west face of masonry pier

Defect Assessment	Est. cost (£)	Extent	Severity	Work	Priority	PD	Comments
Wall (below water line)		D	2	N			100% covered in marine growth below water line. Localised signs of loss of pointing.
Wall (above water line)		B	2	N			Localised signs of loss of pointing and vegetation growth
Handrails	3,000	B	3	R	H		Missing section of handrail to be replaced
Lifebuoy	400	B	3	R	H		Life buoy to be replaced

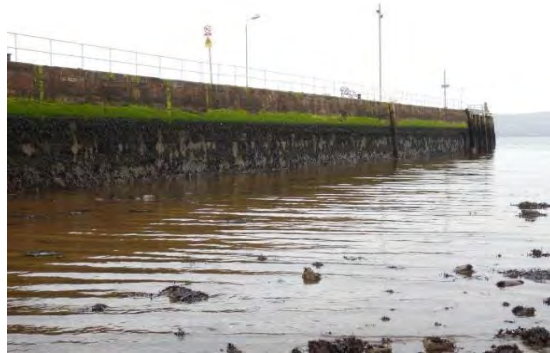
Showing southern face of masonry pier

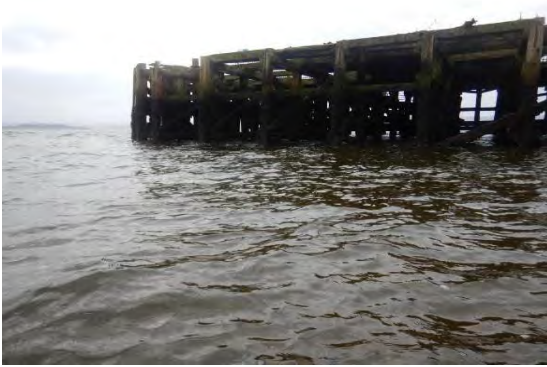
Open piled timber structure, comprising vertical piles with horizontal and diagonal bracing adjacent to the masonry pier. A section of the pier has been isolated to prevent public access.

Showing north east face of timber pier

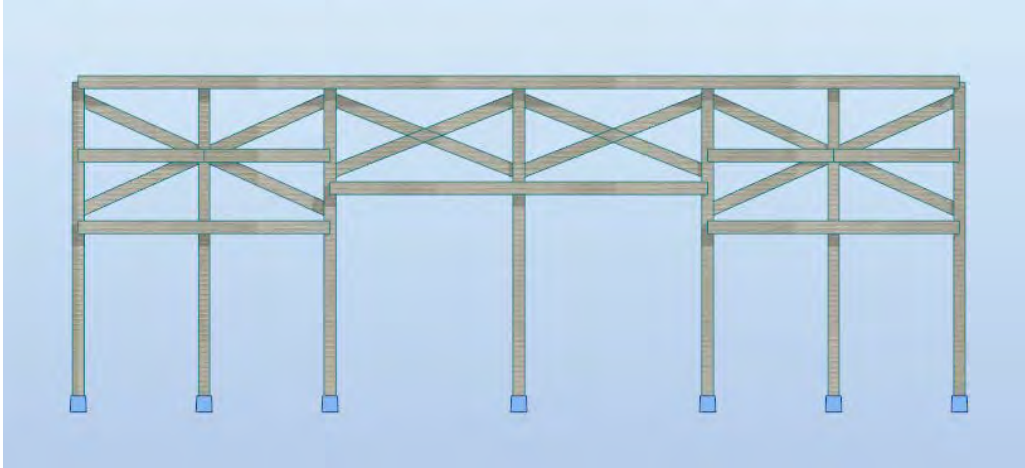
With the present condition of the timber elements, the structure failed with regards to BS 6349 calculated berthing and impact loads for a vessel representing the PS Waverley. The failure of the members was observed in exceeding the allowable displacements and stresses.

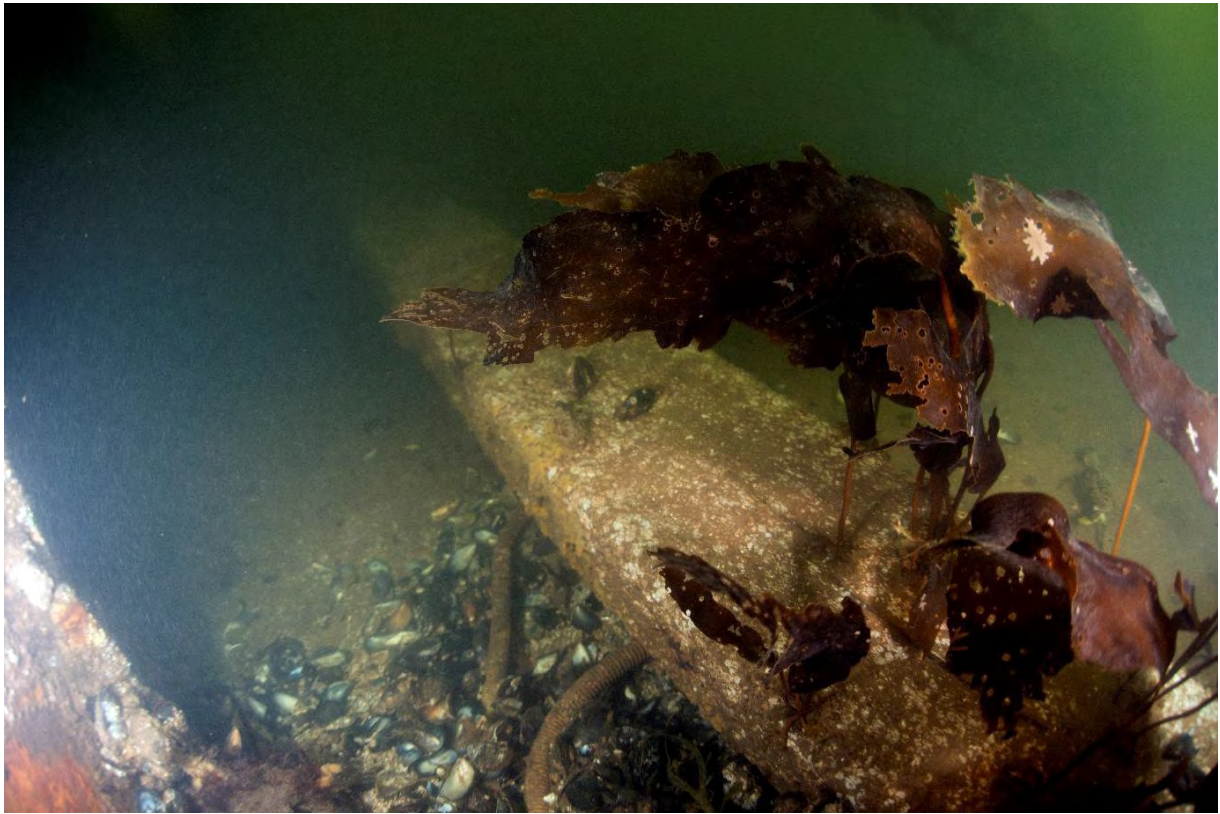
**FIGURE 2: Helensburgh Pier – Between piles 04 and 05 (04-b.jpg)**

Only a few of the intertidal photographs can be matched up with the underwater survey. Pile 01 is the right-hand pile in photograph DSC\_3759.jpg. Intertidal photographs DSC\_3763.jpg and DSC\_3764.jpg match up with Piles 04 and 05, and the photograph 04-b (see Figures 2 and 3). The intertidal photographs appear to show that the structure is partially collapsed in this area.

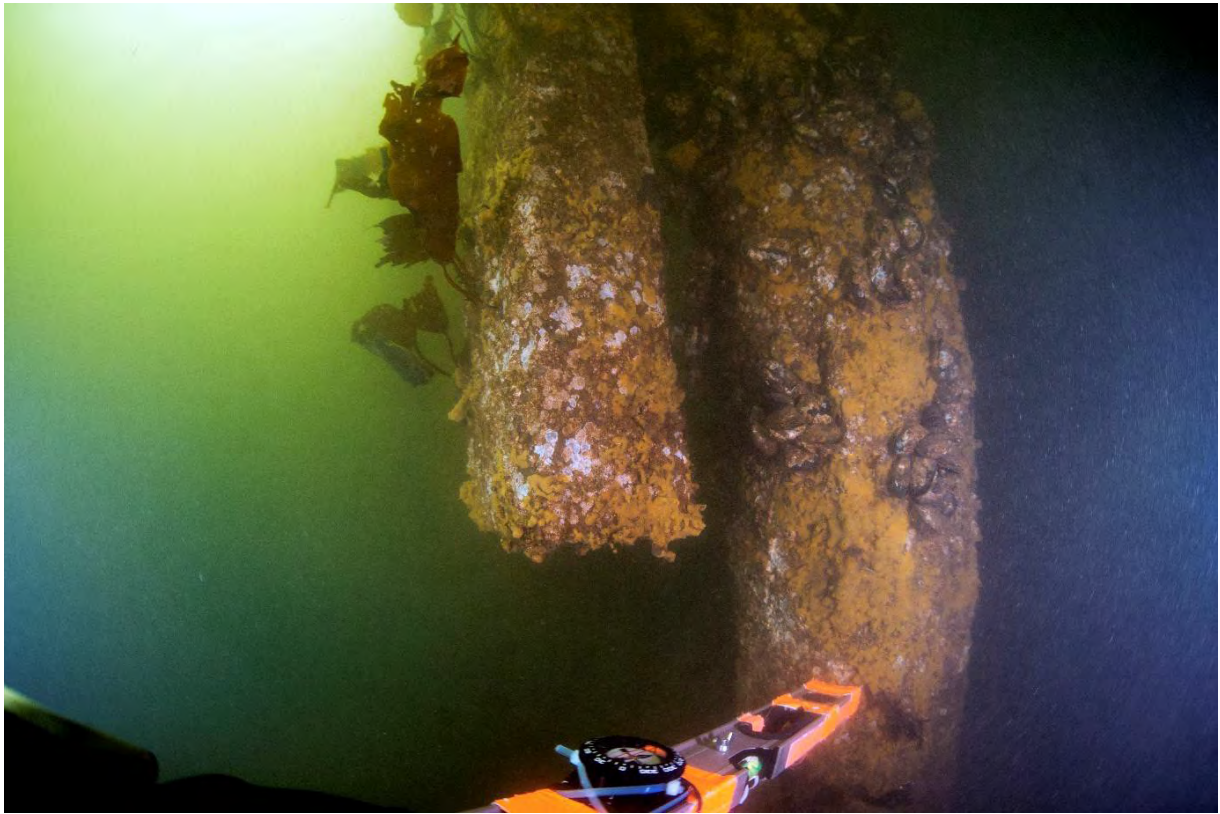
A hanging pile was observed on pile 27 (Figure 8); it was unclear whether this was a structural element or loose fendering.

**FIGURE 8: Helensburgh Pier – Pile 27** (scale = 58.5 x 6.0 cm)

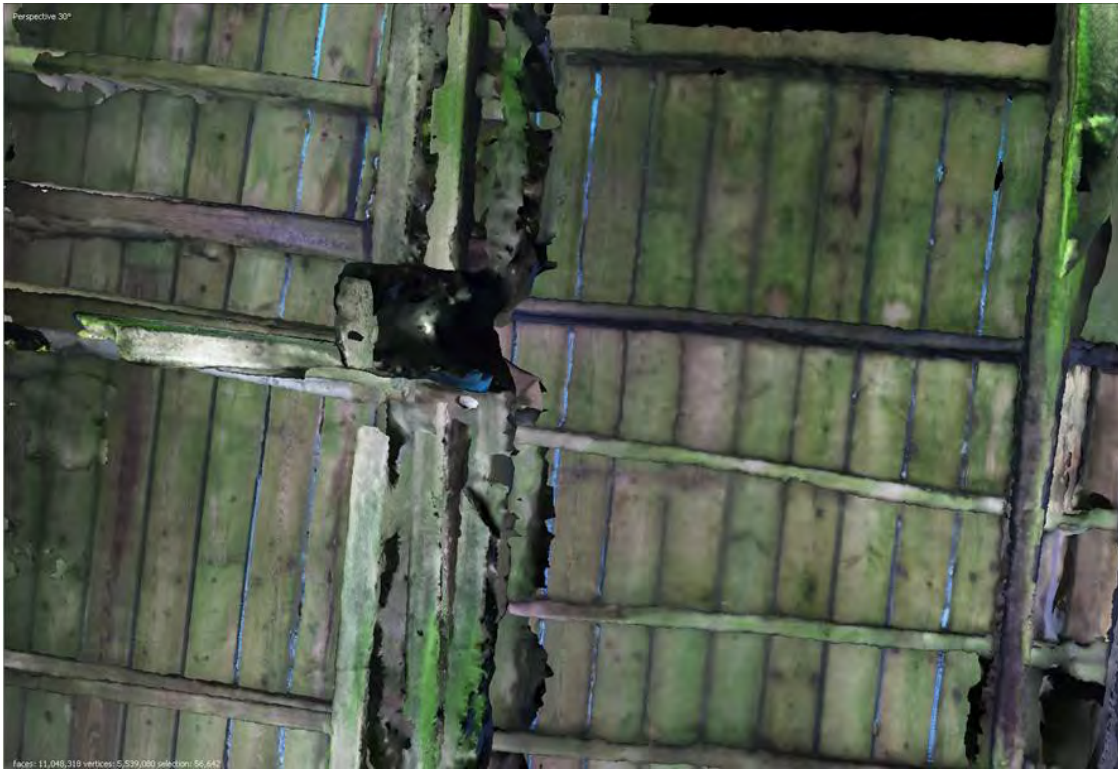
**FIGURE 17: Helensburgh Pier – Misaligned rafters (“E” in Figure 16)**

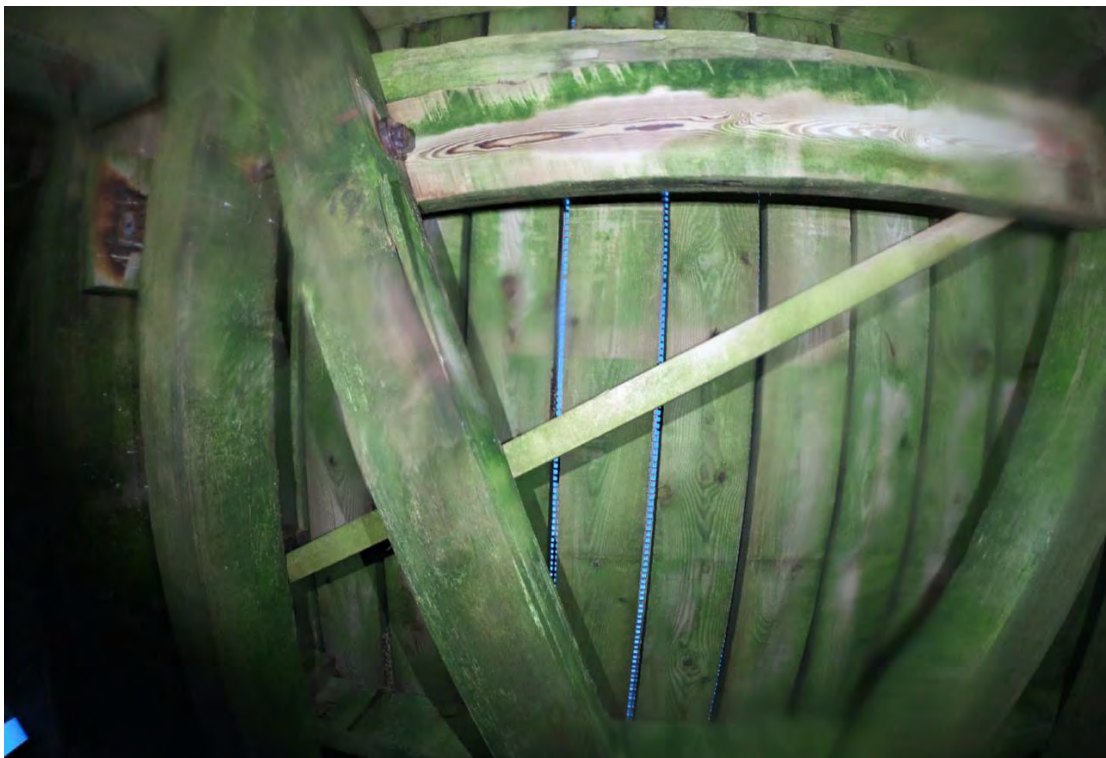
**FIGURE 18: Helensburgh Pier – Misaligned rafters (“F” in Figure 16)**

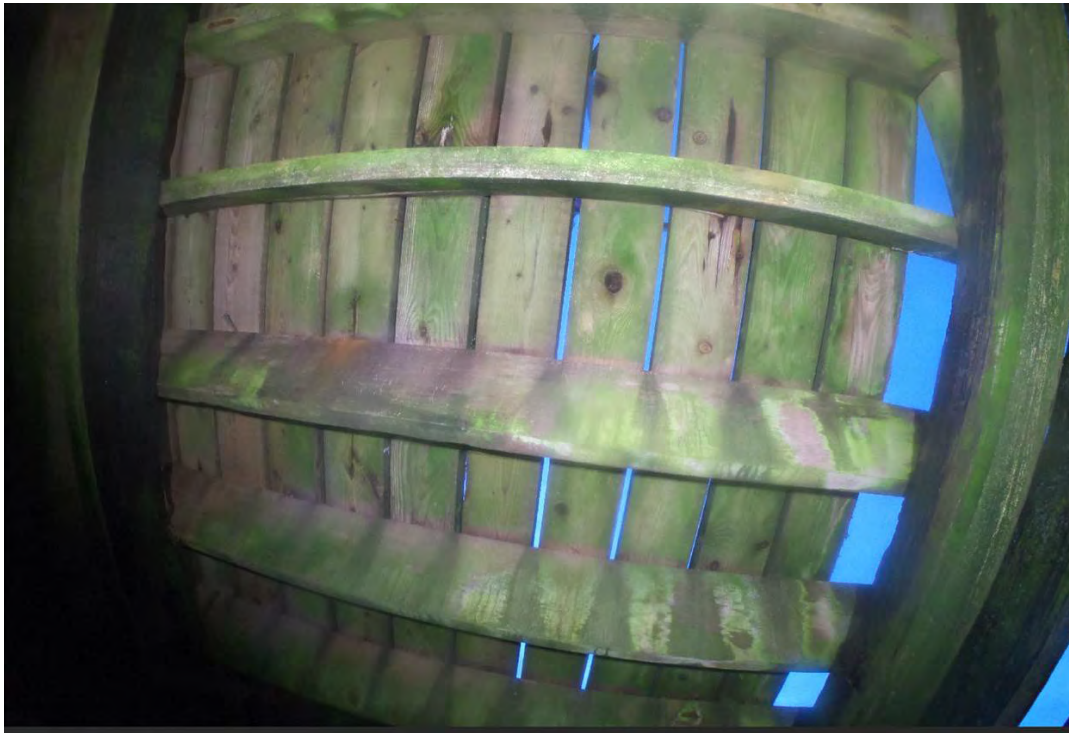
**FIGURE 20: Helensburgh Pier – Angled rafters (“G” in Figure 19)**

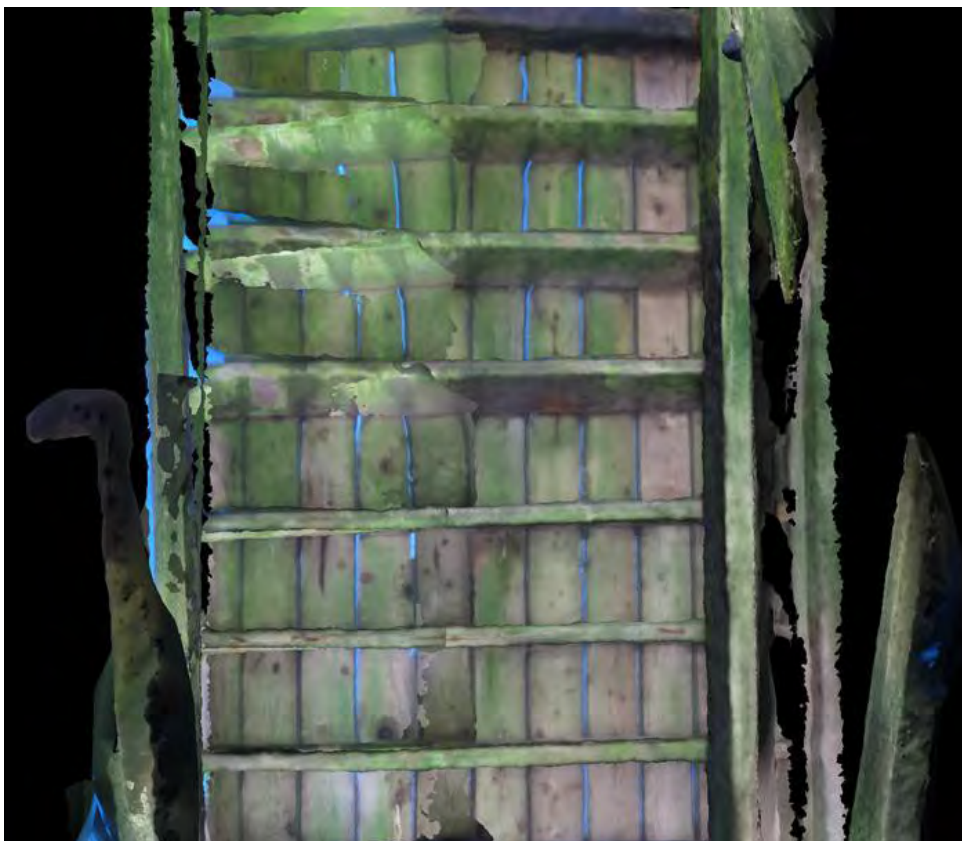
**FIGURE 21: Helensburgh Pier – Angled rafters (“G” in Figure 19)**

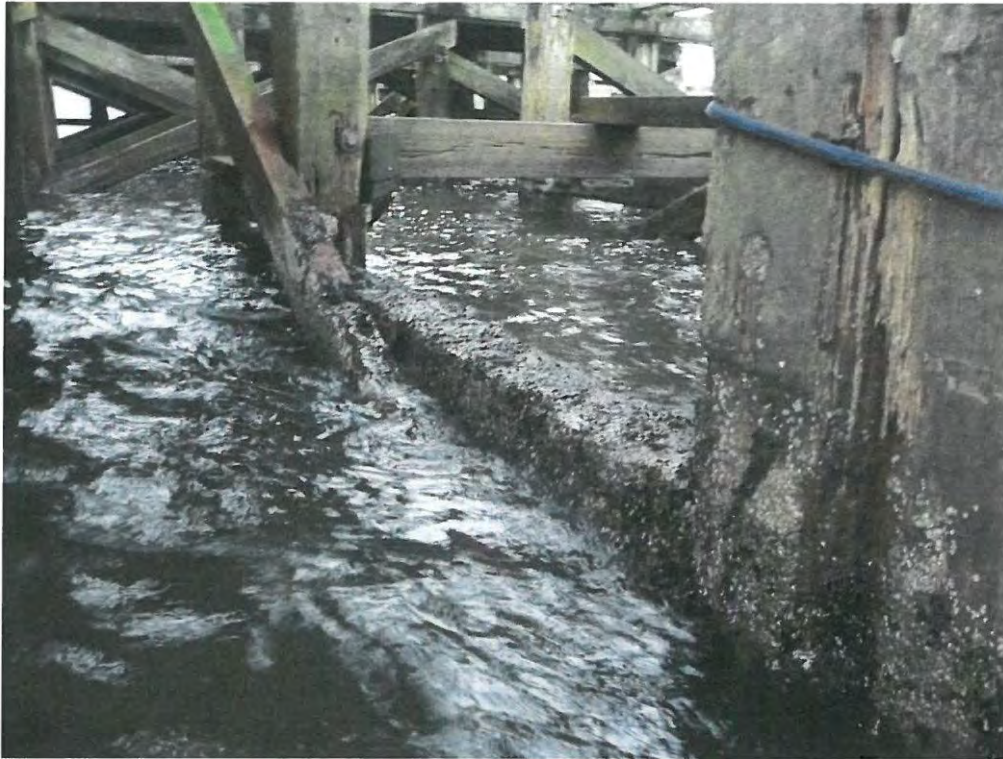
Component Reference	Indicative Grade or not accessible (-)	Condition See comment at the bottom of this table
Mid horizontal 1-2 to I-4	REJ	Reasons unrecorded.
Mid horizontal H-1 to 1-1	REJ	Significant cross grain fracture. Repair/replace.
Mid horizontal E1 to F1 E2 to F2 F1 to G1	3 x REJ	Significant erosion and fungal decay. See Photograph 6. Replace all three members.
Mid horizontal E1 to E2	HS	Sound. Disconnected from original position. Photograph 7.
East ends of all double deck joists F-	-	Significant decay, or completely absent.

**Photograph 7 Mid horizontal E-1 to E-2 dropped from original position.**
