B8035 - Mull Rockfall Interim Assessment

10 October 2025

B8035 - MULL ROCKFALL

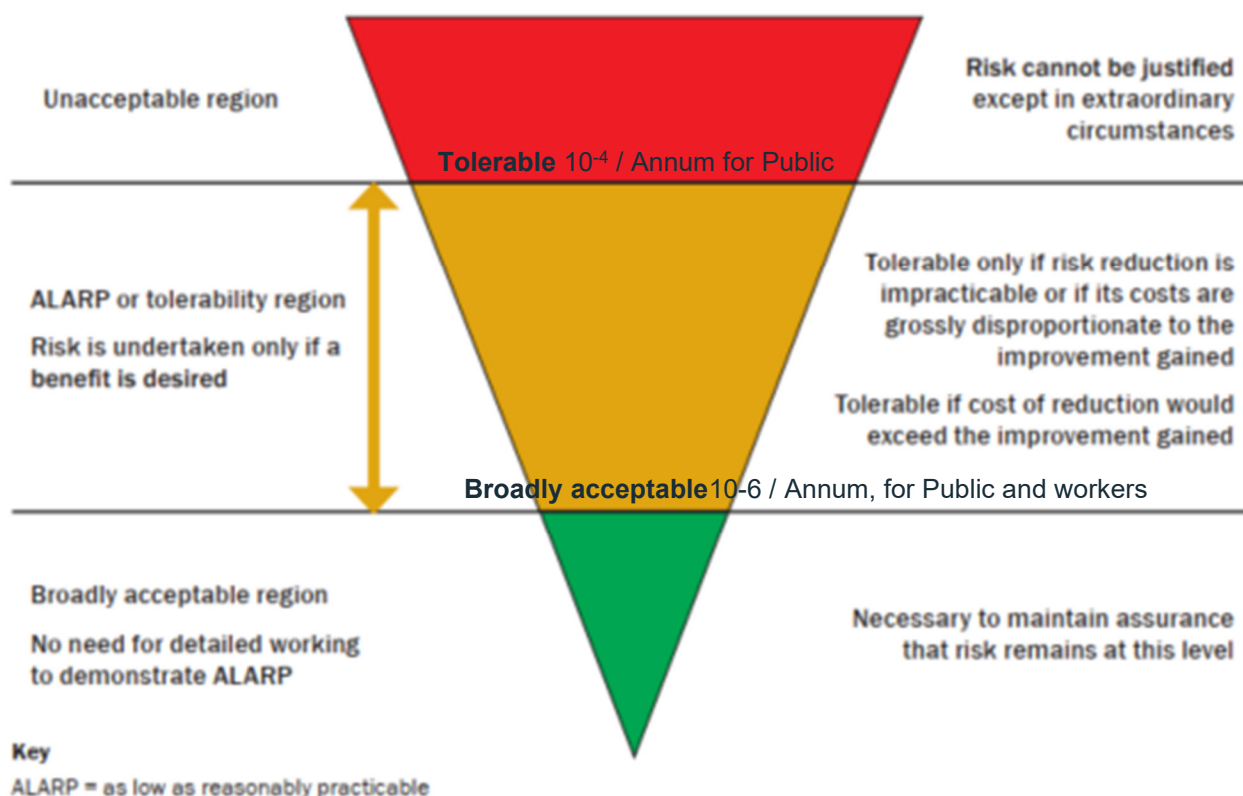
Figure 4-1 - Risk tolerability and the ALARP concept (modified from HSE, 1992)

The health and safety executive considers risk of fatalities below 1×10^{-6} per annum to be broadly acceptable to the public and workers. Risk above this is considered to be tolerable only if interventions to decrease the risk level is impractical or the cost to implement interventions is extremely disproportionate to the risk reduction. As shown in Figure 4-1, this level of risk is also referred to as the ALARP zone or as low as reasonably practicable. Risk levels above 1×10^{-4} is considered unacceptable and intervention to reduce the risk is required.

For the considered scenario, the risk to road users has been calculated to be between 6.55×10^{-5} and 2.62×10^{-3} . This places the risk between the ALARP region and the unacceptable region and means that intervention to reduce the risk to road users to a more tolerable level is required.

As stated in CIRIA C810 (Koe, et al., 2023), mitigation strategies fall into two broad categories: management measures and engineering works. Avoidance measures such as closure of the road to the public, except for access to local properties, would allow for the overall risk to be lowered due to the significant reduction in traffic reducing the total exposure to rockfall risk. Inspection of the rock face and scaling of loose and overhanging blocks would reduce risk by reducing the number of rockfall events impacting the road. However, due to the scale of the site this option would be challenging.

Engineering interventions such as rock bolting of loose blocks, barriers, or the use of mesh to control material falling from the face would reduce the risk by reducing the frequency of rockfall reaching the road. However, due to the large scale of the rock faces on site, these solutions are likely to take a significant amount of time to implement at significant expense. Further assessment of potential remedial options and a cost-benefit analysis will be presented within the final options report.
