**Mull 2-18 Campus
Site Selection
Options Appraisal**

Project number
10742

Document reference
RYD-00-XX-RP-A-0004-S2

Site Option Overview

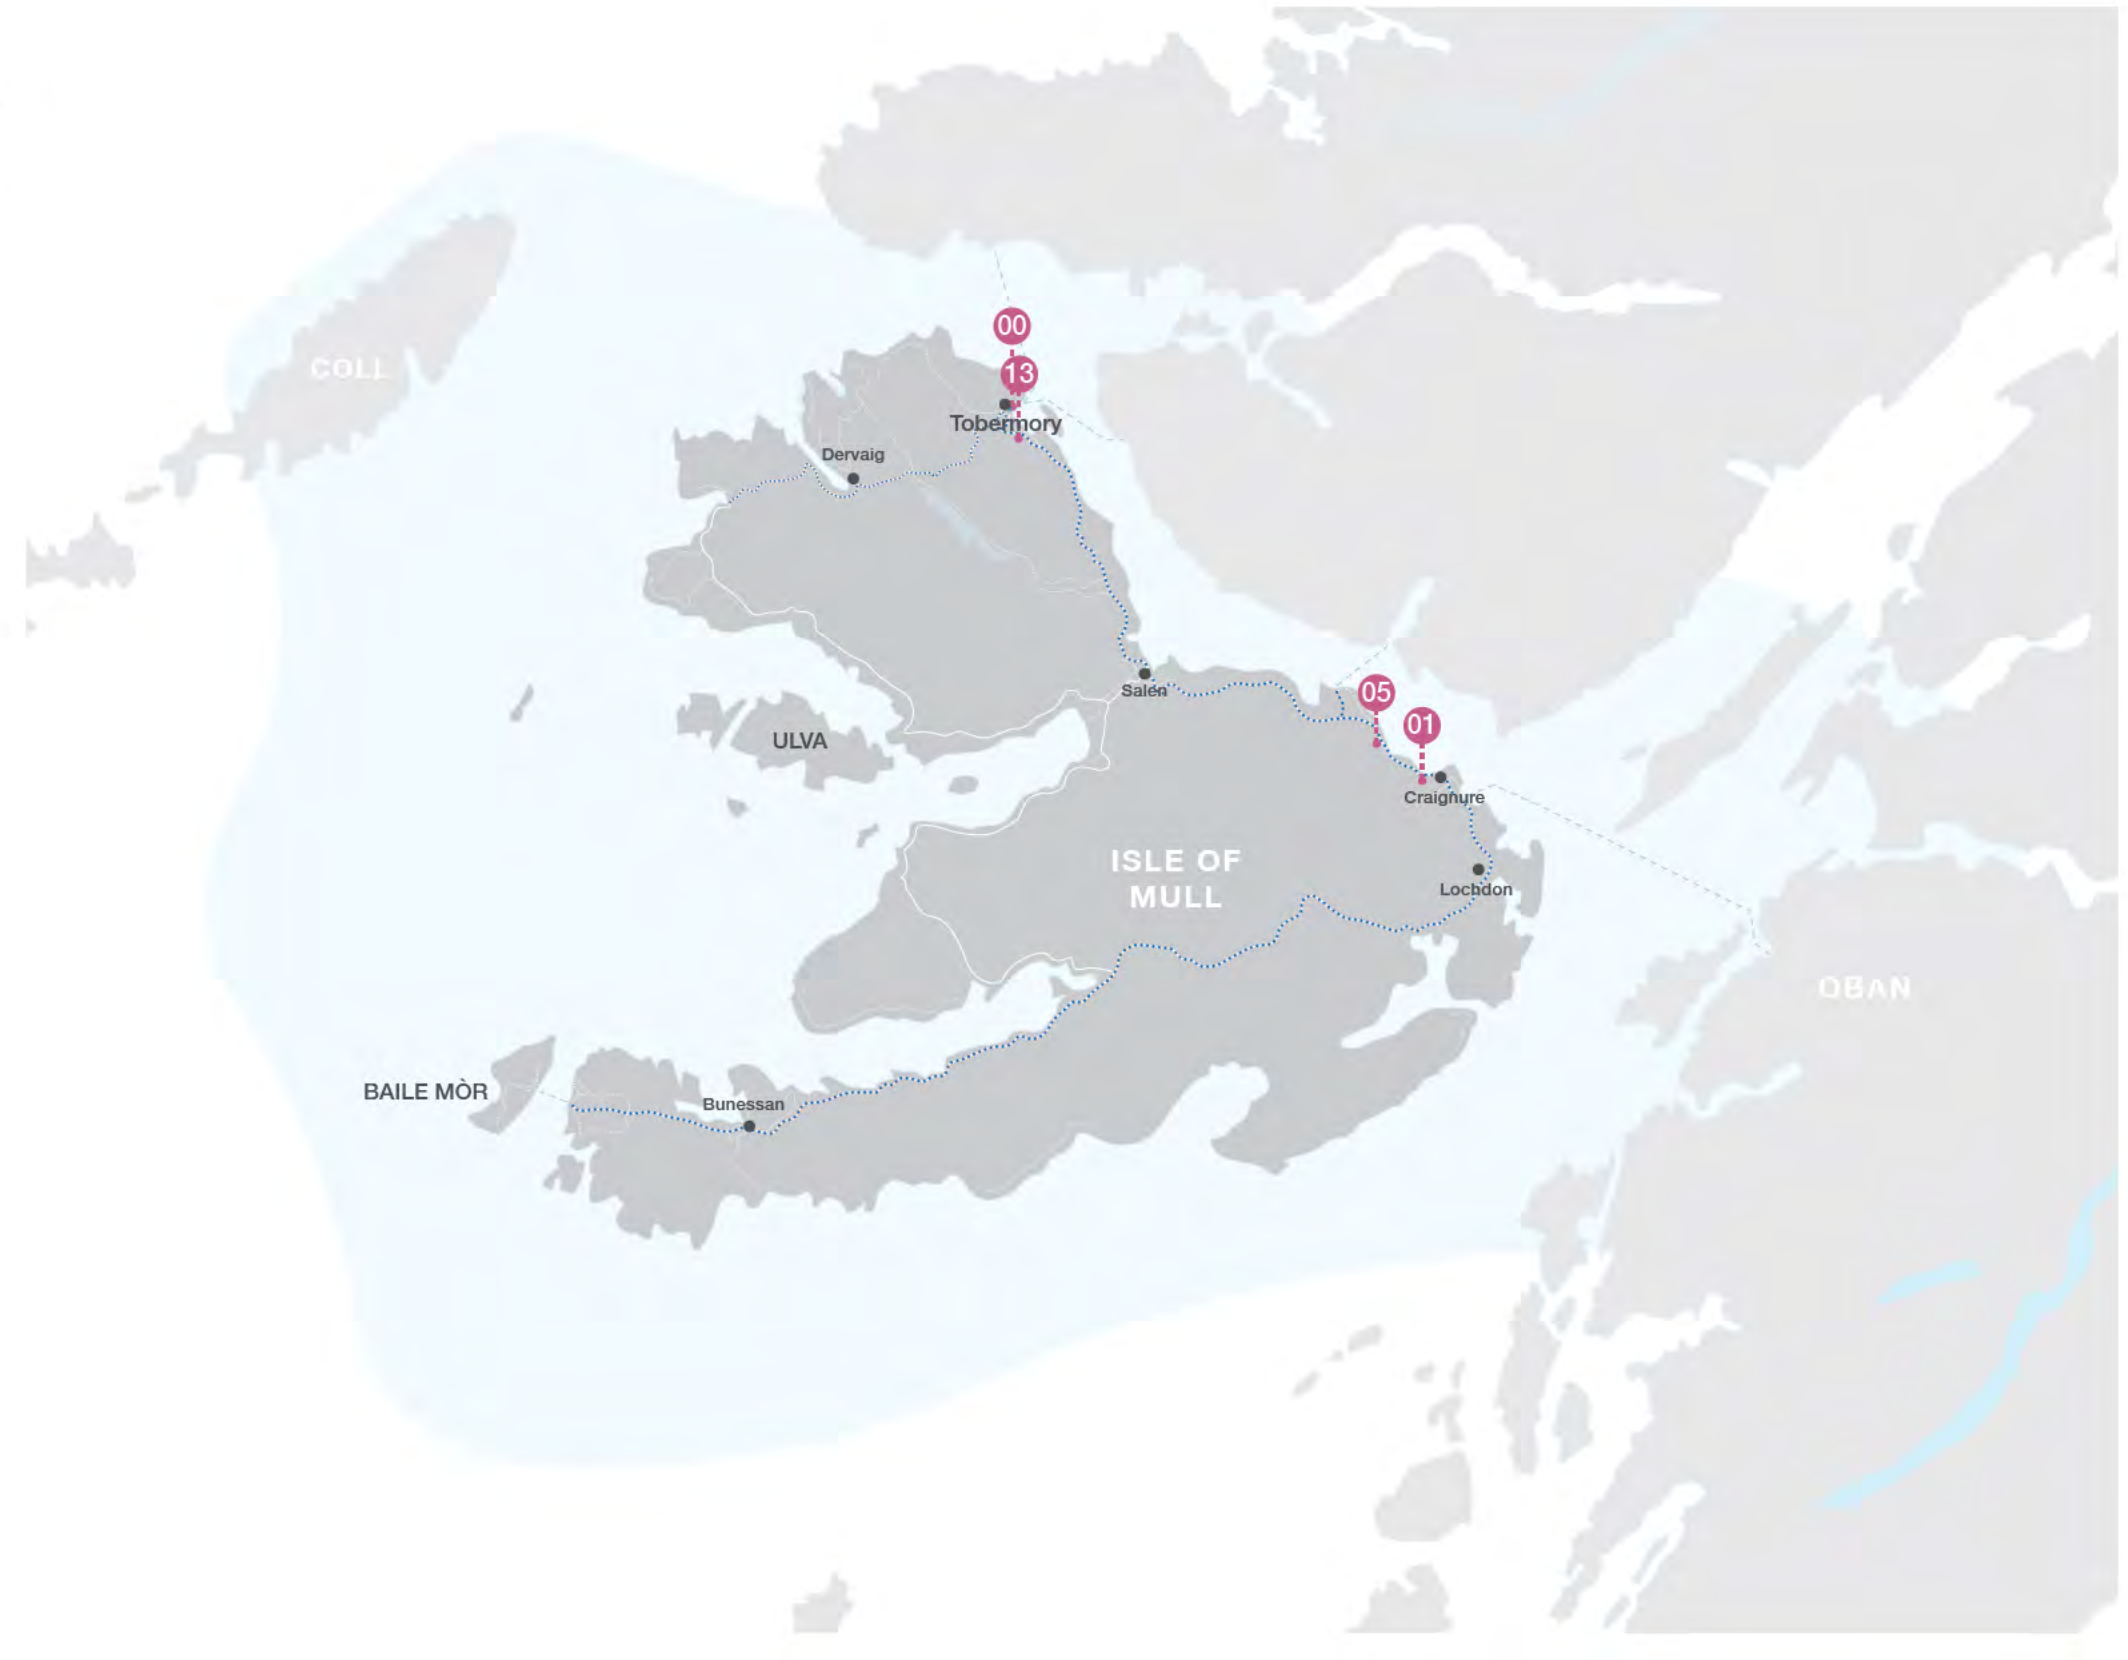
This document sets out sites which Ryder Architecture in partnership with Argyll and Bute Council (ABC) have identified as potential sites for the new Mull 2-18 Campus.

The potential sites cover a range from Craignure to Tobermory.

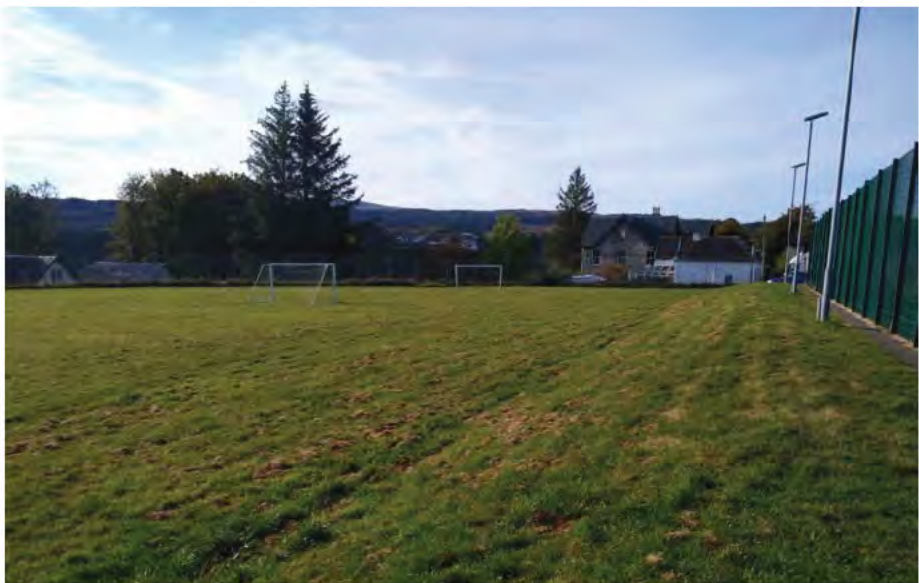
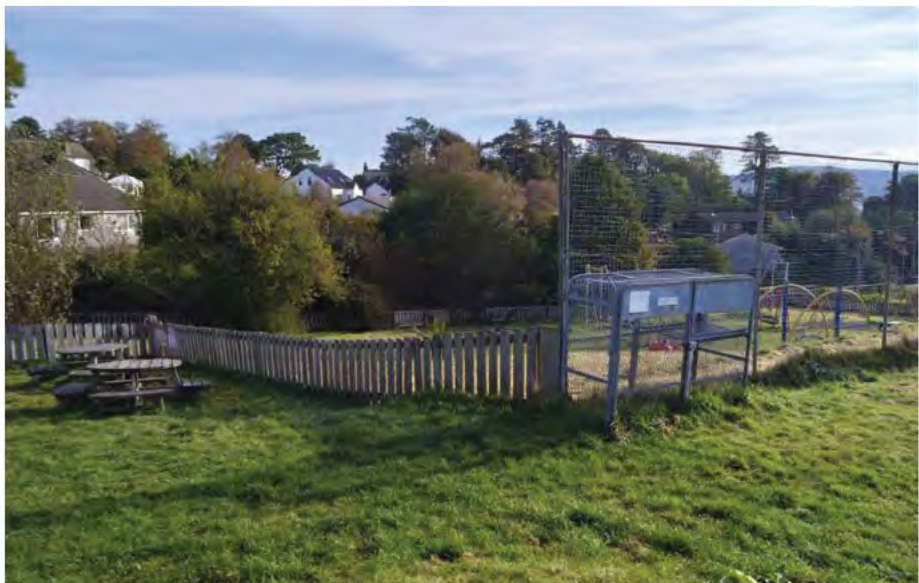
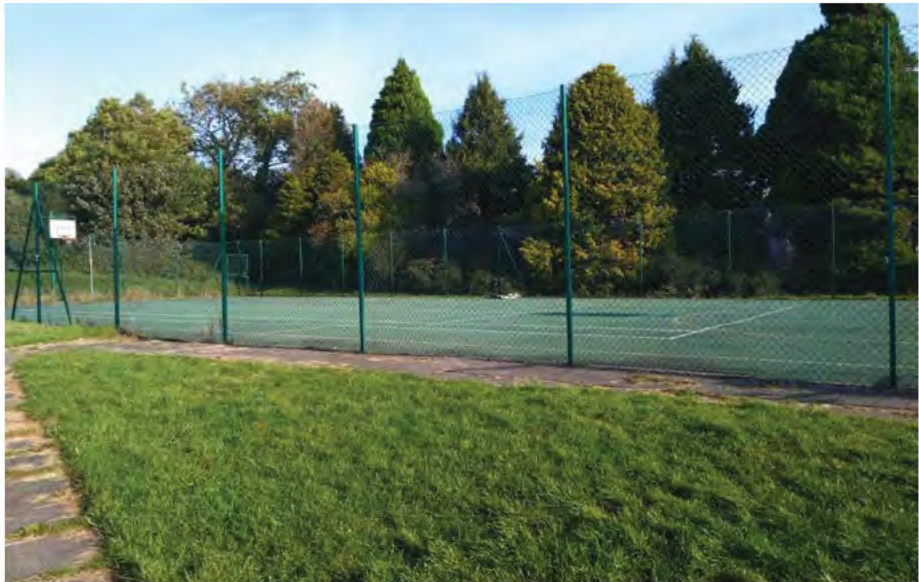
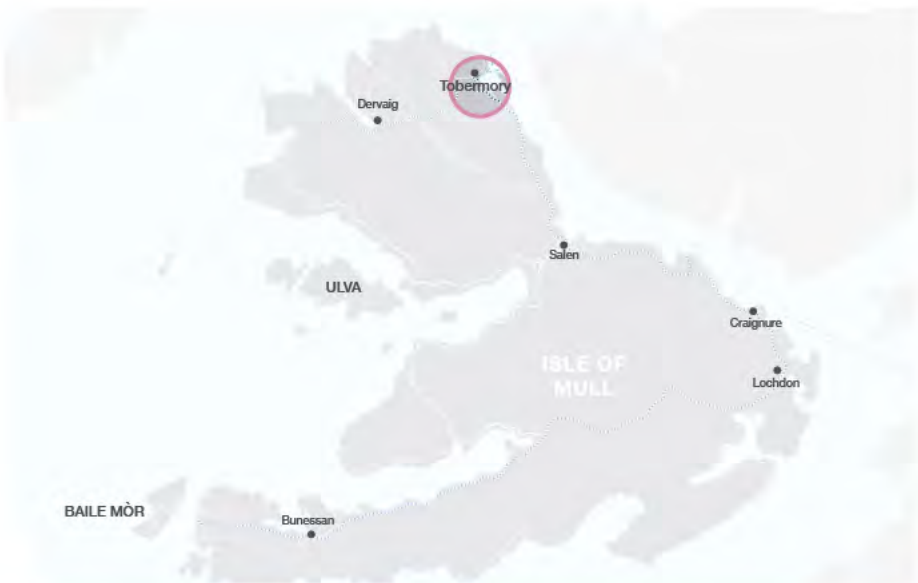
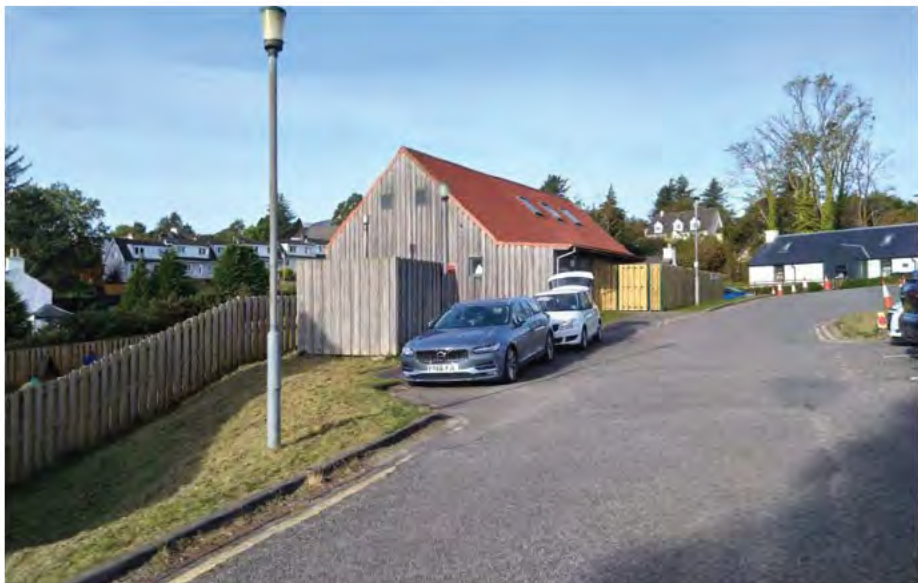
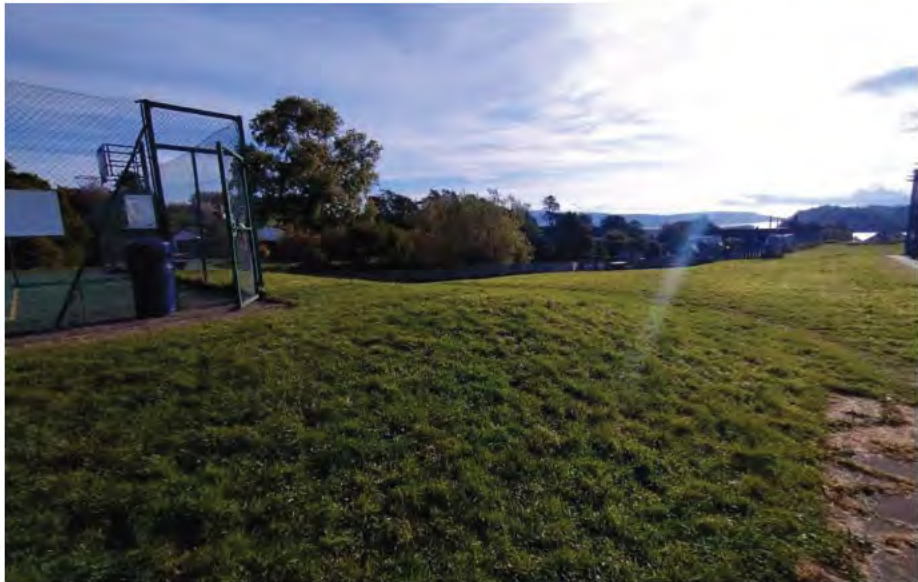
Existing Site Tobermory

The site area is 2.3 ha. While the site has capacity to construct a new campus within the boundary of the existing school site, construction logistics will be challenging both in accessing the site from the surrounding road network and within the site, with the likely loss of use of the all weather pitch during the construction phase.

The existing school boundary area is elevated above land to the south, west and east, with land rising to the north. Within the school site, the ground slopes from north to south, with significant level changes which impact on the suitability of the existing buildings on site. Developable land is restricted to the grass area south of the all weather pitch, which could potentially be included. The eastern edge of the site drops down significantly to the children’s play park.

Logistics of construction and ensuring capacity of school to continue to operate will be challenging. The area of land south of the all weather pitch and children’s playground is also designated King George V land, which presumes retention for outdoor recreational use.

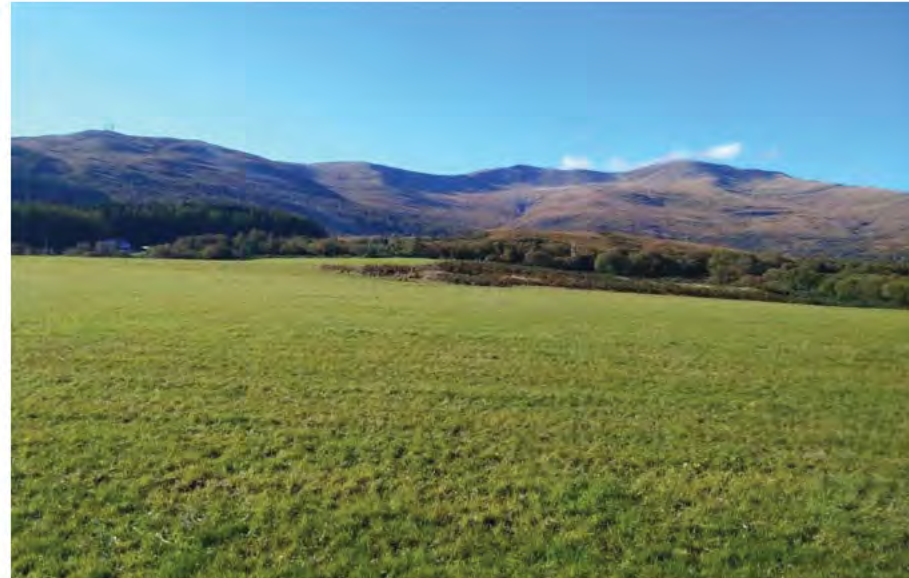
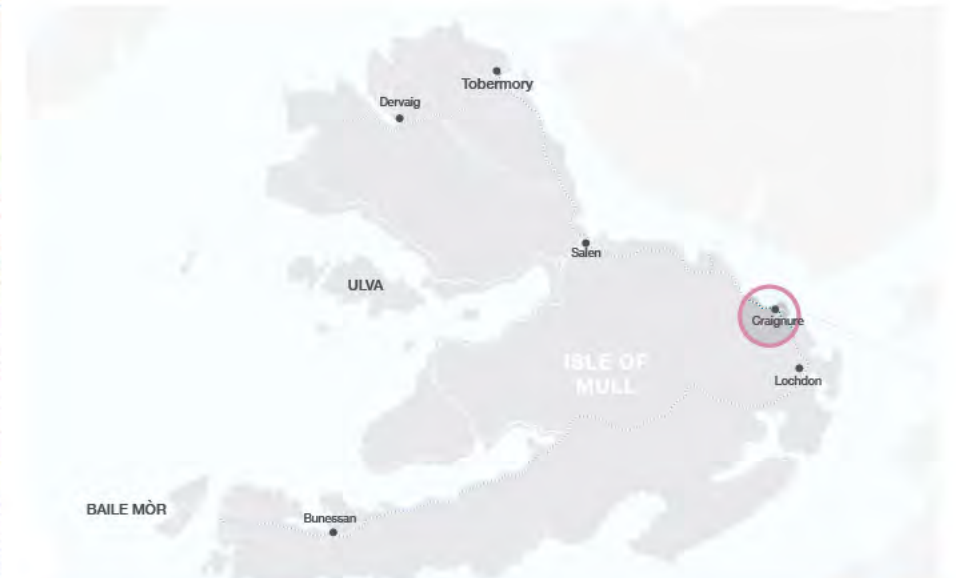
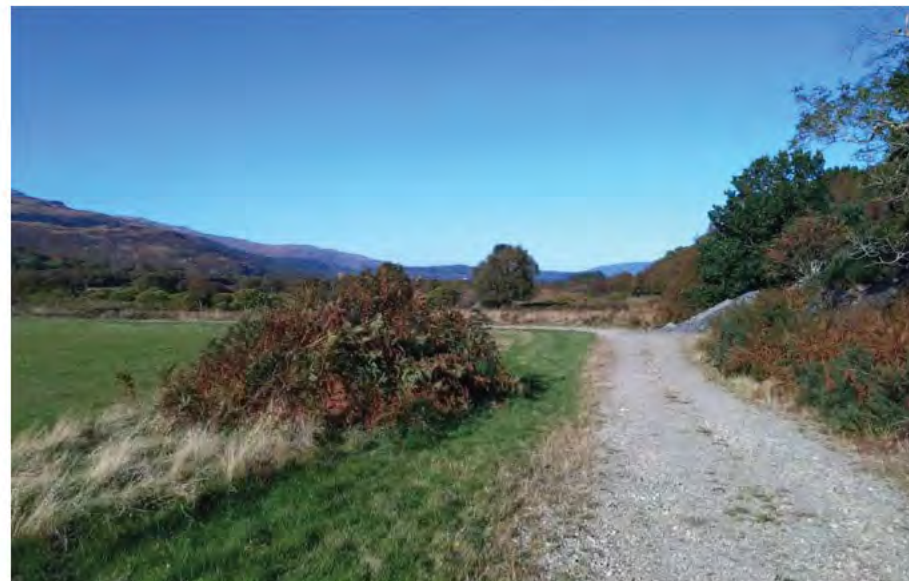
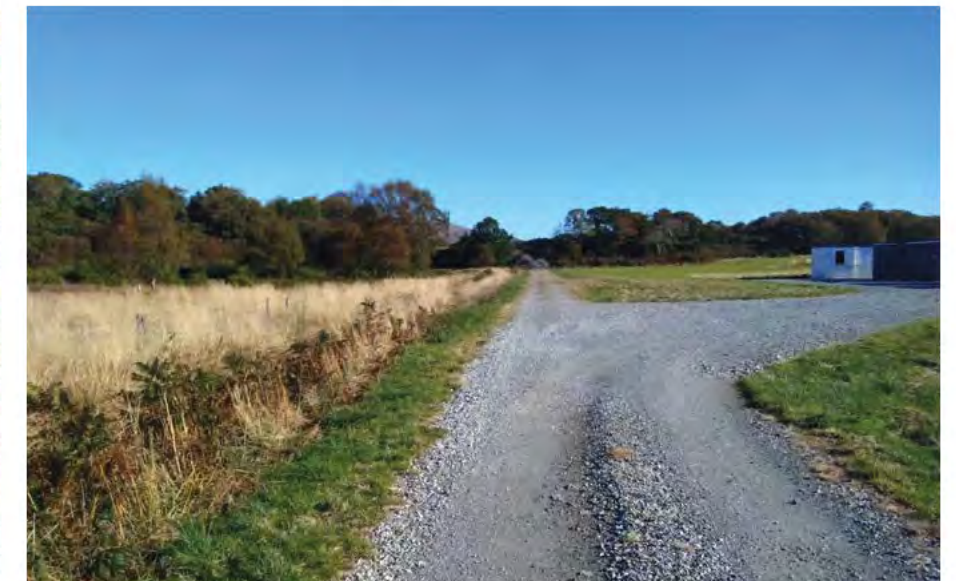
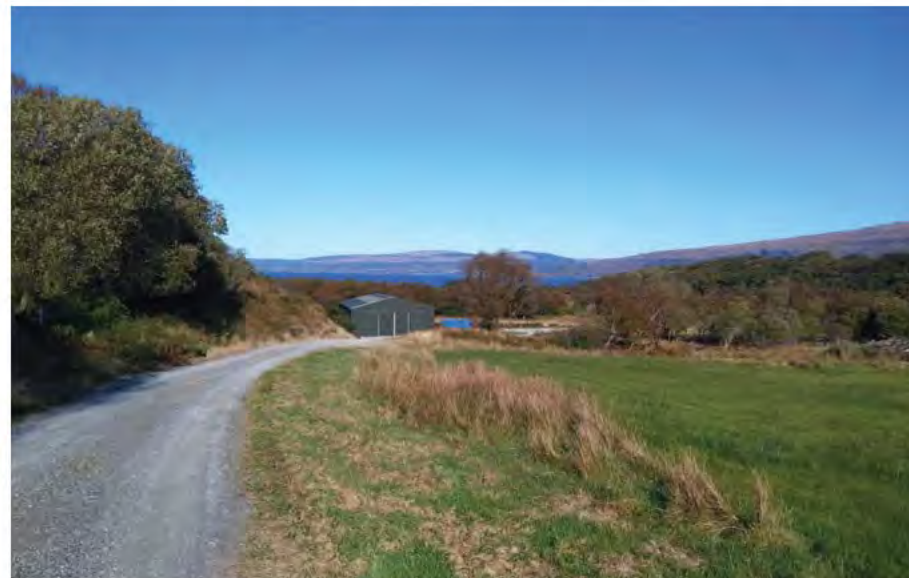
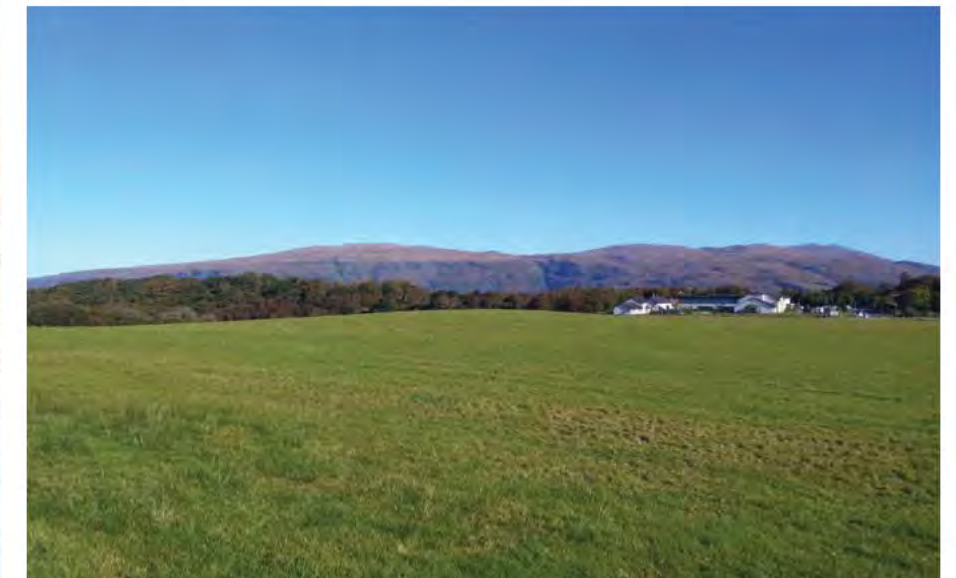
Site 001 Craignure

The site is in close proximity to the Mull and Iona Community Hospital helipad. While not anticipated as a major issue given the playing fields at the existing Tobermory High School are used for emergency landings, it will require consideration as part of any design development.

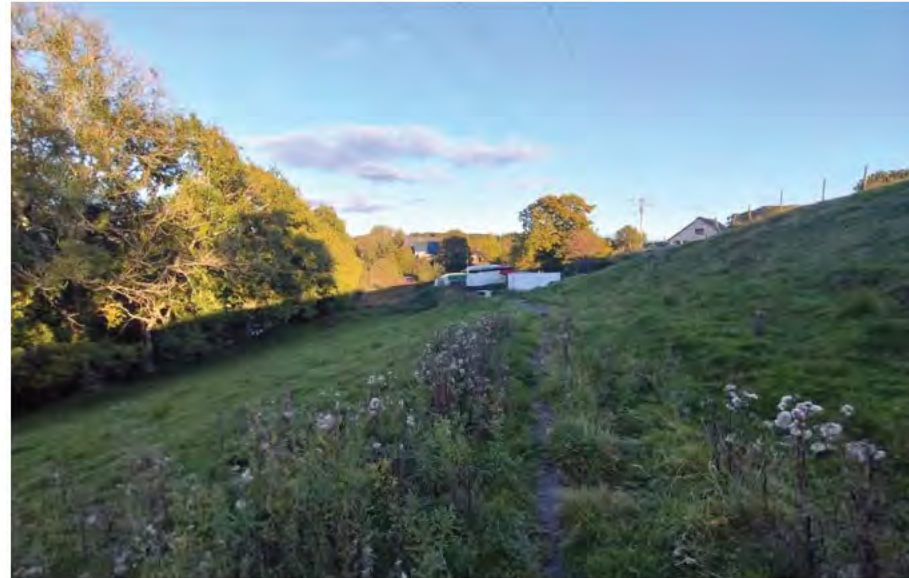
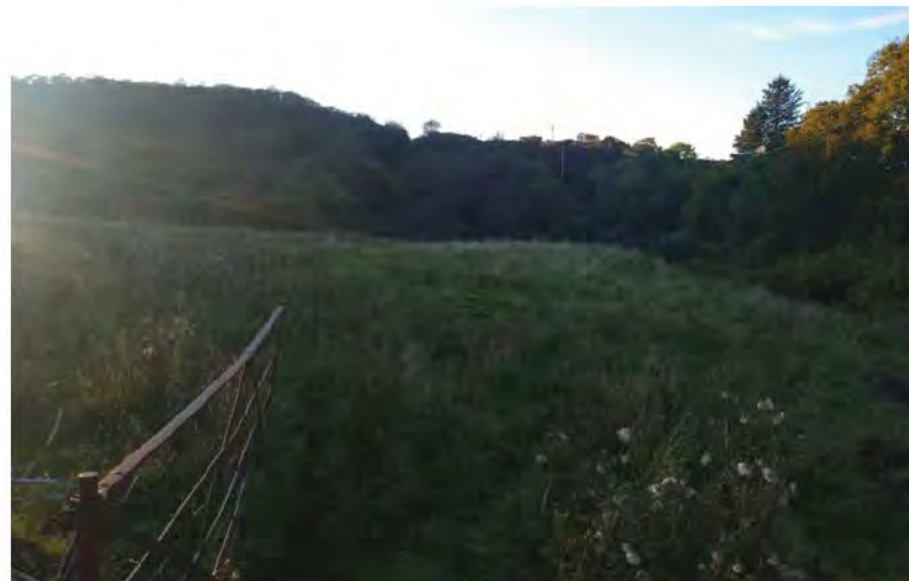
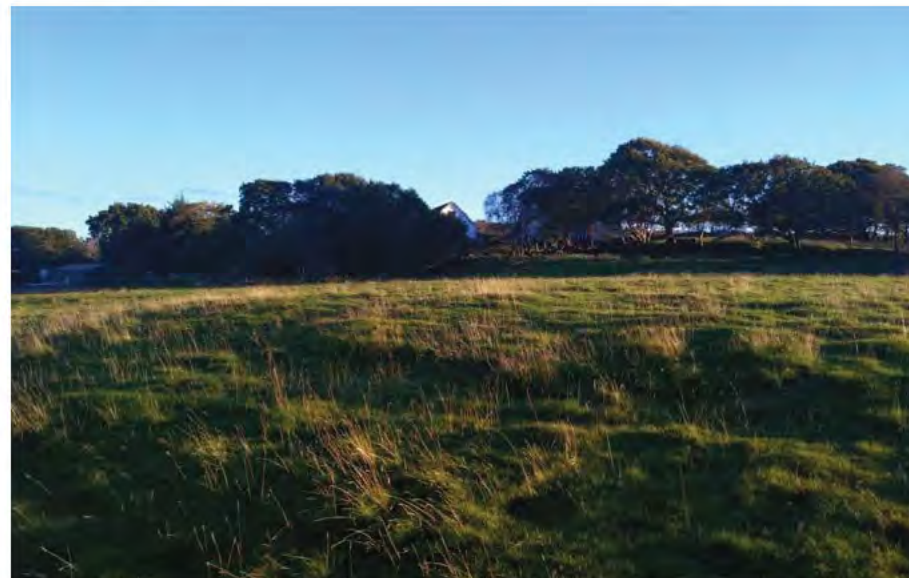
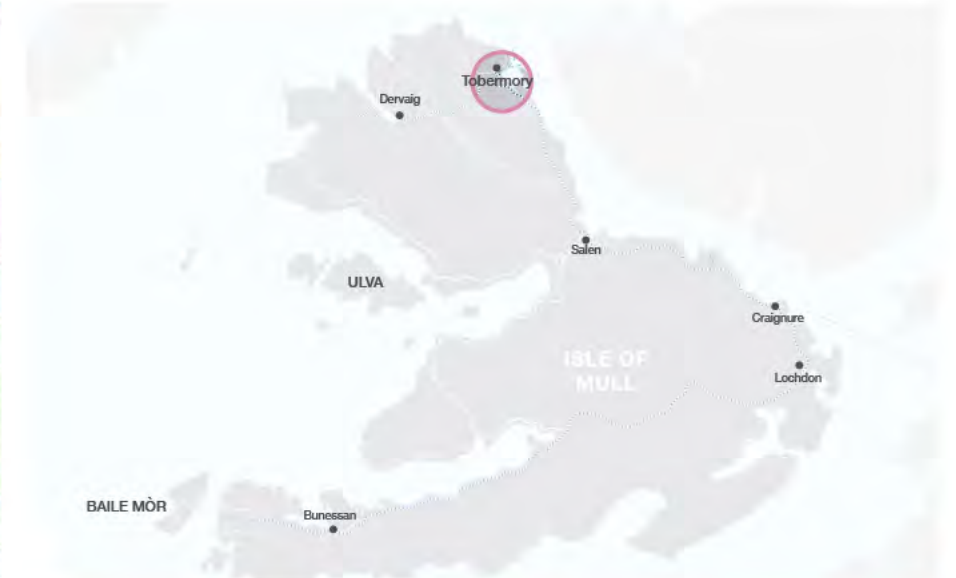
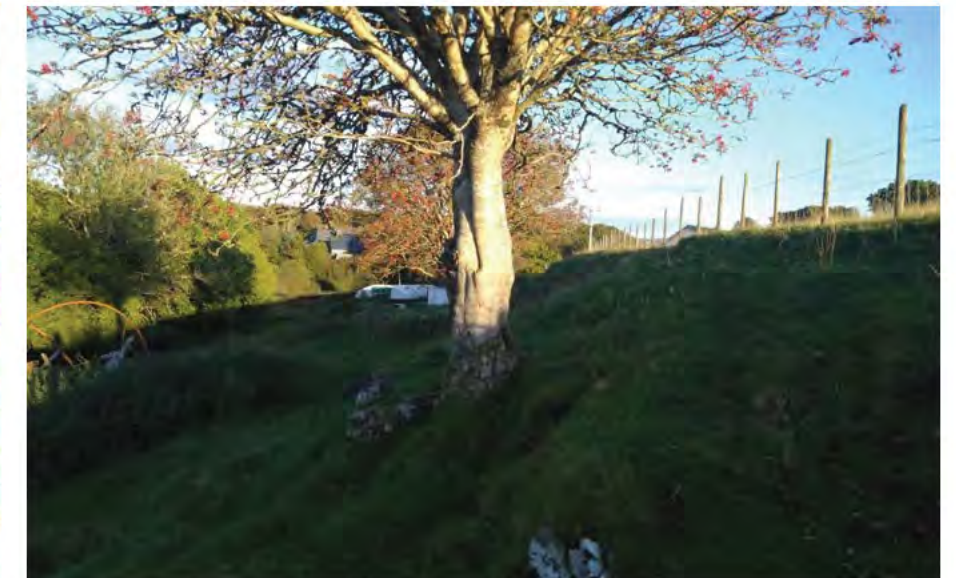
Site 003 Eas Brae

There are areas of soft ground around the watercourse at the north end of the site, further information on ground conditions should be available from the current residential planning consent.

An overhead power line cuts across the centre of the site, which would need relocated. There are also many substantial mature trees along the river, which may impact on development space should any be subject to Tree Protection Orders.

Site 003 is located in Tobermory, next to Tobermory River.

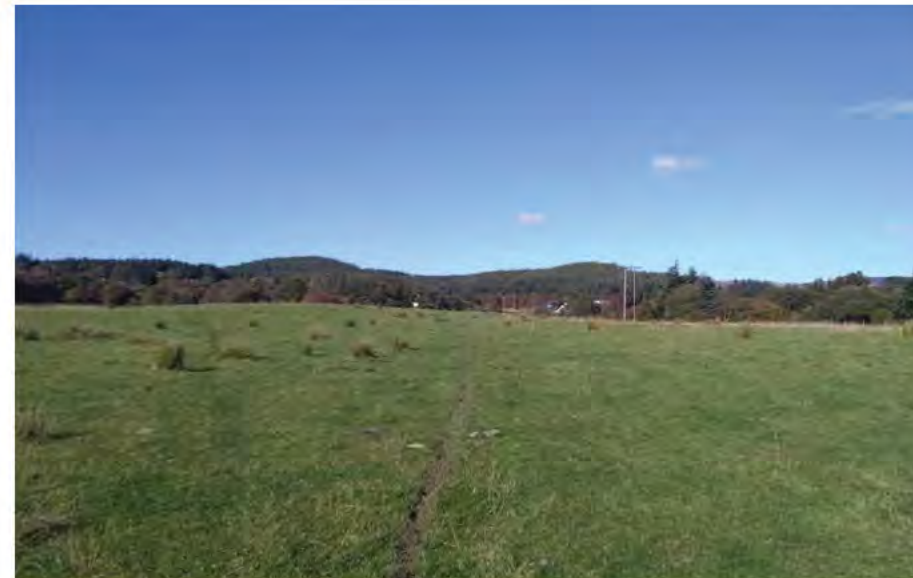
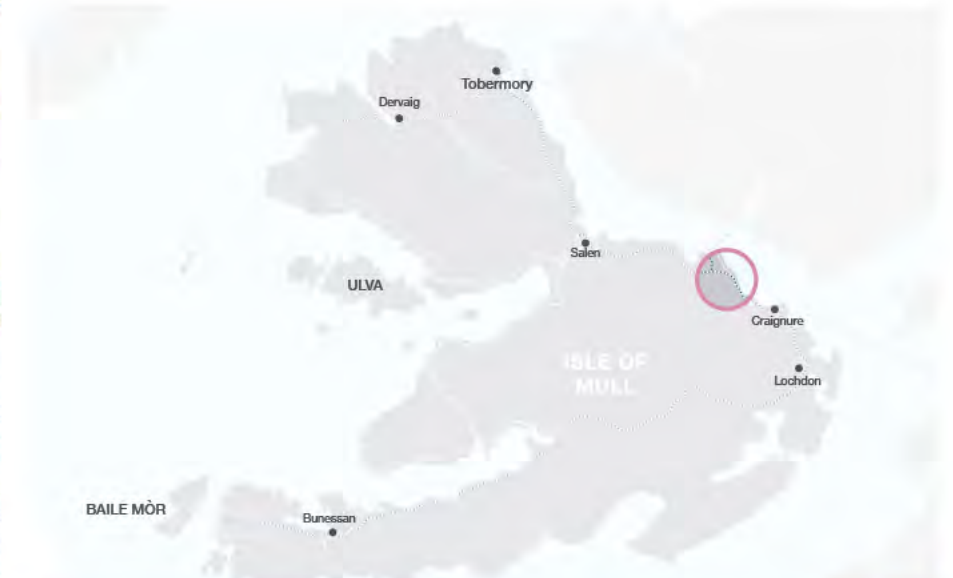
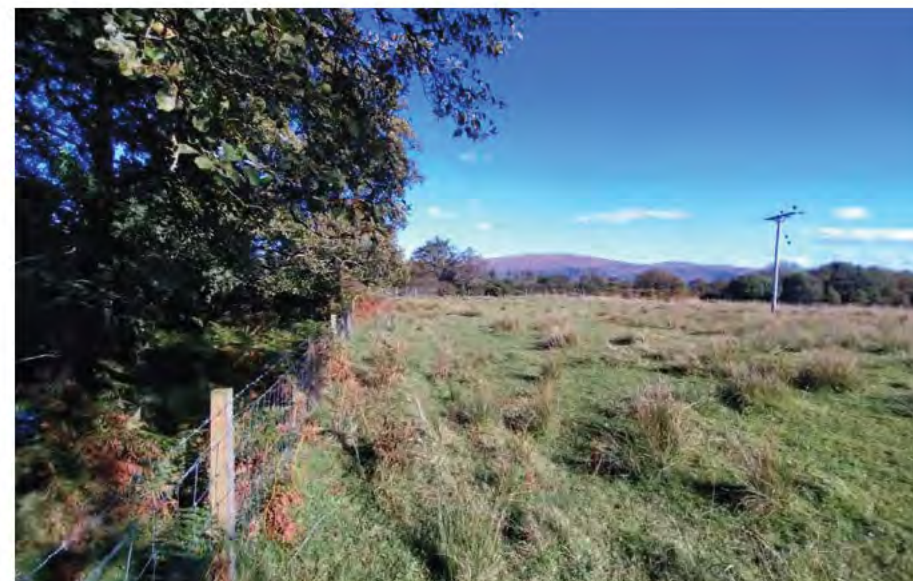
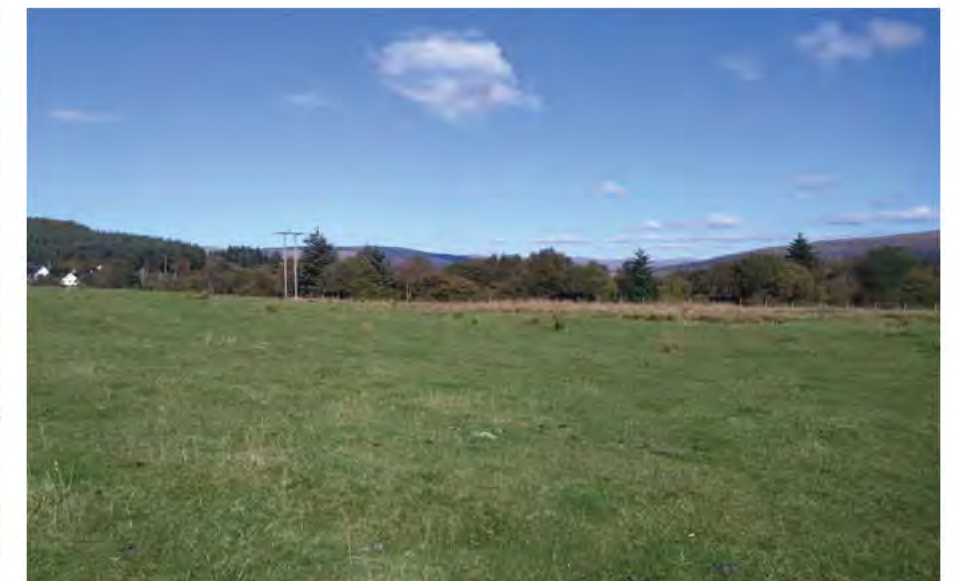
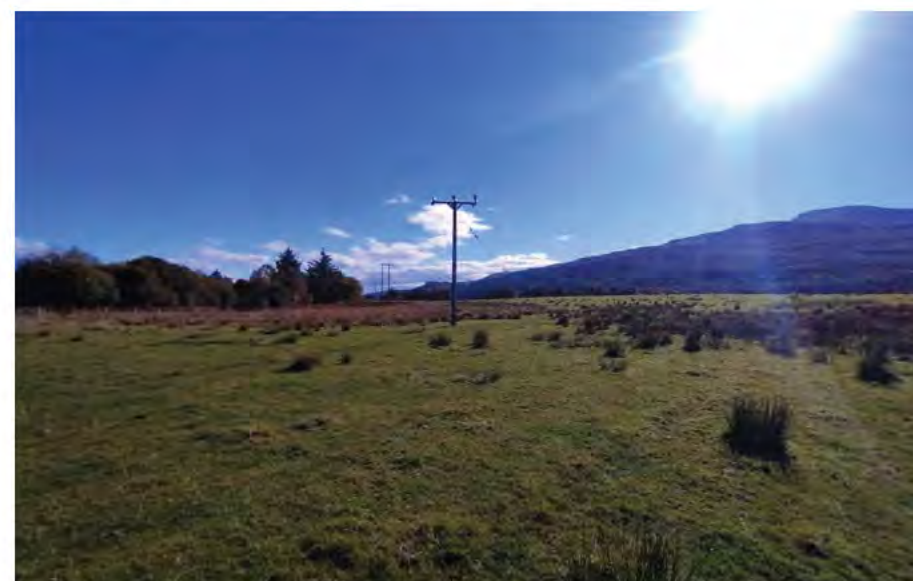
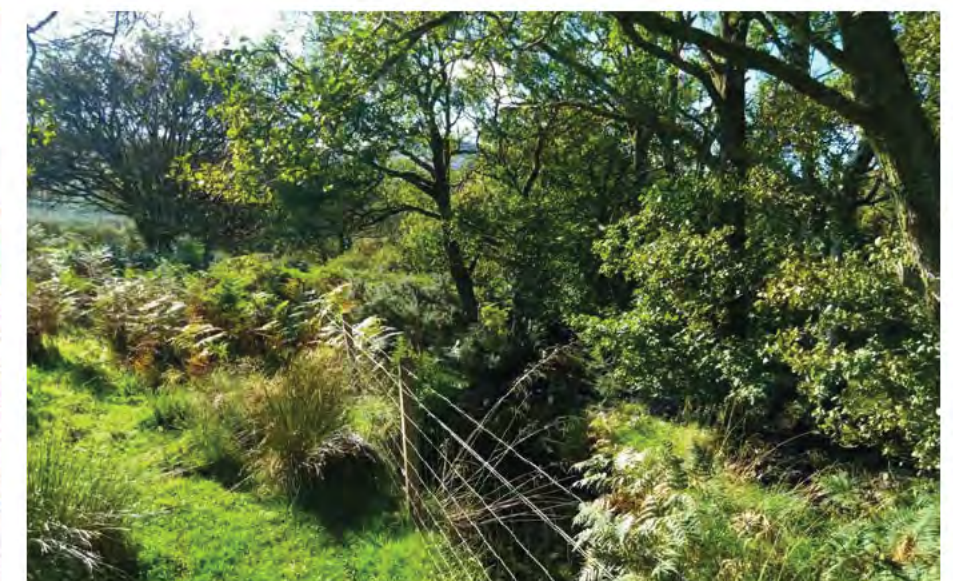
Site 004 has overhead power lines running north south across it, which would need relocated prior to any development. Very limited adjacent facilities

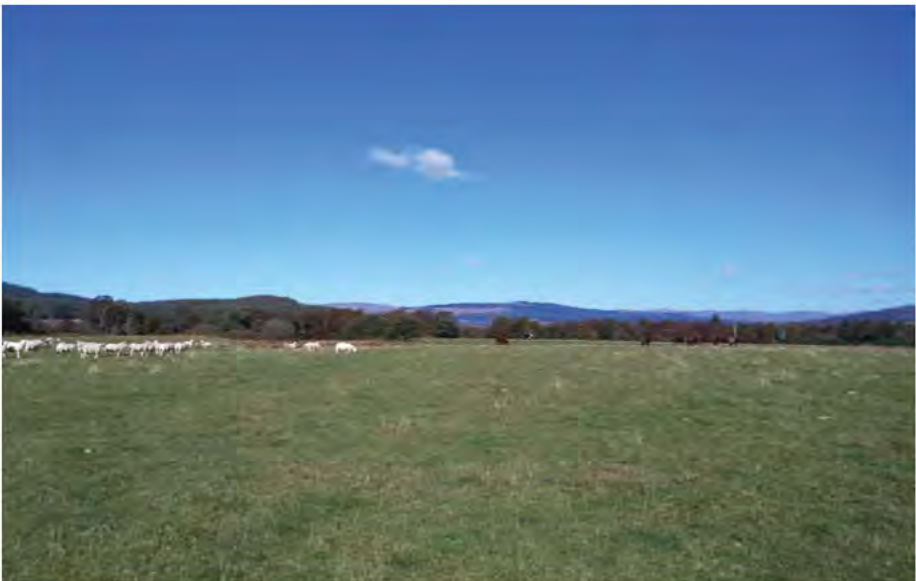
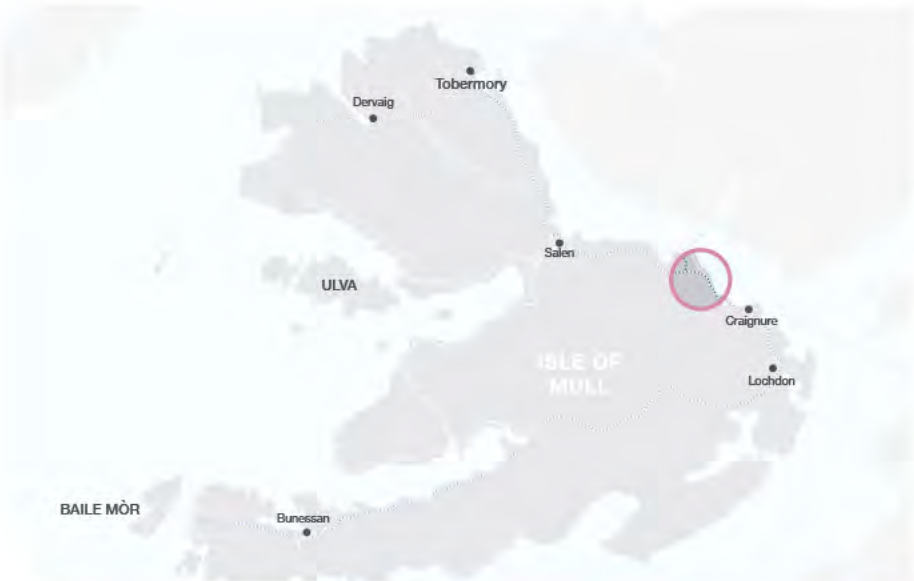
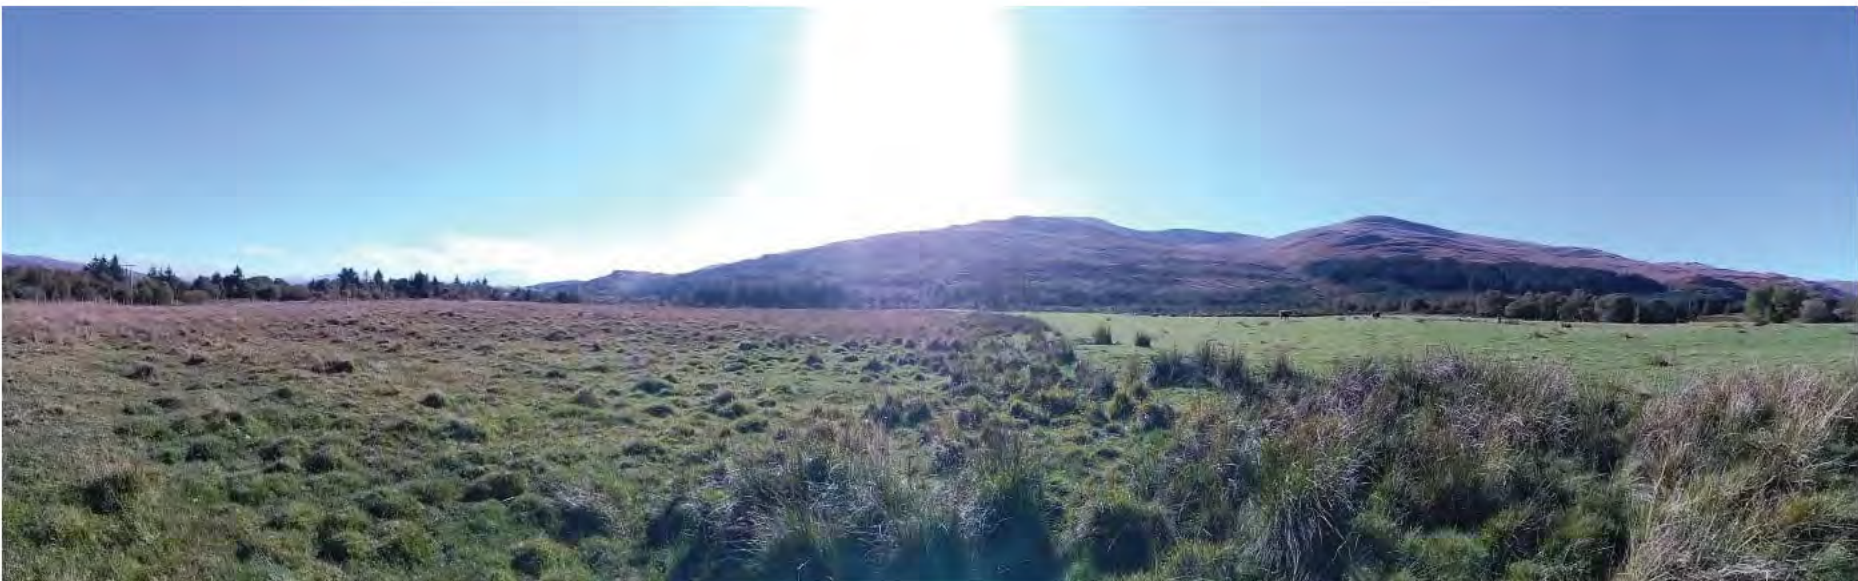
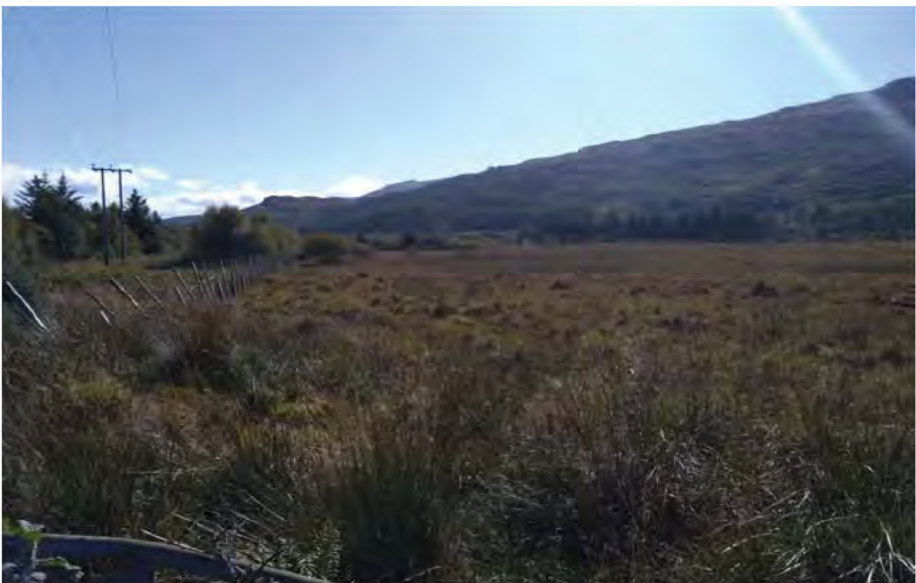
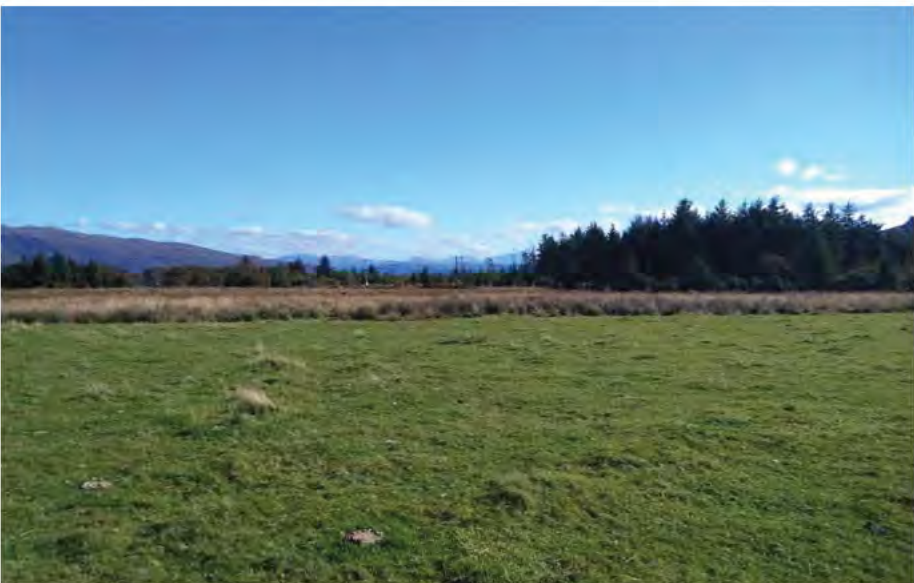
The site has two distinct areas - the land at the eastern portion of the site is boggy, and has a likelihood of peat deposits. However, the large grassed area to the south part of the site has firm ground conditions, and presents a more viable proposition for development.

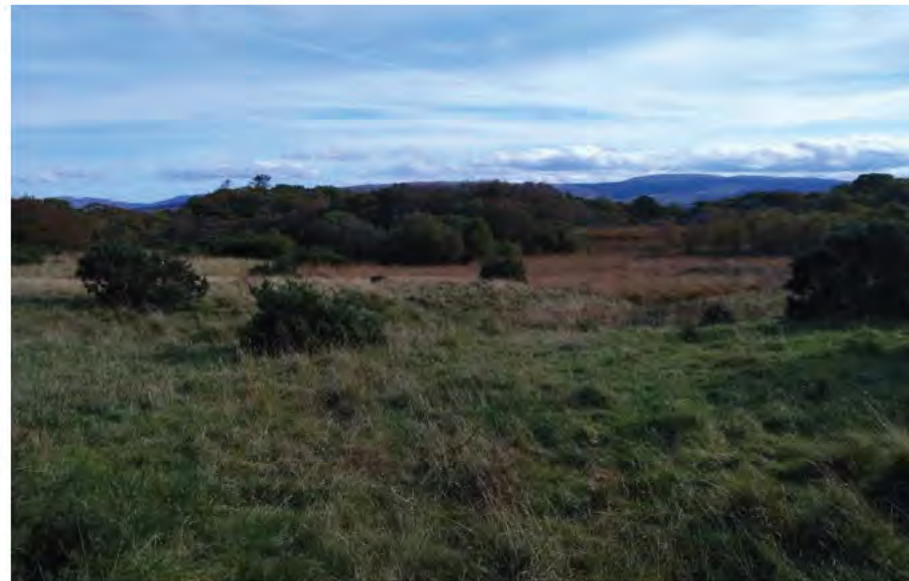
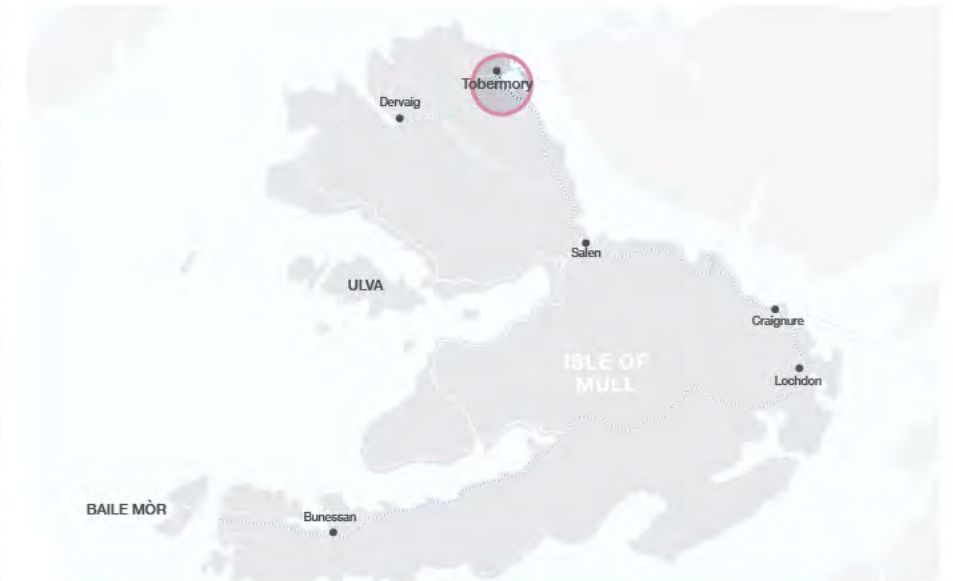
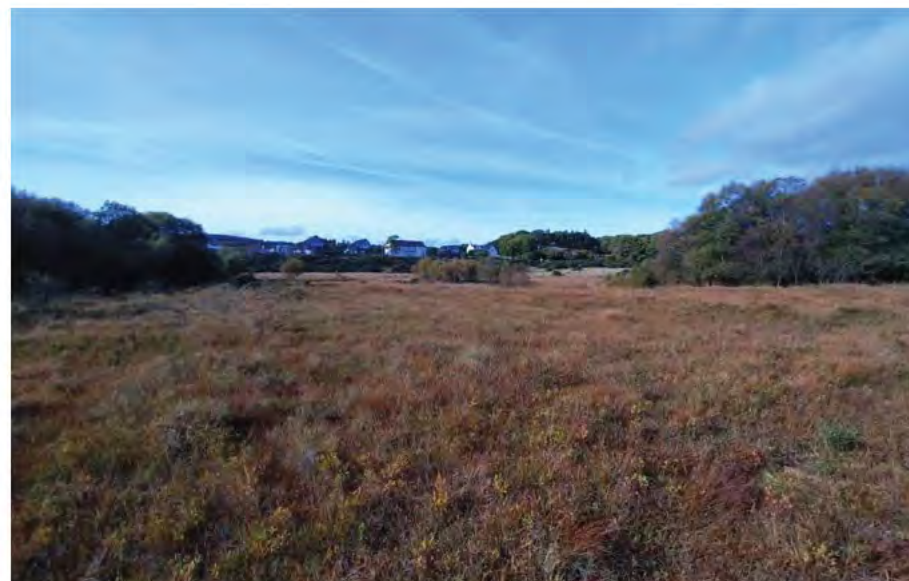
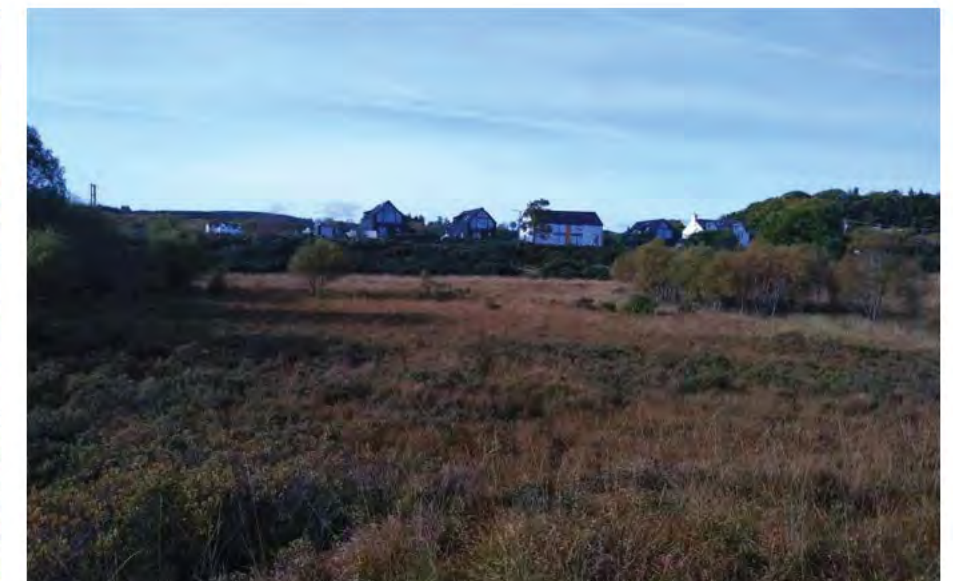
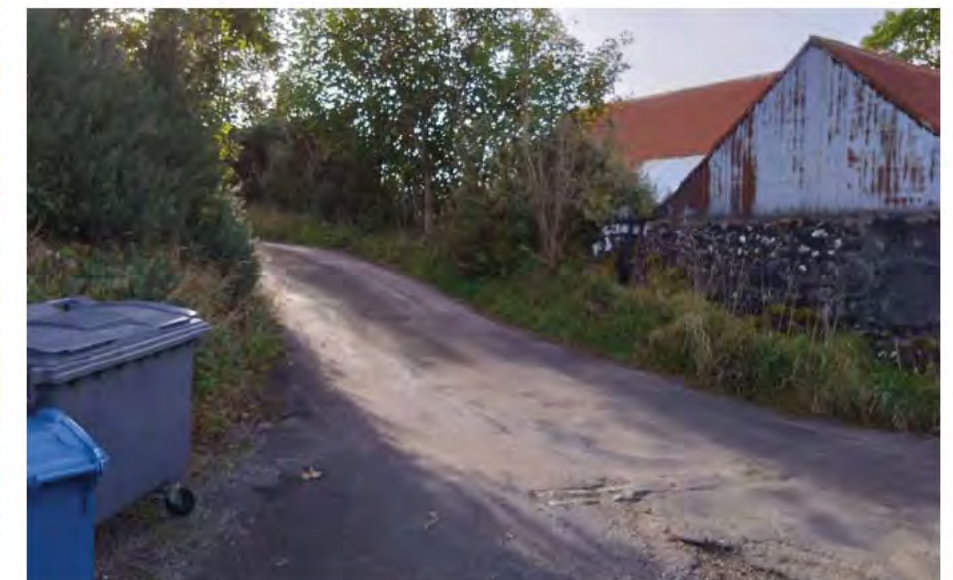
Site 007

The site is a plateau above the coast, with the northeastern edge of the site occupied by steep wooded slopes falling down towards the water - no development is practical in this part of the site. The western part of the site is the highest area, which falls down towards the east in a series of natural terraces. In the centre of the site, there is a depression which runs to the northeast, meeting the wooded slope. The central southern part of the site is the most level area, and ground conditions notwithstanding would be the most appropriate area for the new campus.

Power lines run across the site from southeast to northwest and would likely need rerouted. The site is also likely to have significant habitat and ecological value.
