Argyll and Bute Council

Oban Harbour

Navigational Risk Assessment

May 2023

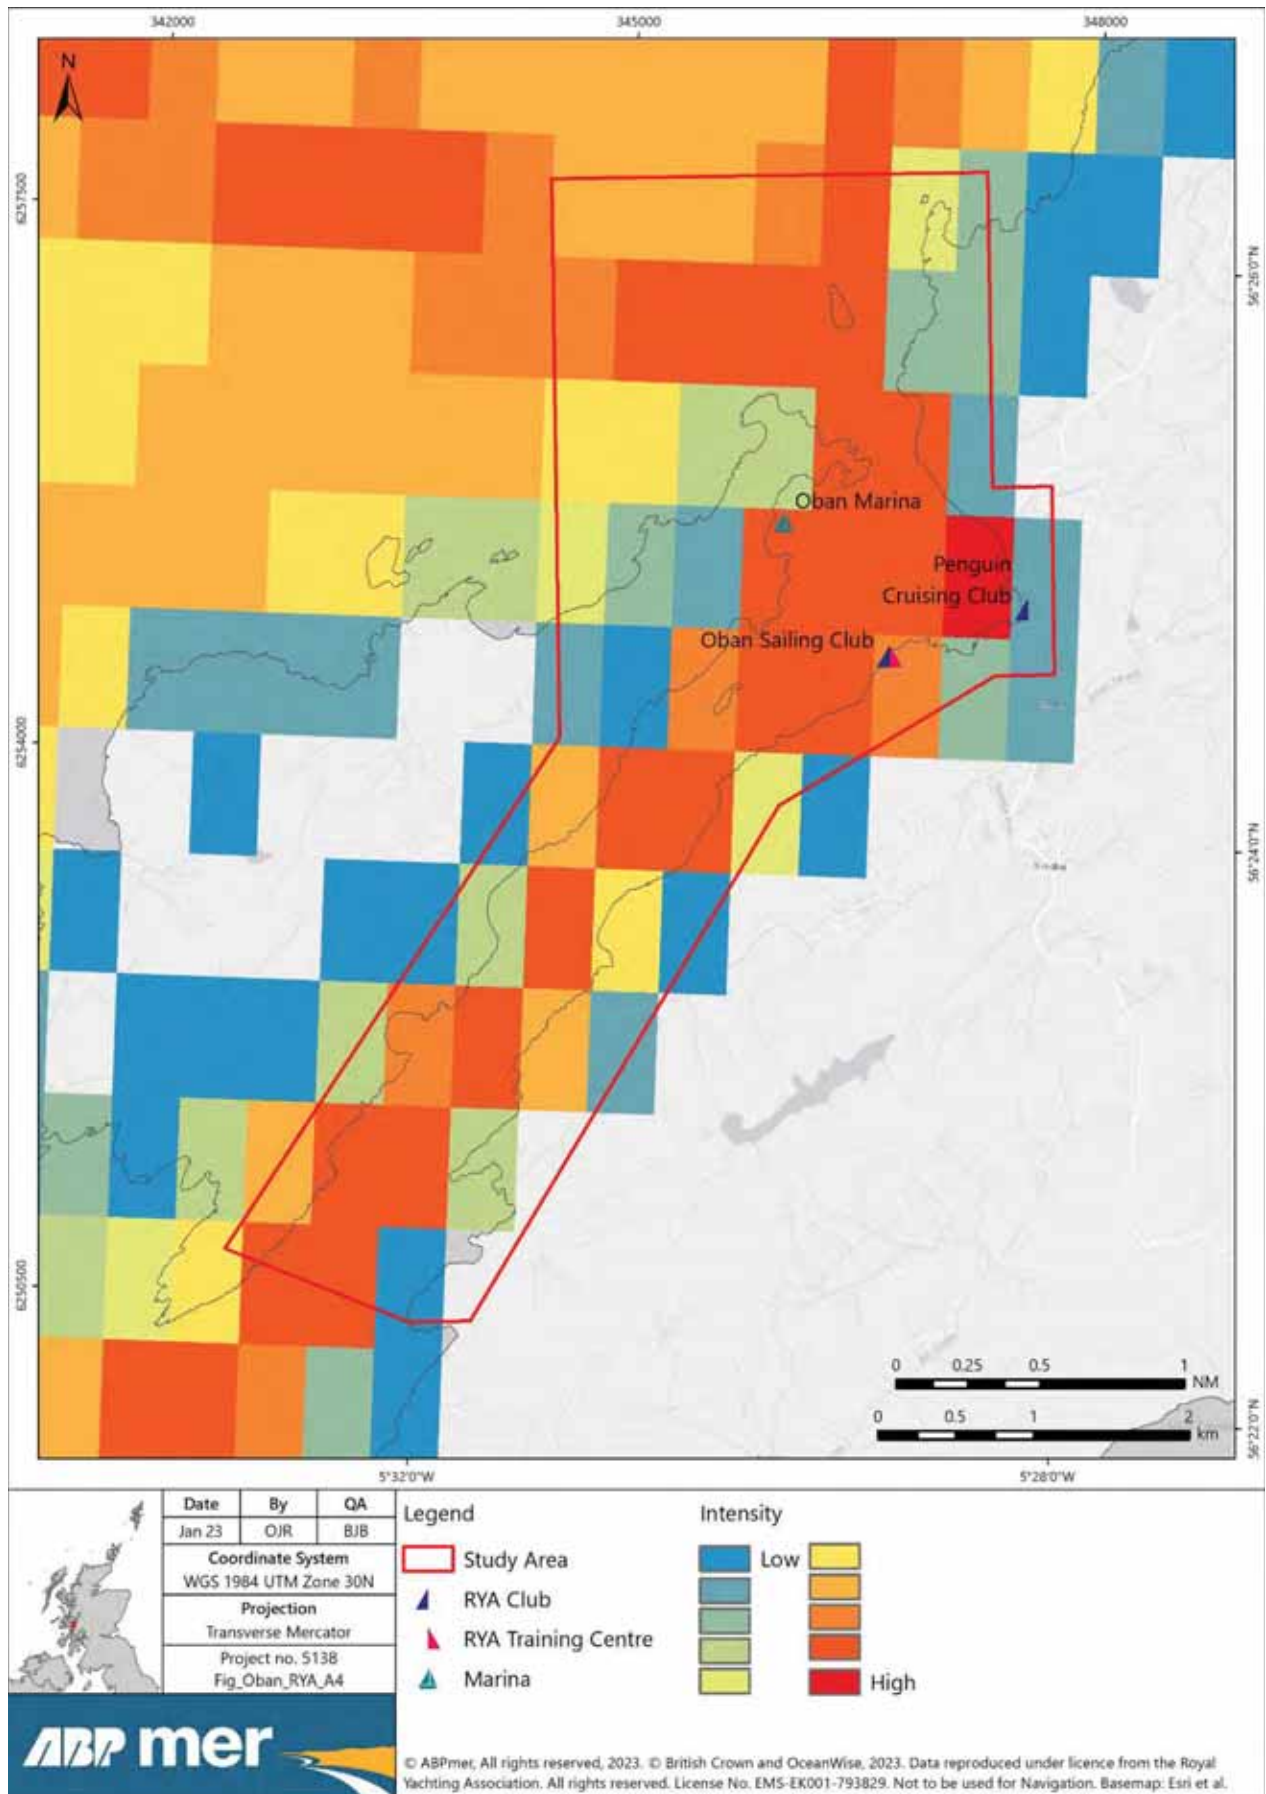
Figure 5. RYA activity intensity and marine facility locations

There are a variety of recreational activities which take place in the waters of Oban Bay, including sailing, diving and kayaking. There are also several established watersports clubs in the area which host popular events. Oban Sailing Club runs training and racing sessions for dinghies, yachts and keelboats. These sessions mainly occur between April and September and include events such as the Round Mull Race. Oban Sea School focuses specifically on yachts, offering RYA training, charters and cruises. In addition to this, there are many independent recreational cruising yachts which pass through or stay at the marinas. The RYA has published data on the intensity of their activities, which is shown in Figure 5.

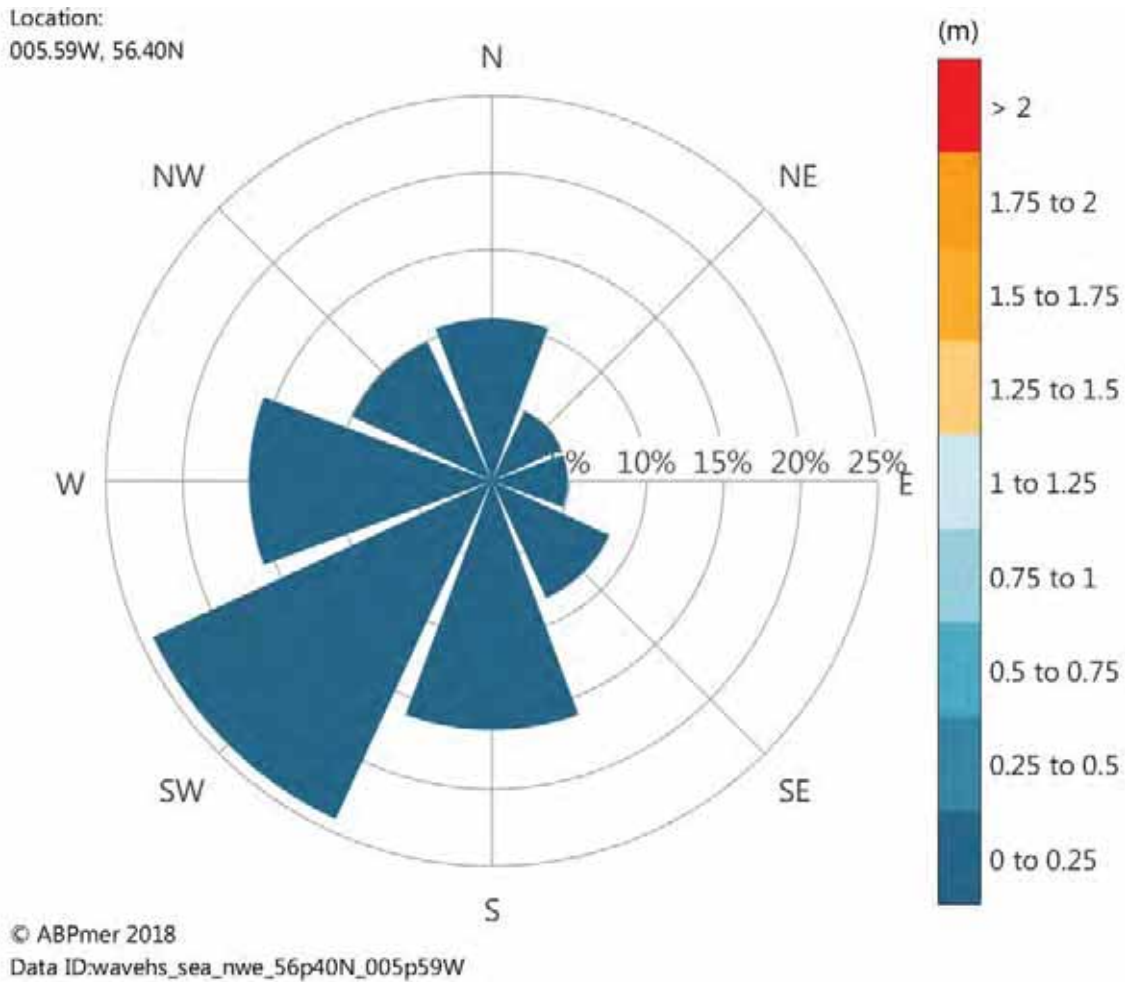
Figure 6. Wave rose for the Firth of Lorn

It can be seen from Figure 6 that the waves experienced are predominantly from the southwest. The waves do not exceed 0.25 m. The area is sheltered from most directions, with the small fetch not allowing waves to build up in height. The lowest concentration of waves is from the northeast and east.

This section details the wind and wave characteristics of the study area, Figure 6 and Figure 7 are rose diagrams for waves and wind conditions prevalent in the area.

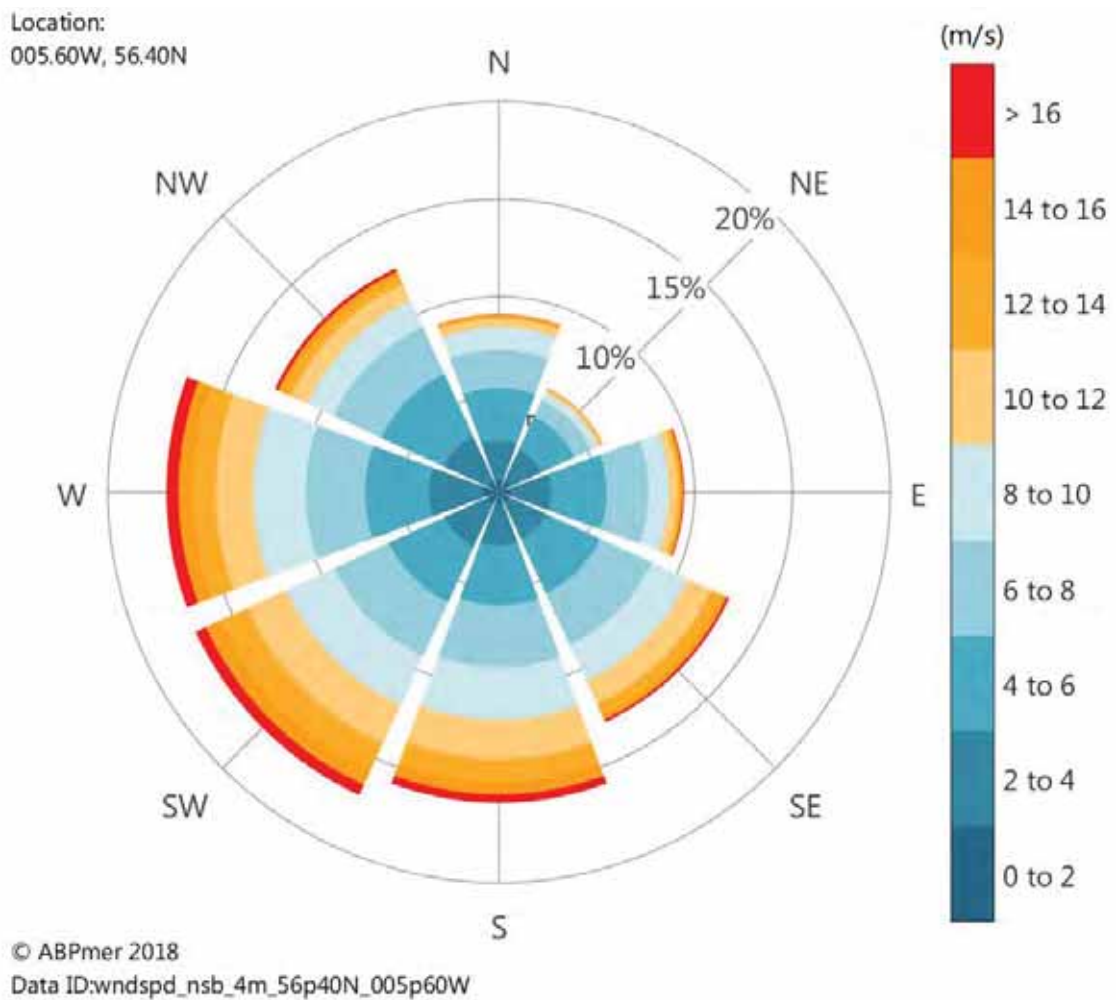
Figure 7. Wind rose for the Firth of Lorn

Figure 7 identifies that the wind is predominantly from the south-west, west, and south. The strongest winds of greater than 16 m/s (Beaufort wind force 7) are also predominantly from the south-west and west. These wind speeds can be seen from all directions except north and northeast. It is far more common to have wind speeds of 6-8 m/s.

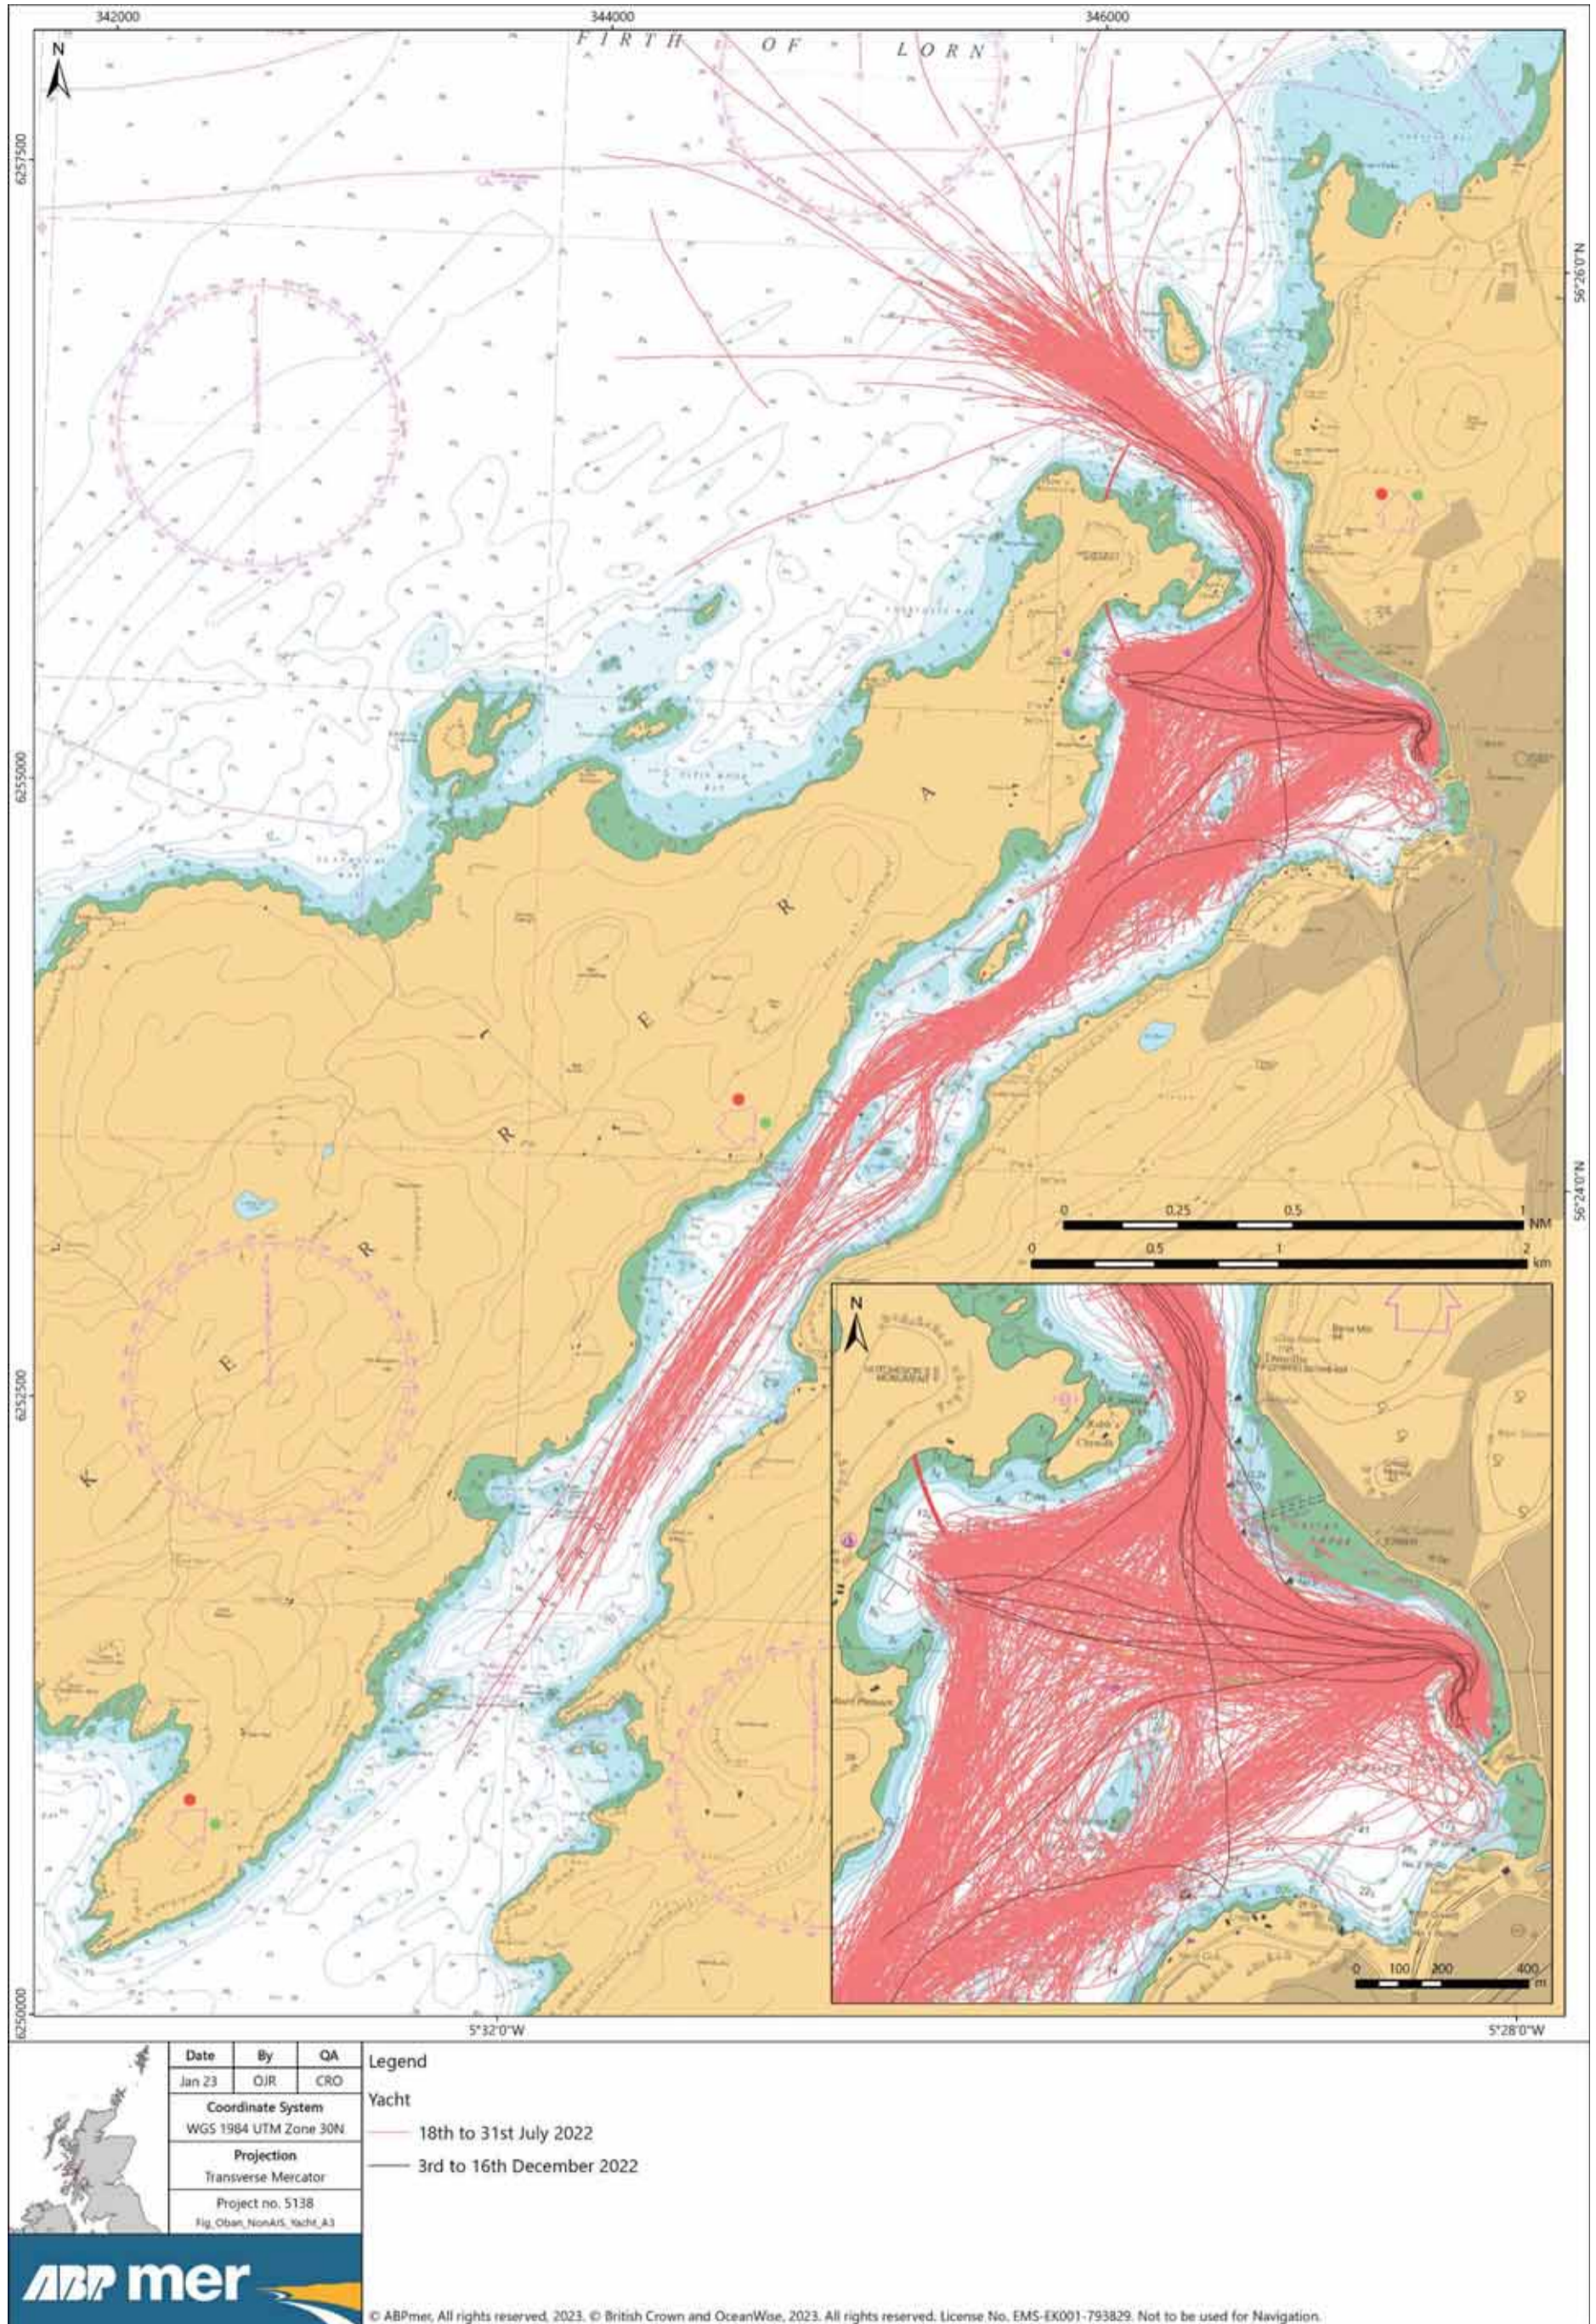
Figure B15. Non-AIS Transits – Yachting vessels

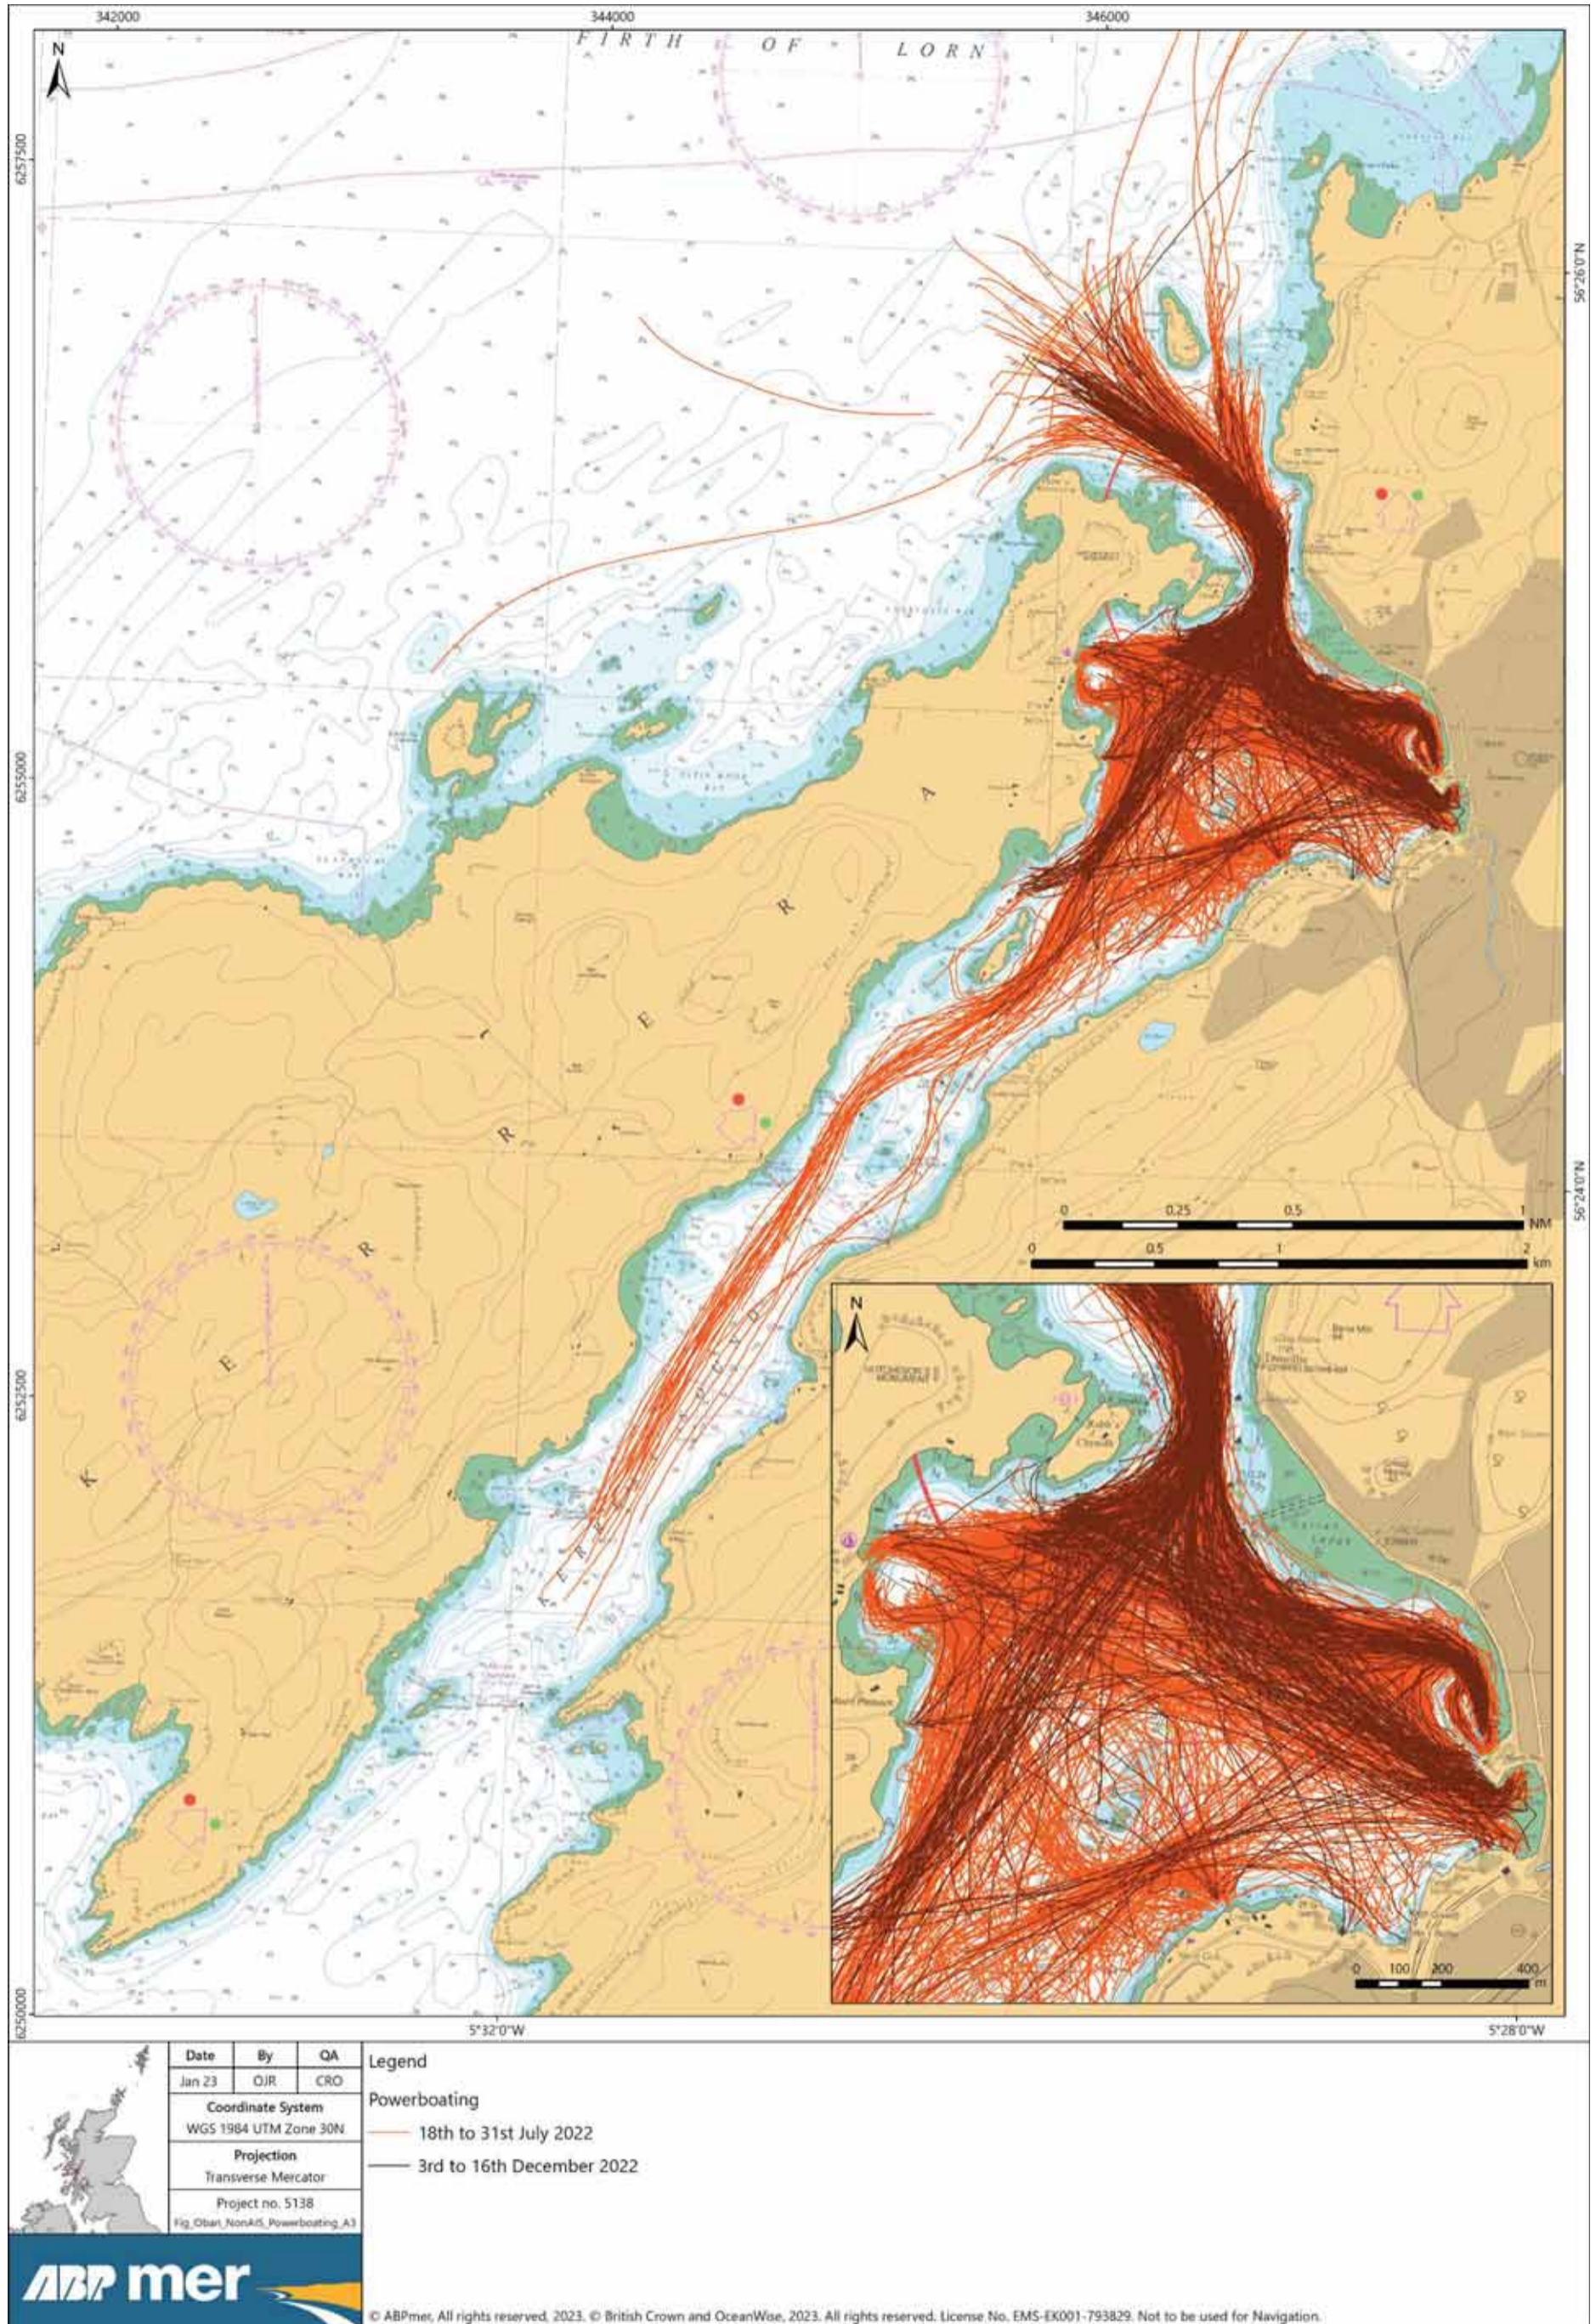
Figure B17. Non-AIS Transits – Powerboating

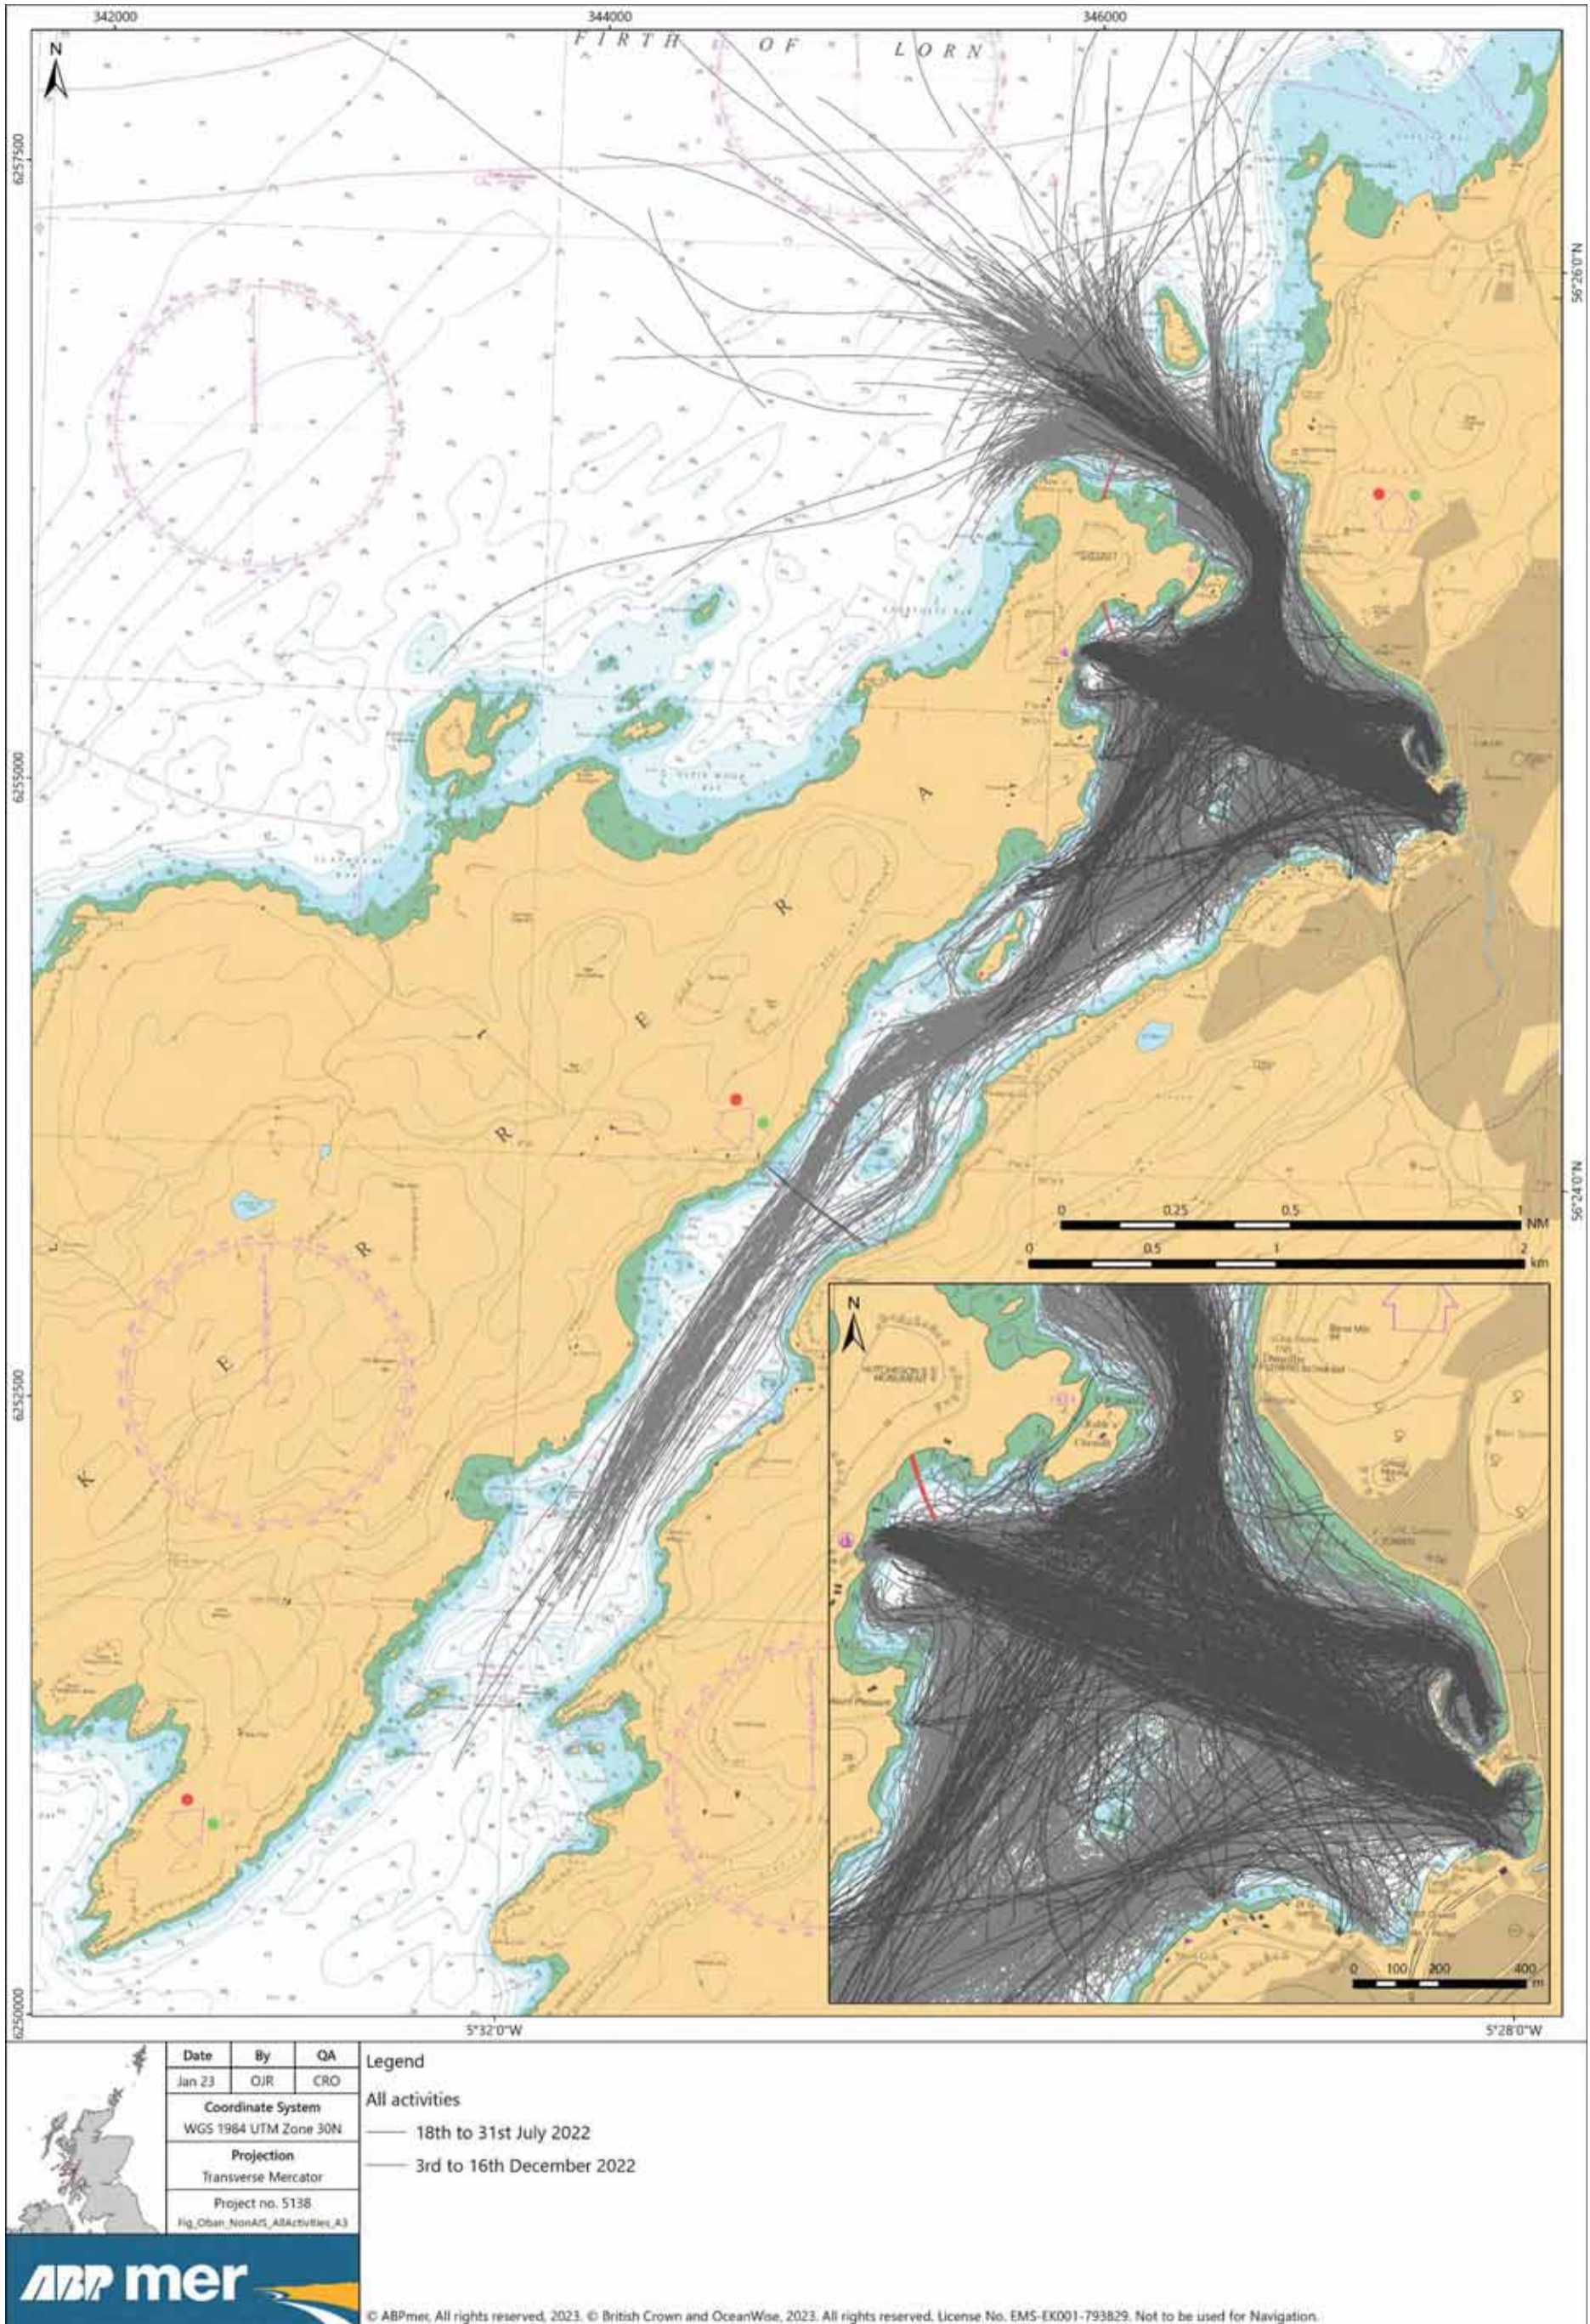
Figure B18. Non-AIS Transits – Overall

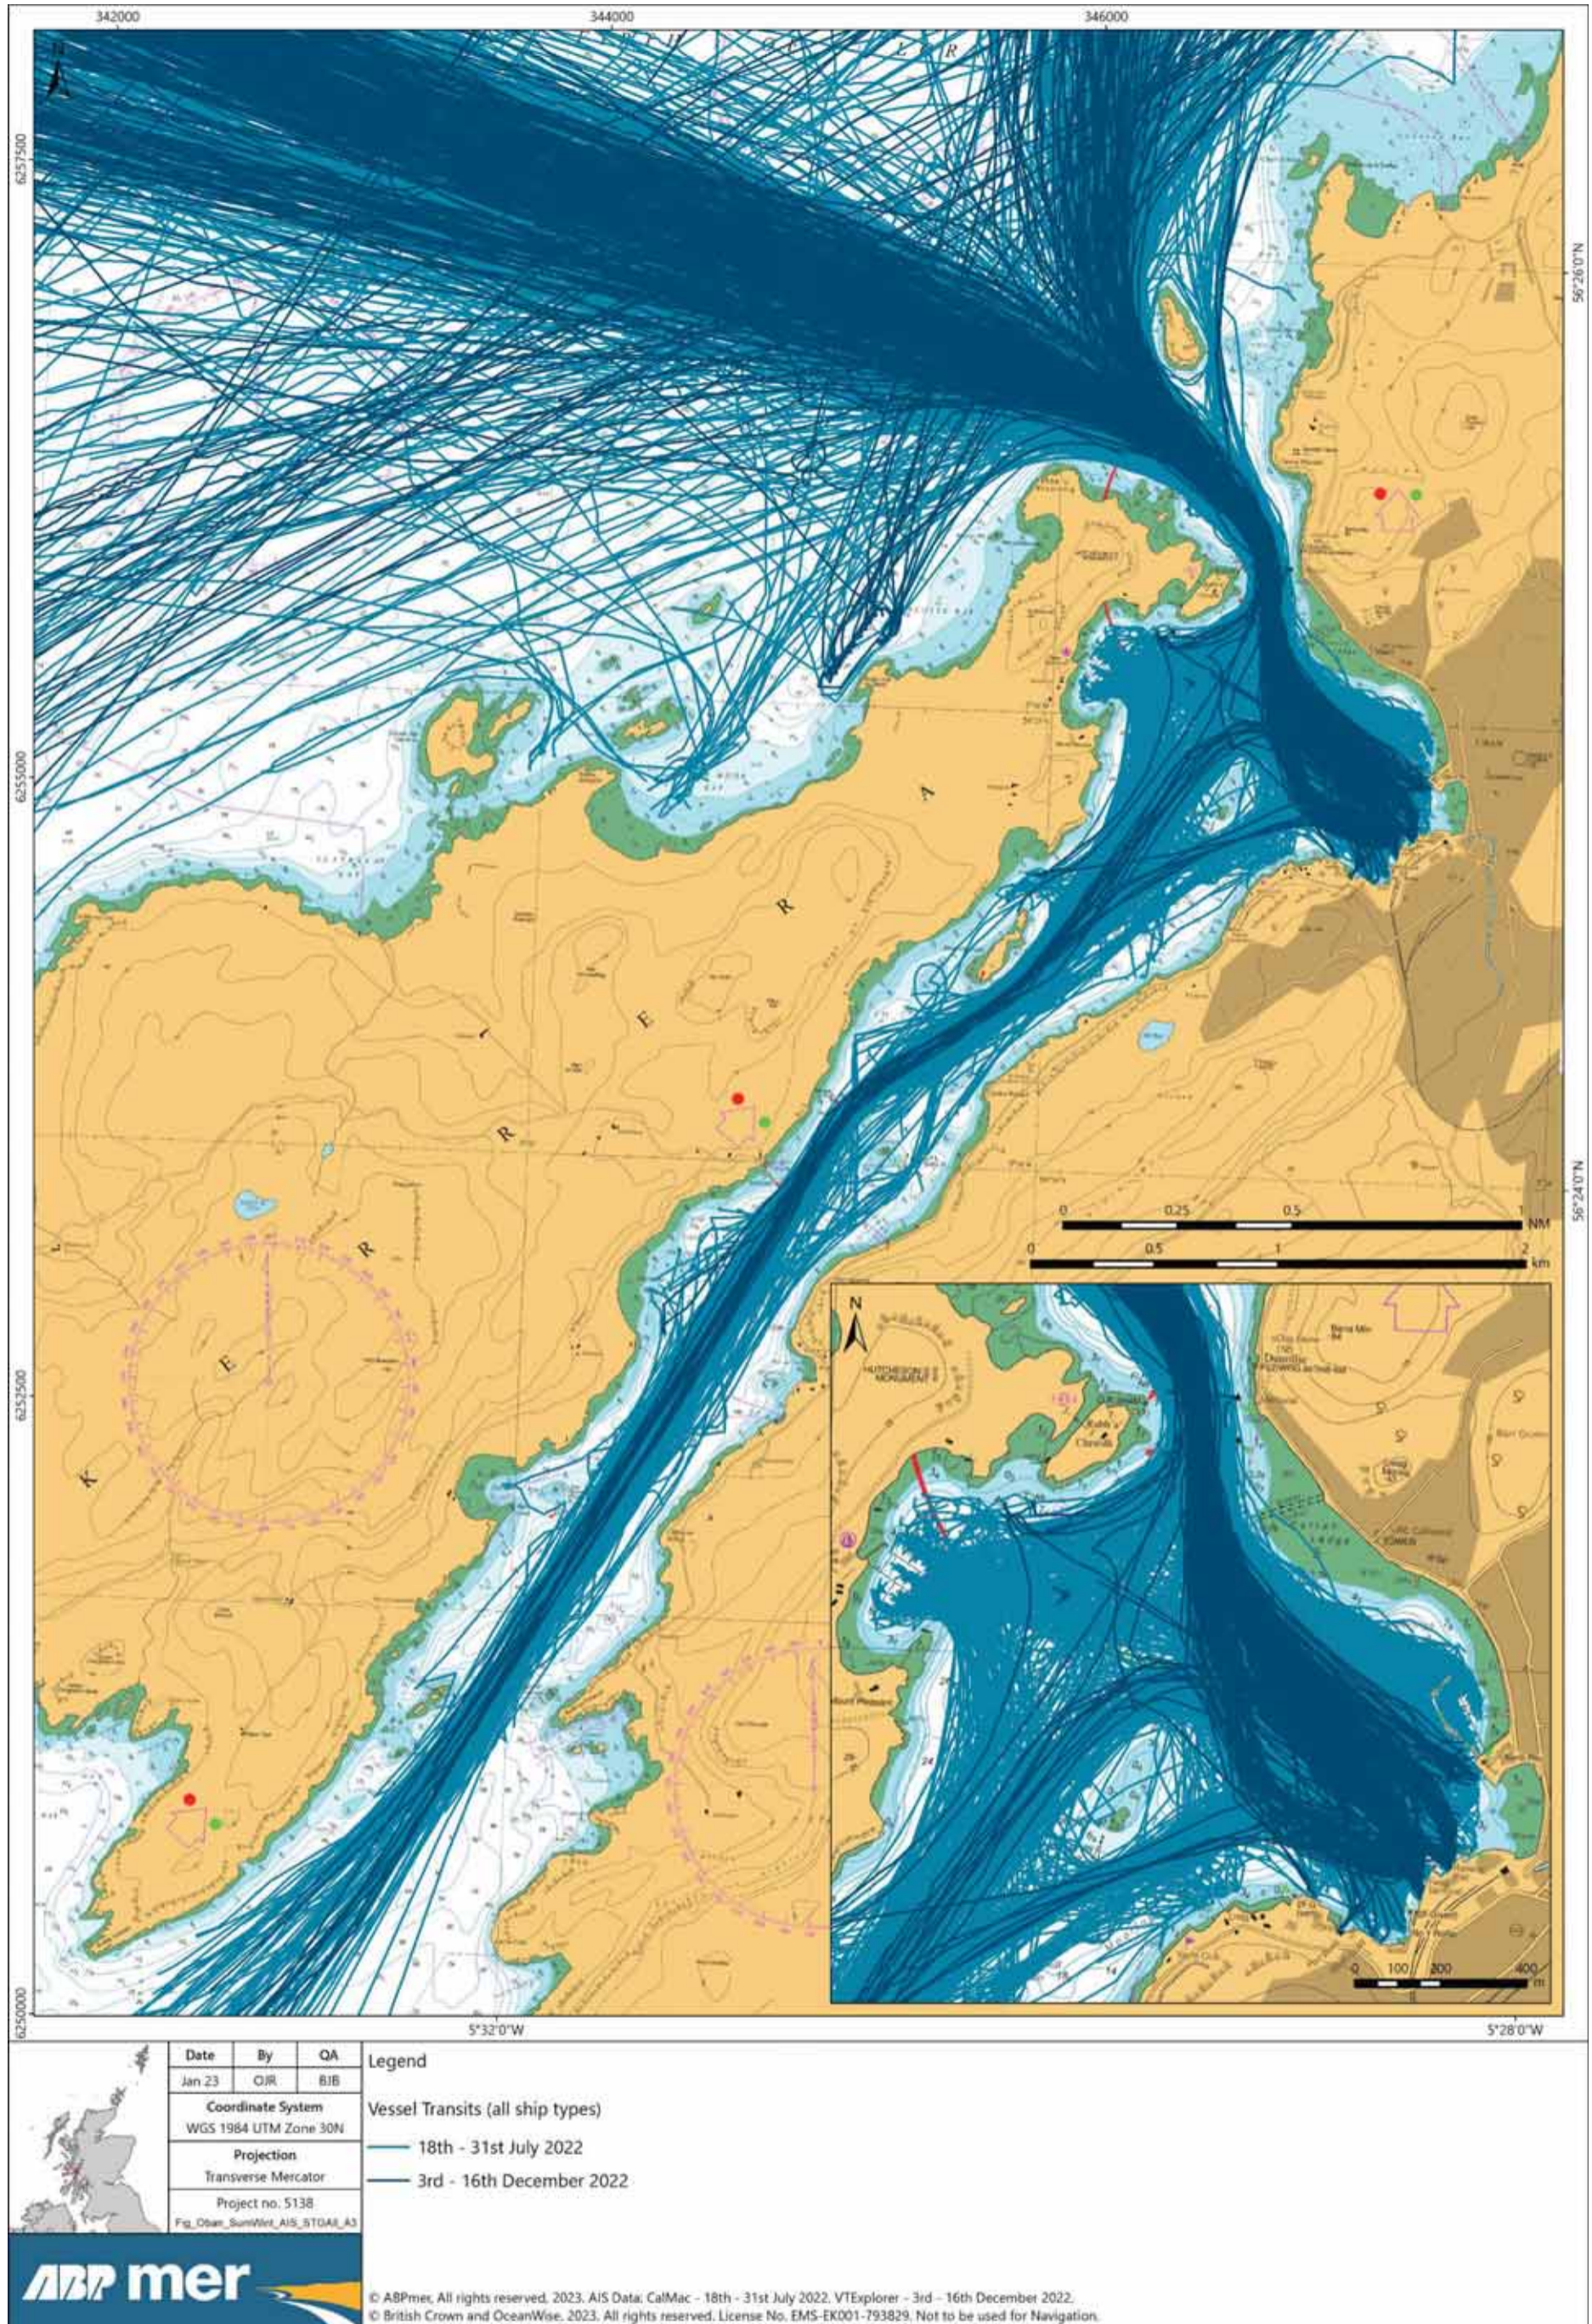
Figure B19. Vessel transits 2022 overview
