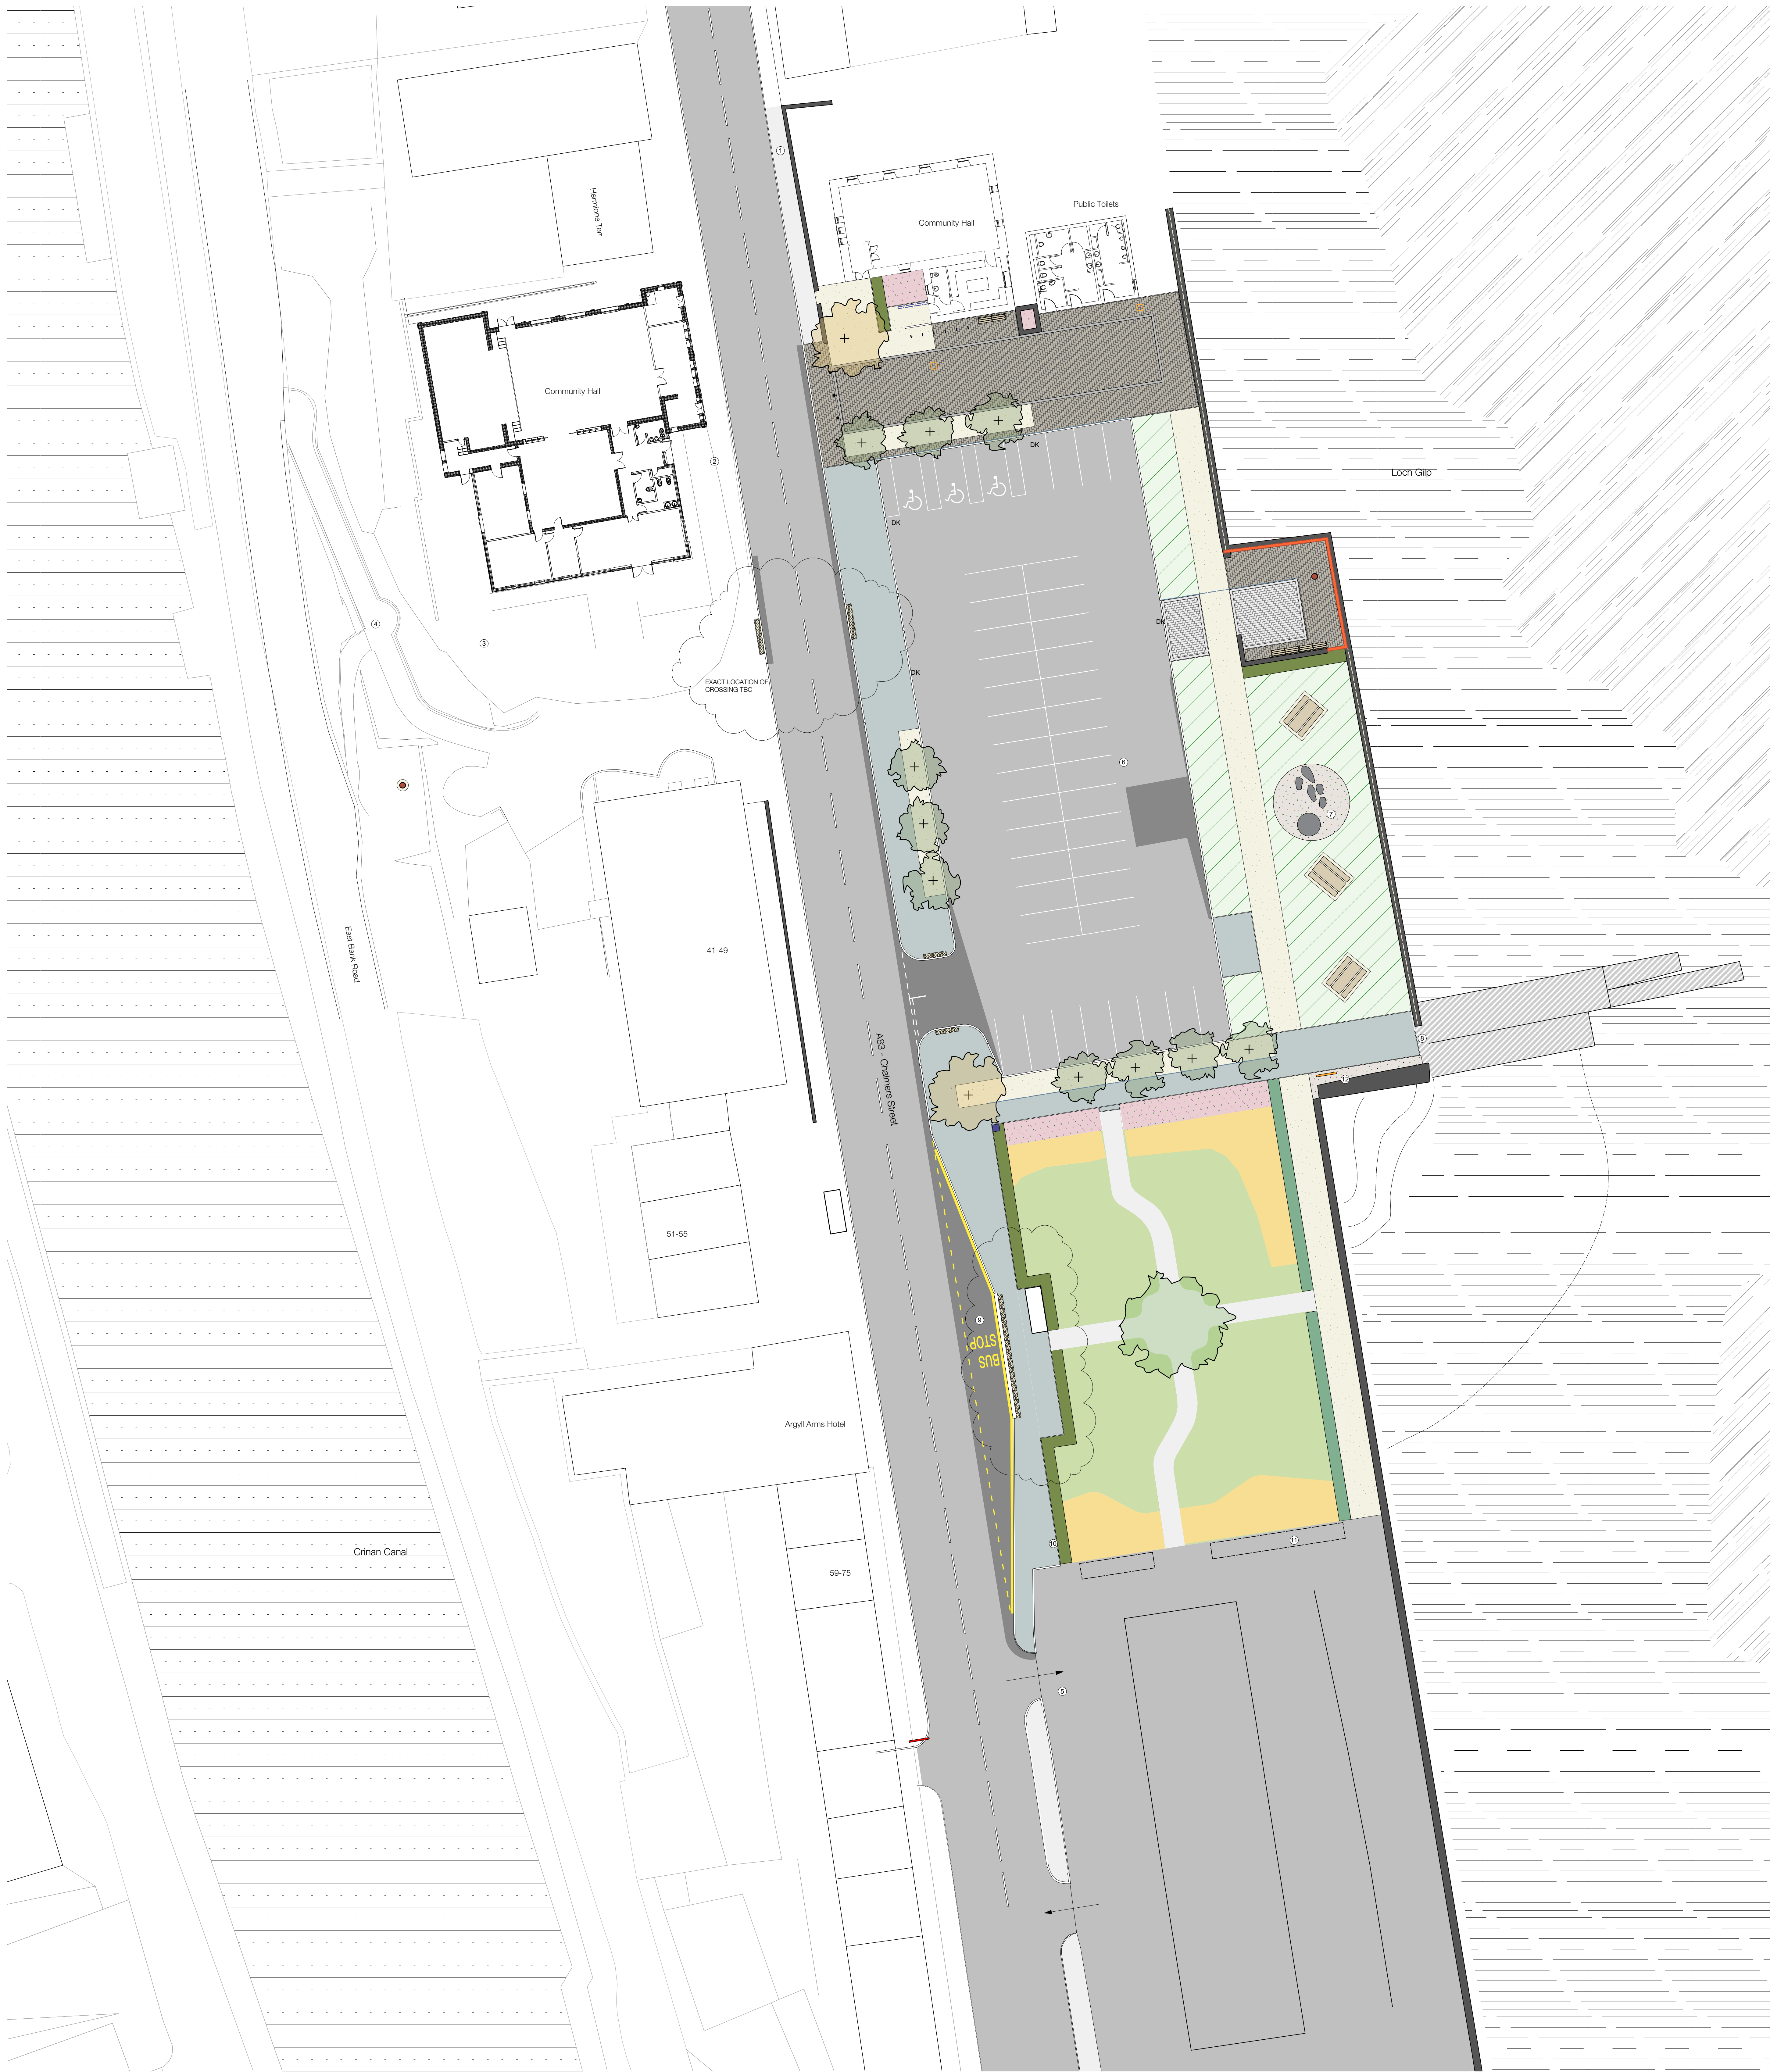
- 2no. Speed reduction camera/signs, location tbc
- Works adjacent to community hall not part of contract
- Vehicle access to rear of hall remains, not part of works
- Reverse in / out flow to car park, allowance for signage and lining
- Existing ramp retained, not part of works
- Bays re-lined to free up space
37no. bays & 3no. disabled bays
- Existing memorial retained
- Existing slipway, allowance for localised repairs
- Relocated bus pull in with raised bus boarder kerbs
- Relocated bus shelter
- Relocated recycling bins
- Relocated map board
