**UPDATE ON A82 AND A83**

- 1.1 This report provides an update on the preferred route option for the upgrading of the A82 between Tarbet and Invararnan and A83 Rest and Be Thankful.

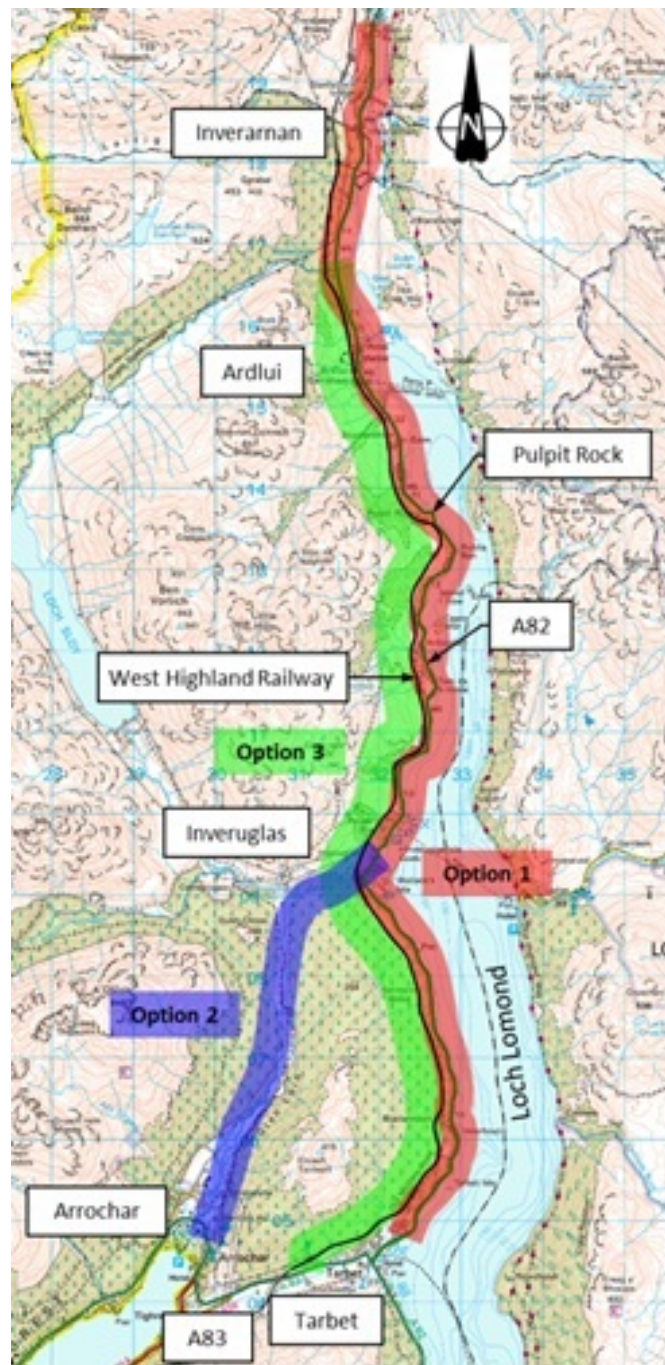
Appendix 1 – Preferred Route Plan

- 4.1 Scottish Government has announced the preferred route option for the upgrading of the A82 between Tarbet and Invararnan. Based on the route options assessment process, Route Option 1 – online upgrade – is to be taken forward as the preferred route option (see Appendix 1). Transport Scotland have confirmed that further consideration will be given to the following as part of the design and development of the preferred option (Design Manual for Roads and Bridges Stage 3 assessment process):

- Inclusion of 2 short off line sections near Ardvorlich.
  - The alignment will be developed to reduce impact on properties and landowners.
  - The alignment will also be adjusted to assist construction and reduce impact on road users.

- A carriageway width of 6 metres and 7.3 metres (both with 1 meter hard strips) will be considered.
- 4.2 Transport Scotland has also confirmed that the next steps of the development and assessment of the development and assessment of the preferred route will be:
