Environmental Health Report Variation of Premises Licence Board Meeting 27th April 2021

The Rumblin'Tum Café and Lorne Bar, 79a/87 Chalmers Street, Ardrishaig PA30 8DX

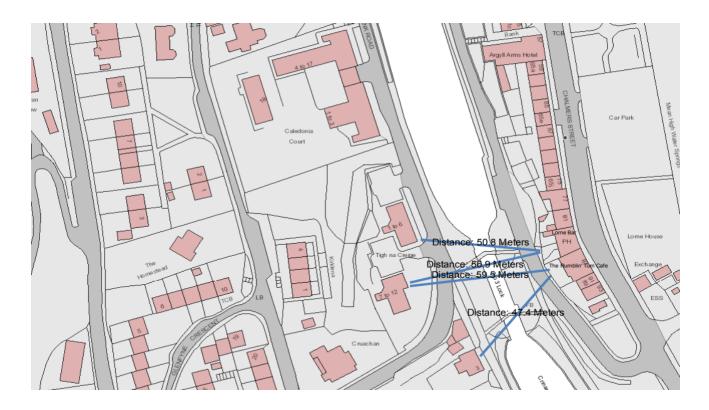
The location of the beer garden to the nearest noise sensitive receptors are a flat above the Rumblin'Tum Café and flats on either side of the Rumblin'Tum Café and the Lorne Bar and residential properties across the Crinan Canal, the nearest of which is approximately 47 meters away as shown on the map below.

The close proximity of the proposed beer garden to residential properties may cause potential noise nuisance issues.

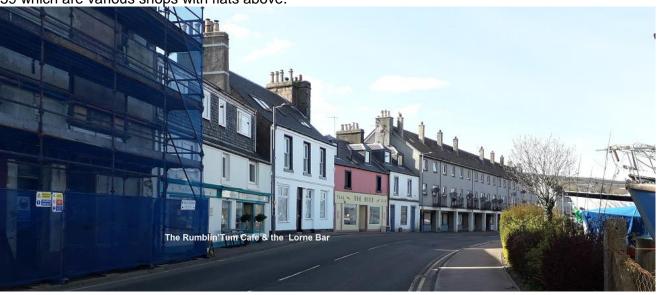
Picture 1 below, shows the properties along Chalmers Street. Starting on the left with 93 – 89 which are being refurbished, followed by 87-79a, The Rumblin'Tum Café and the Lorne Bar and then 77 – 59 which are various shops with flats above.

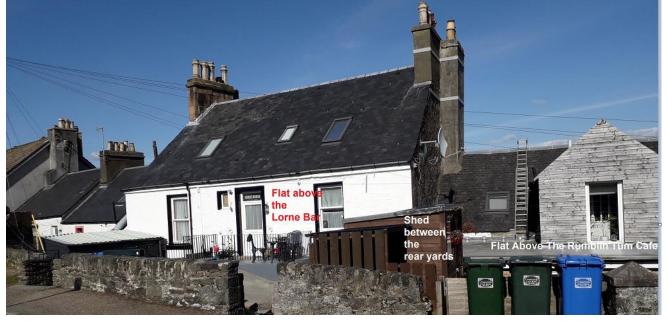
Picture 2 below, shows the two flats above The Rumblin'Tum Café and the Lorne Bar. The proposal for the beer garden is to remove the shed and join both back yard areas together.

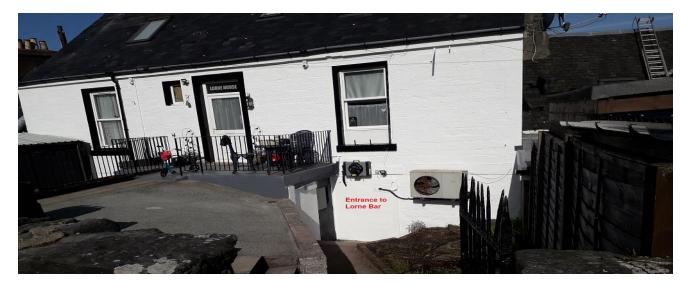
Picture 3, shows the rear yard area of the flat above the Lorne Bar. The entrance to the bar is down the steps.

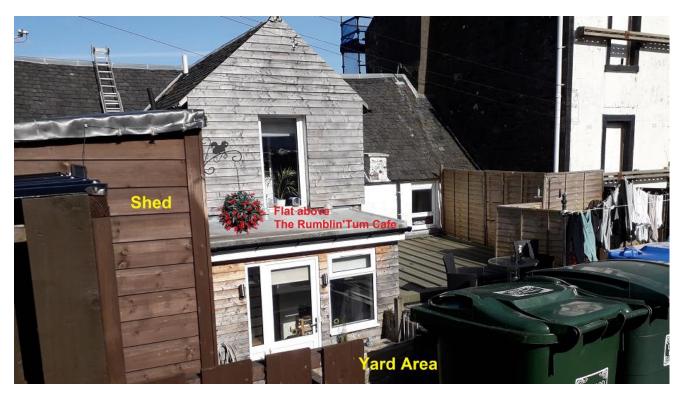
Picture 4 below, shows the rear aspect of the flat above The Rumblin'Tum Café, the small yard area and the shed between the two properties.

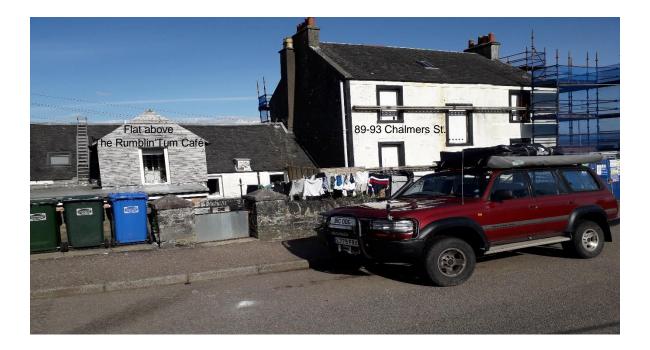
Picture 5, shows the properties to the right of The Rumblin'Tum Café at 89 – 93 Chalmers Street which are under refurbishment

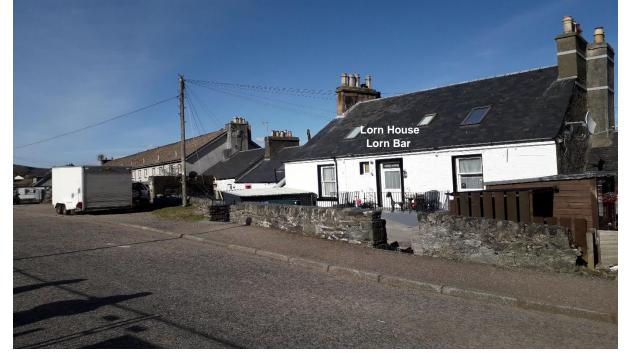
Picture 6 below, shows the flats further along Chalmers Street to the left of Lorne House/Lorn Bar

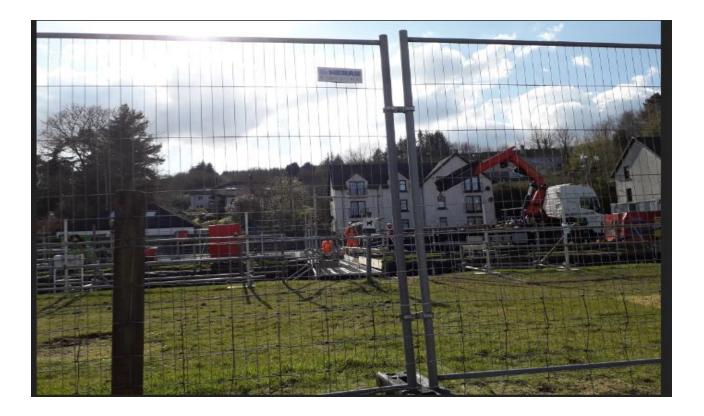
Picture 7 below, shows the view across the canal to the residential properties
