## SITE IS1

# Argyll and Bute Landscape Capacity Study

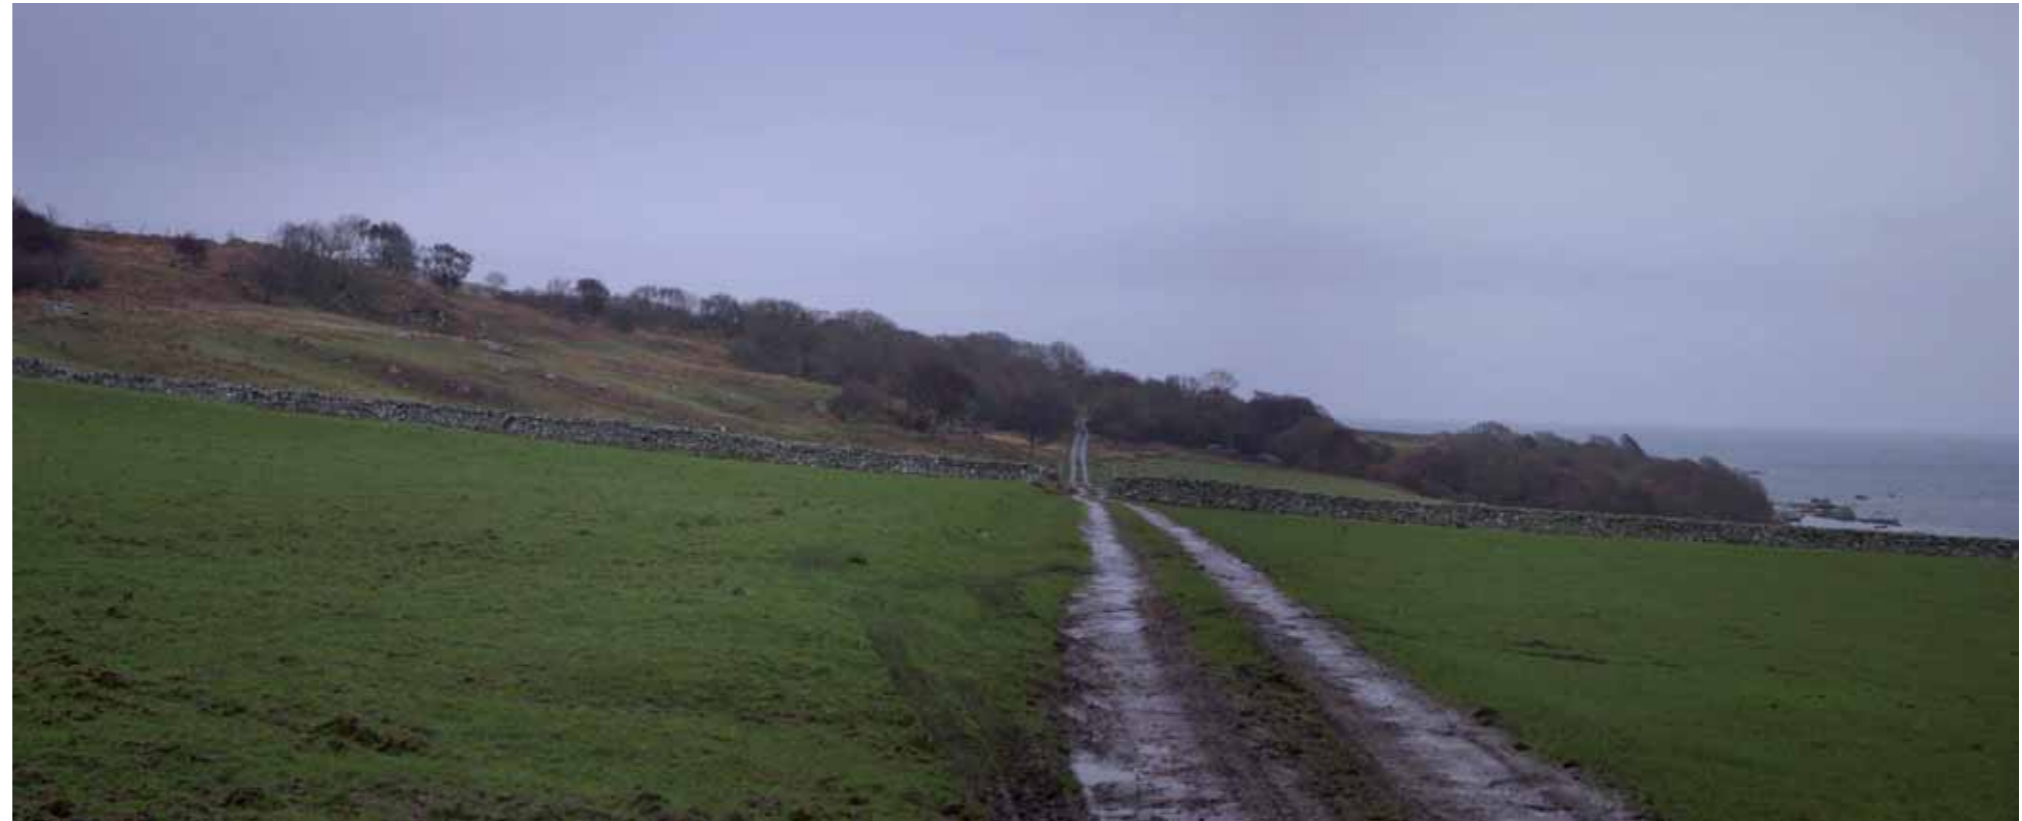
IS1 - Looking north. Ardtalla Farm screened from view behind trees

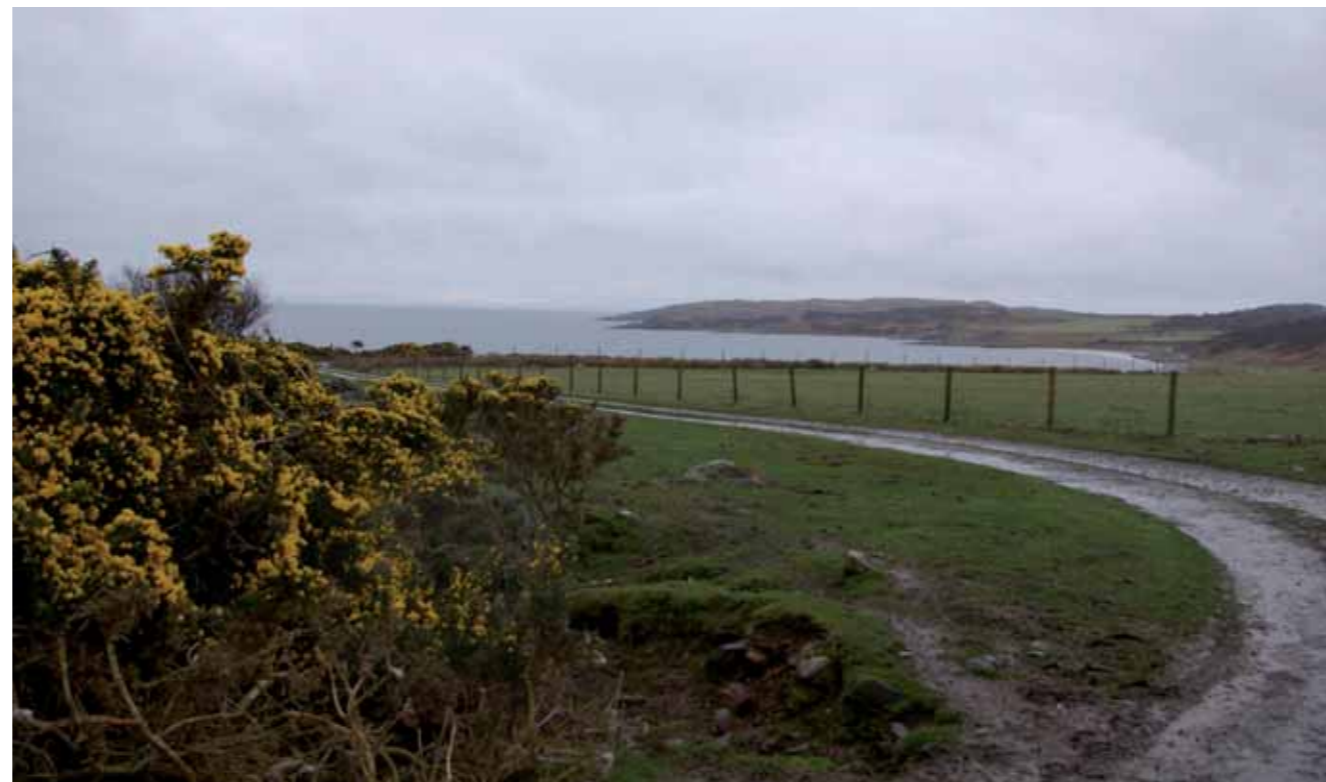
IS1 - Looking south over Claggain Bay to Trudernish Point

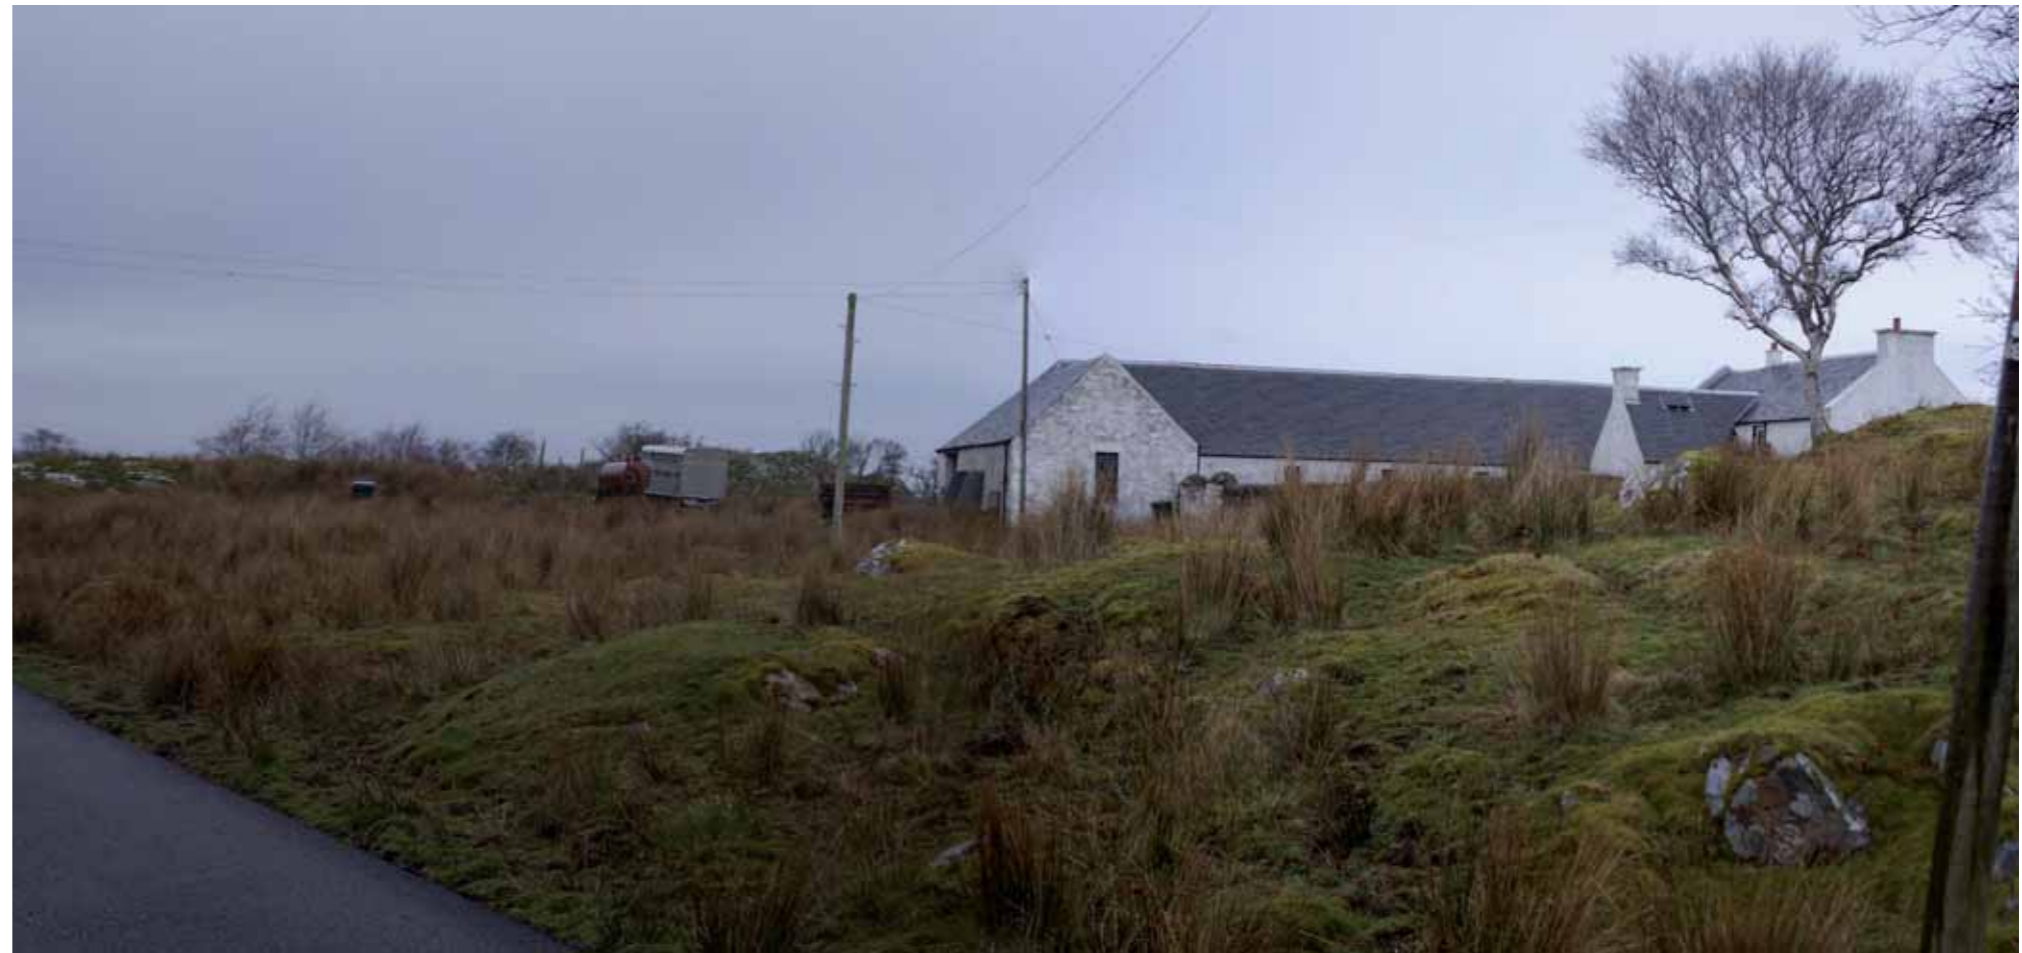
IS2 - looking northeast from road to Trudernish Farm

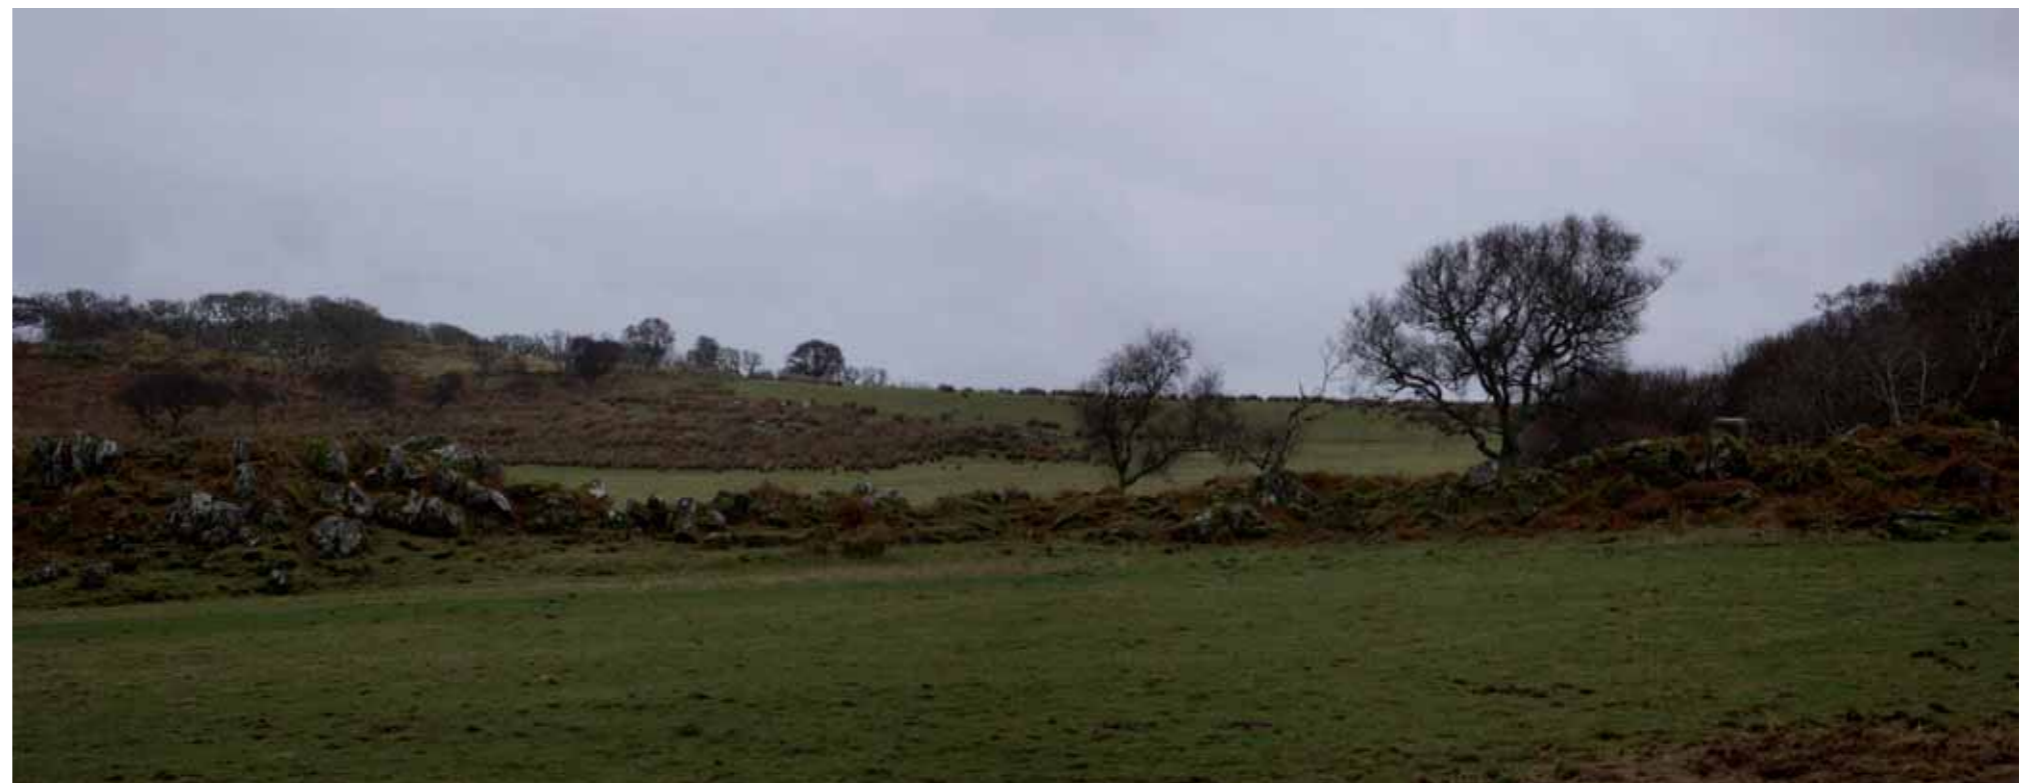
IS2 - looking south. The site is on the higher ground and sloping away to the south

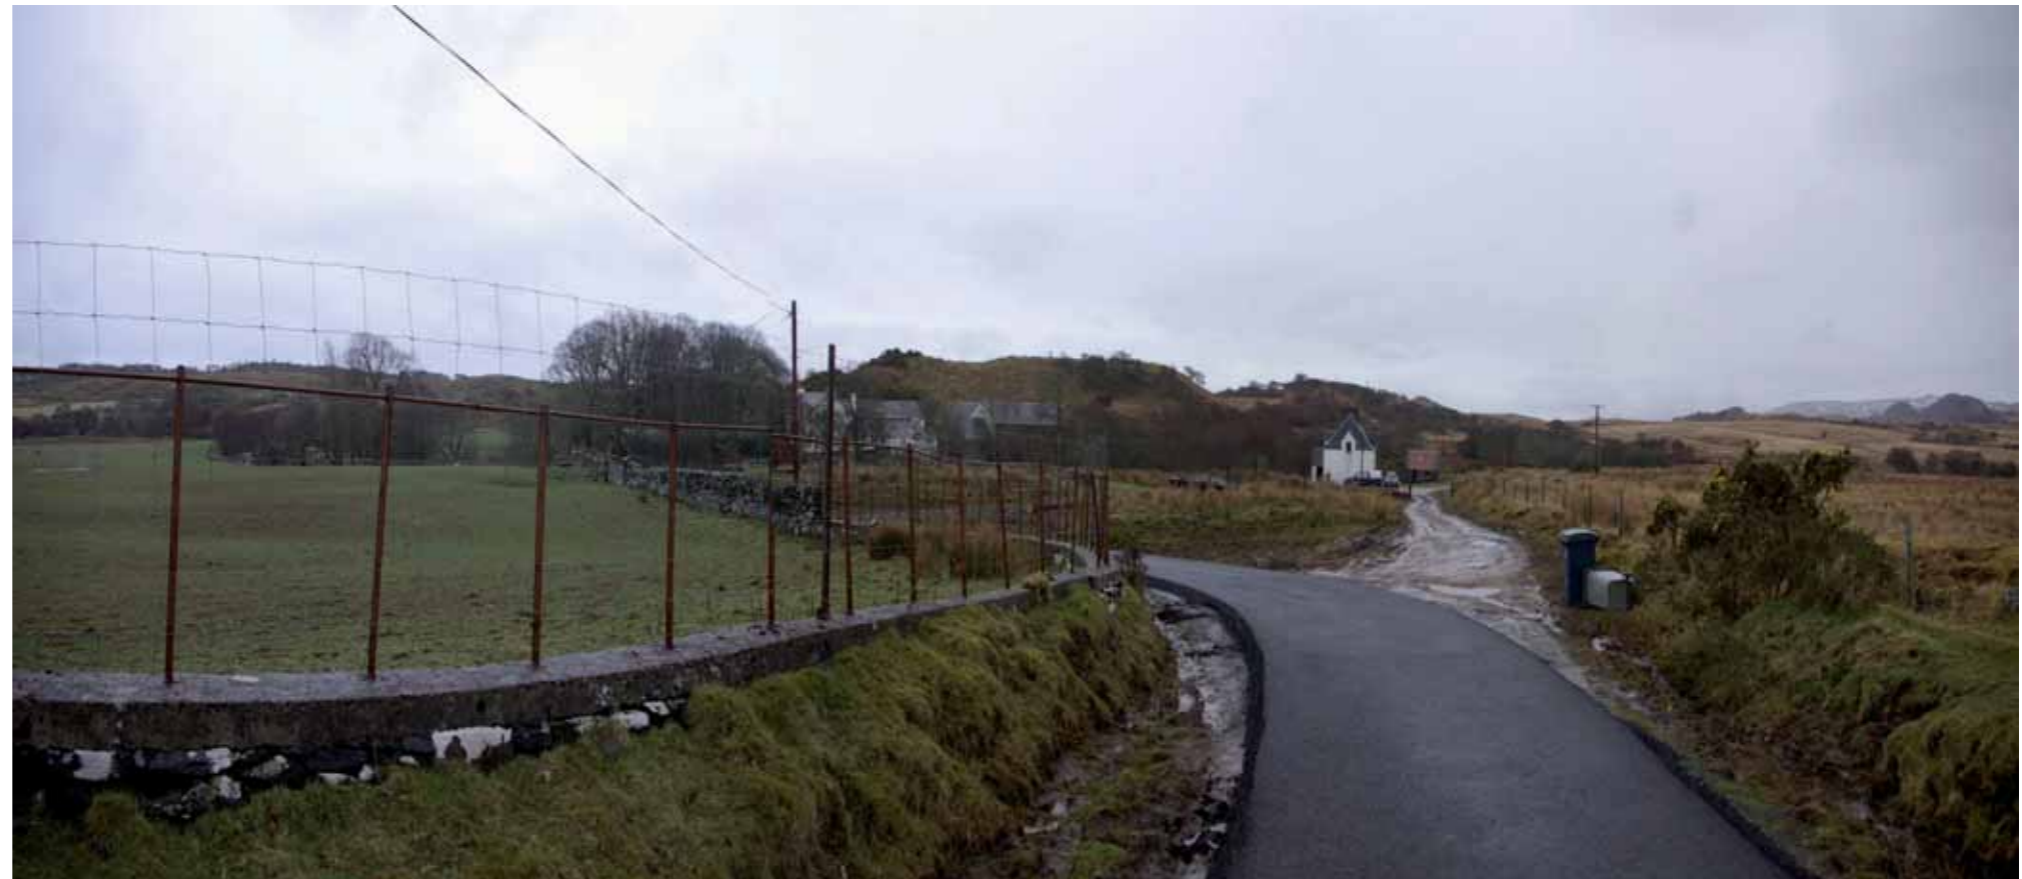
IS3 - Looking south towards Kintour

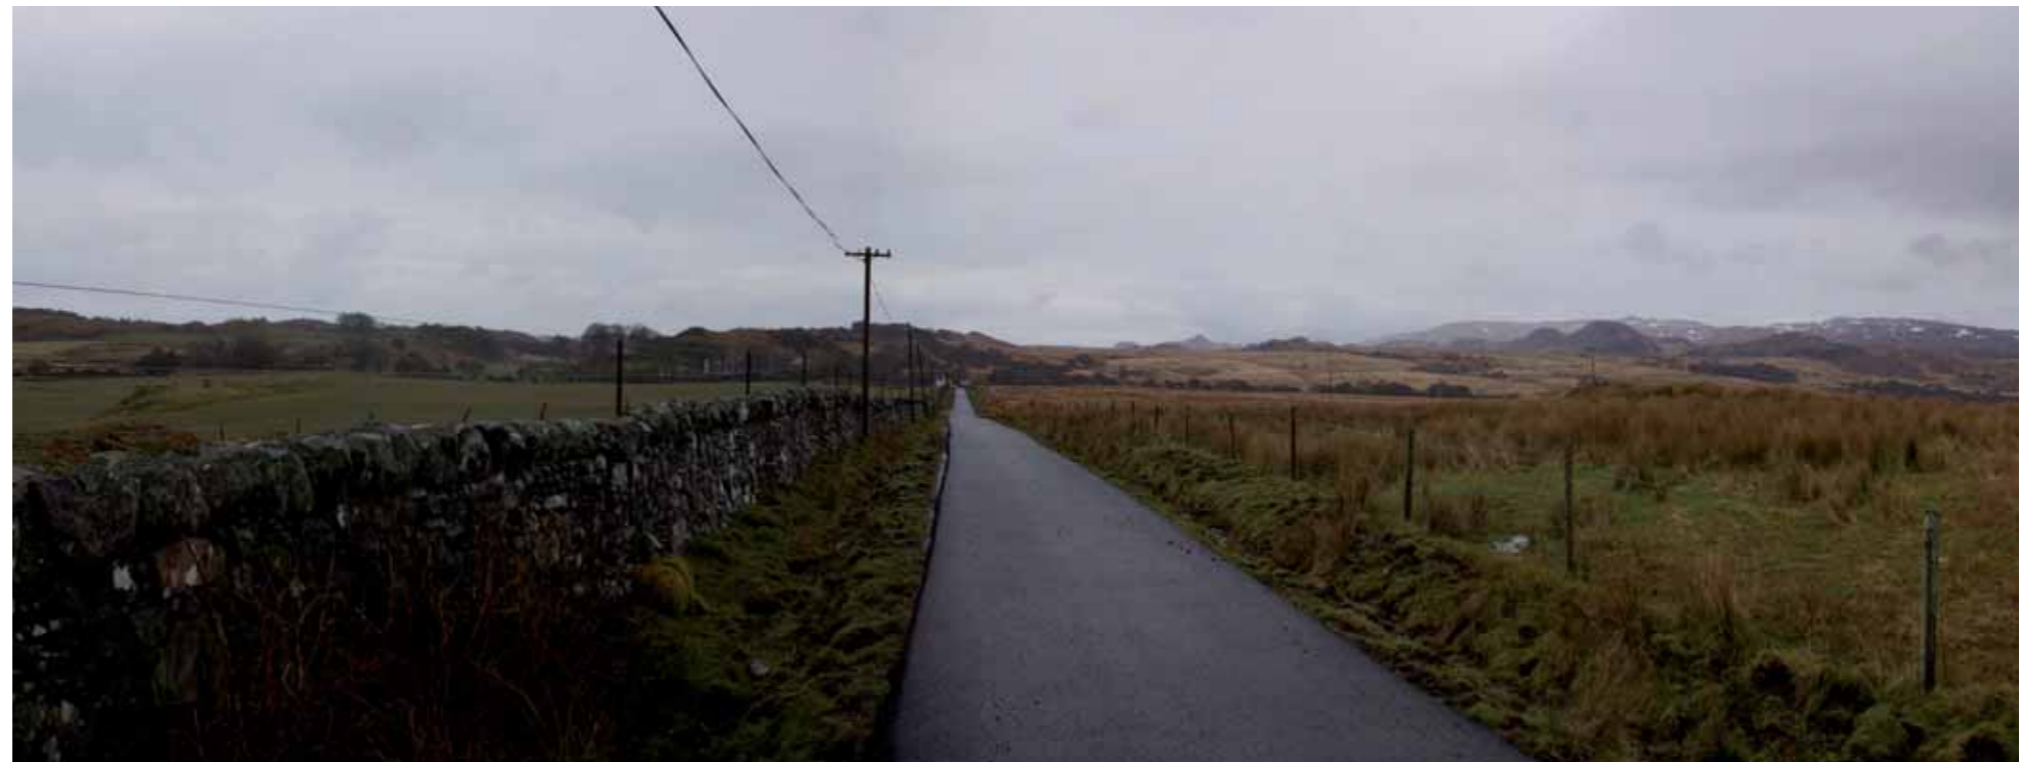
IS3 - Looking north towards the Old School House and Aros House

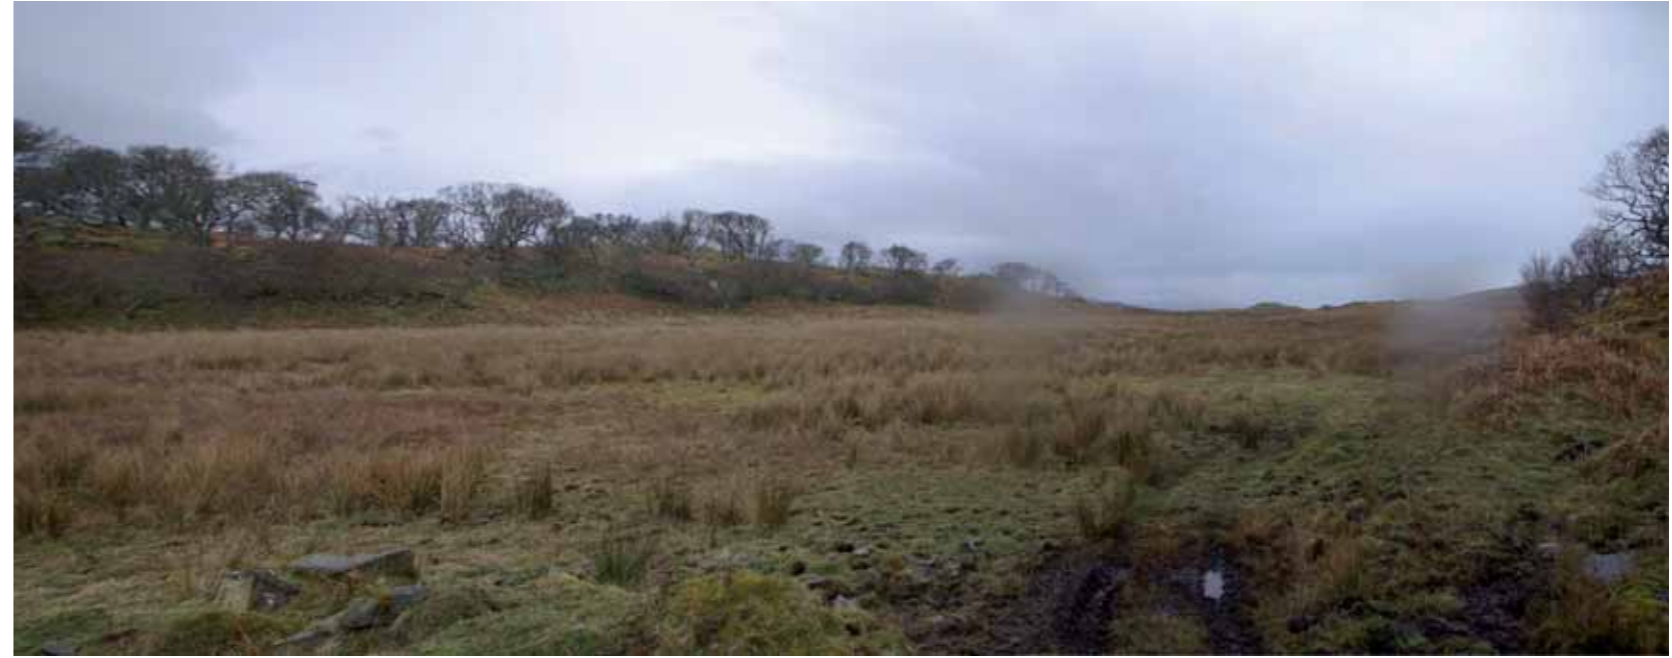
IS4 - Looking north with glimpsed views of mountains on Jura

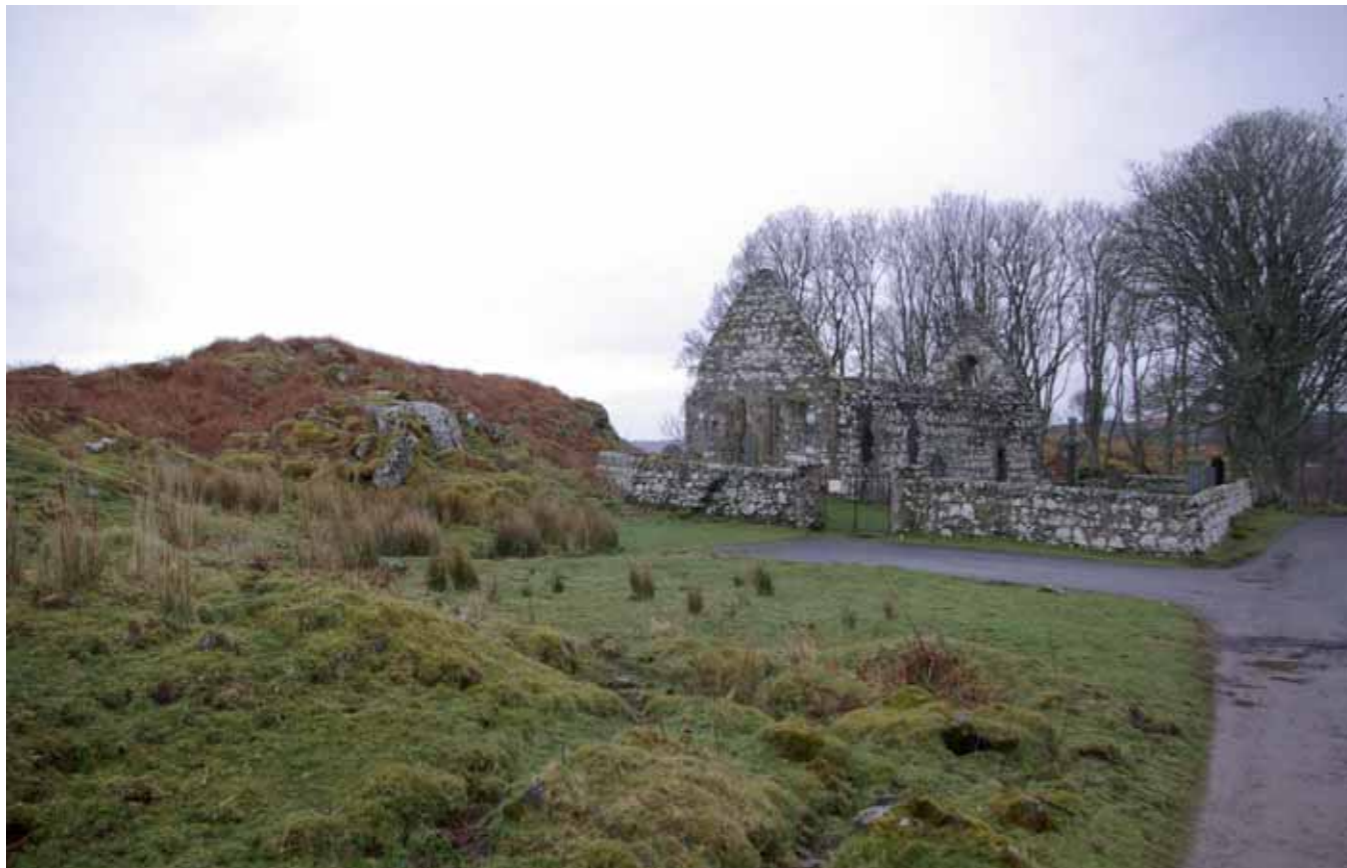
IS6 - Looking west: the site is in the foreground with the Old Parish Church and High Cross of Kildalton beyond

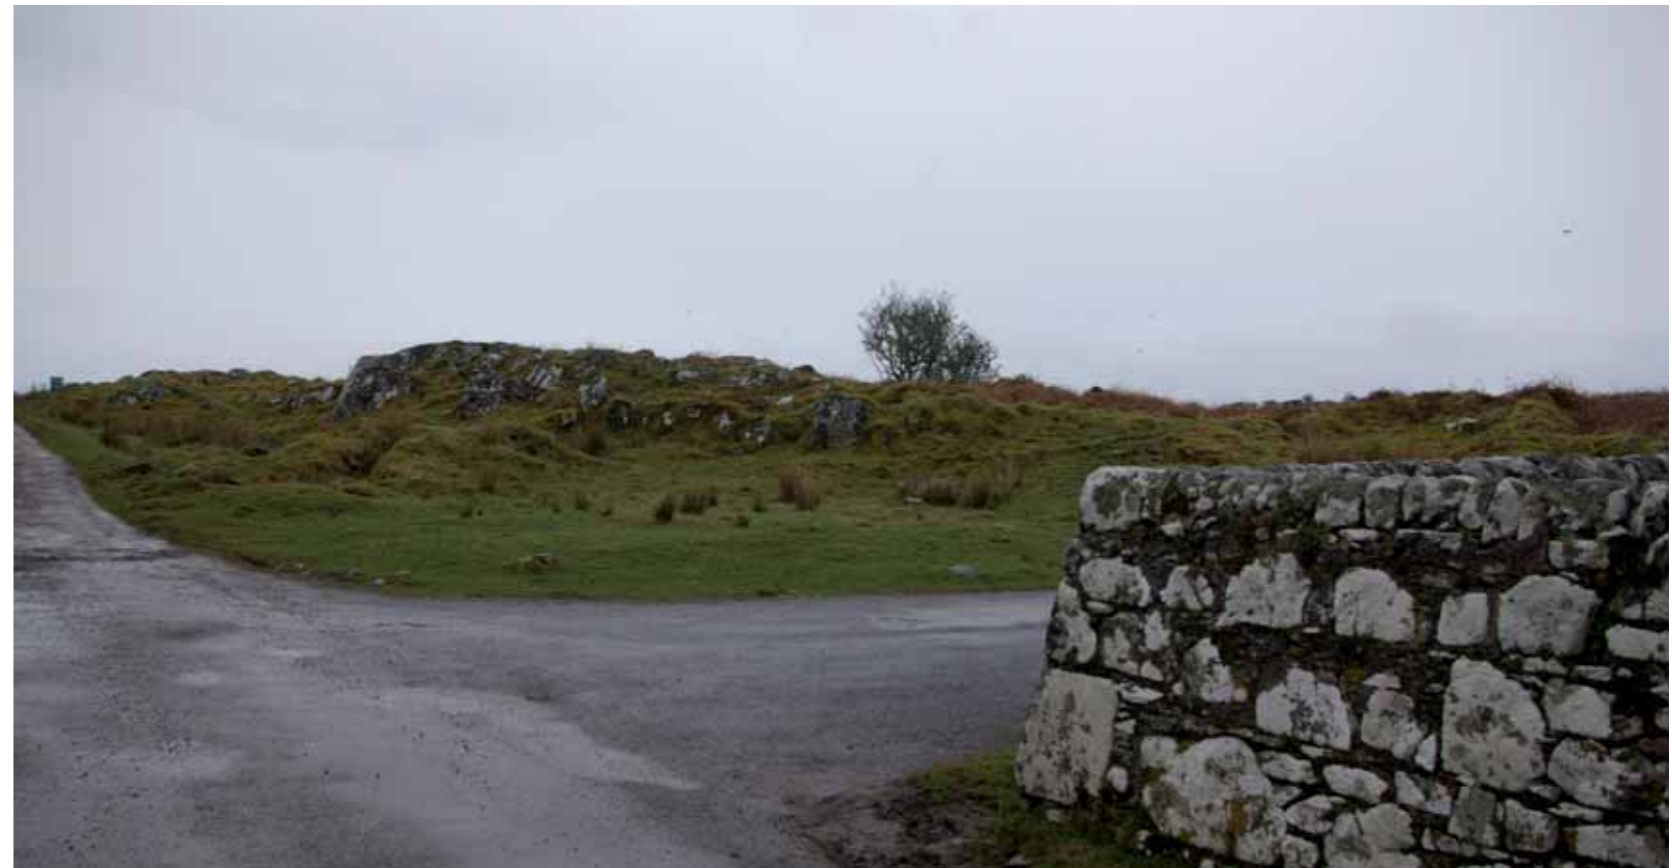
IS6 - Looking at the site with the boundary wall to the Old Parish Church cemetery on the right

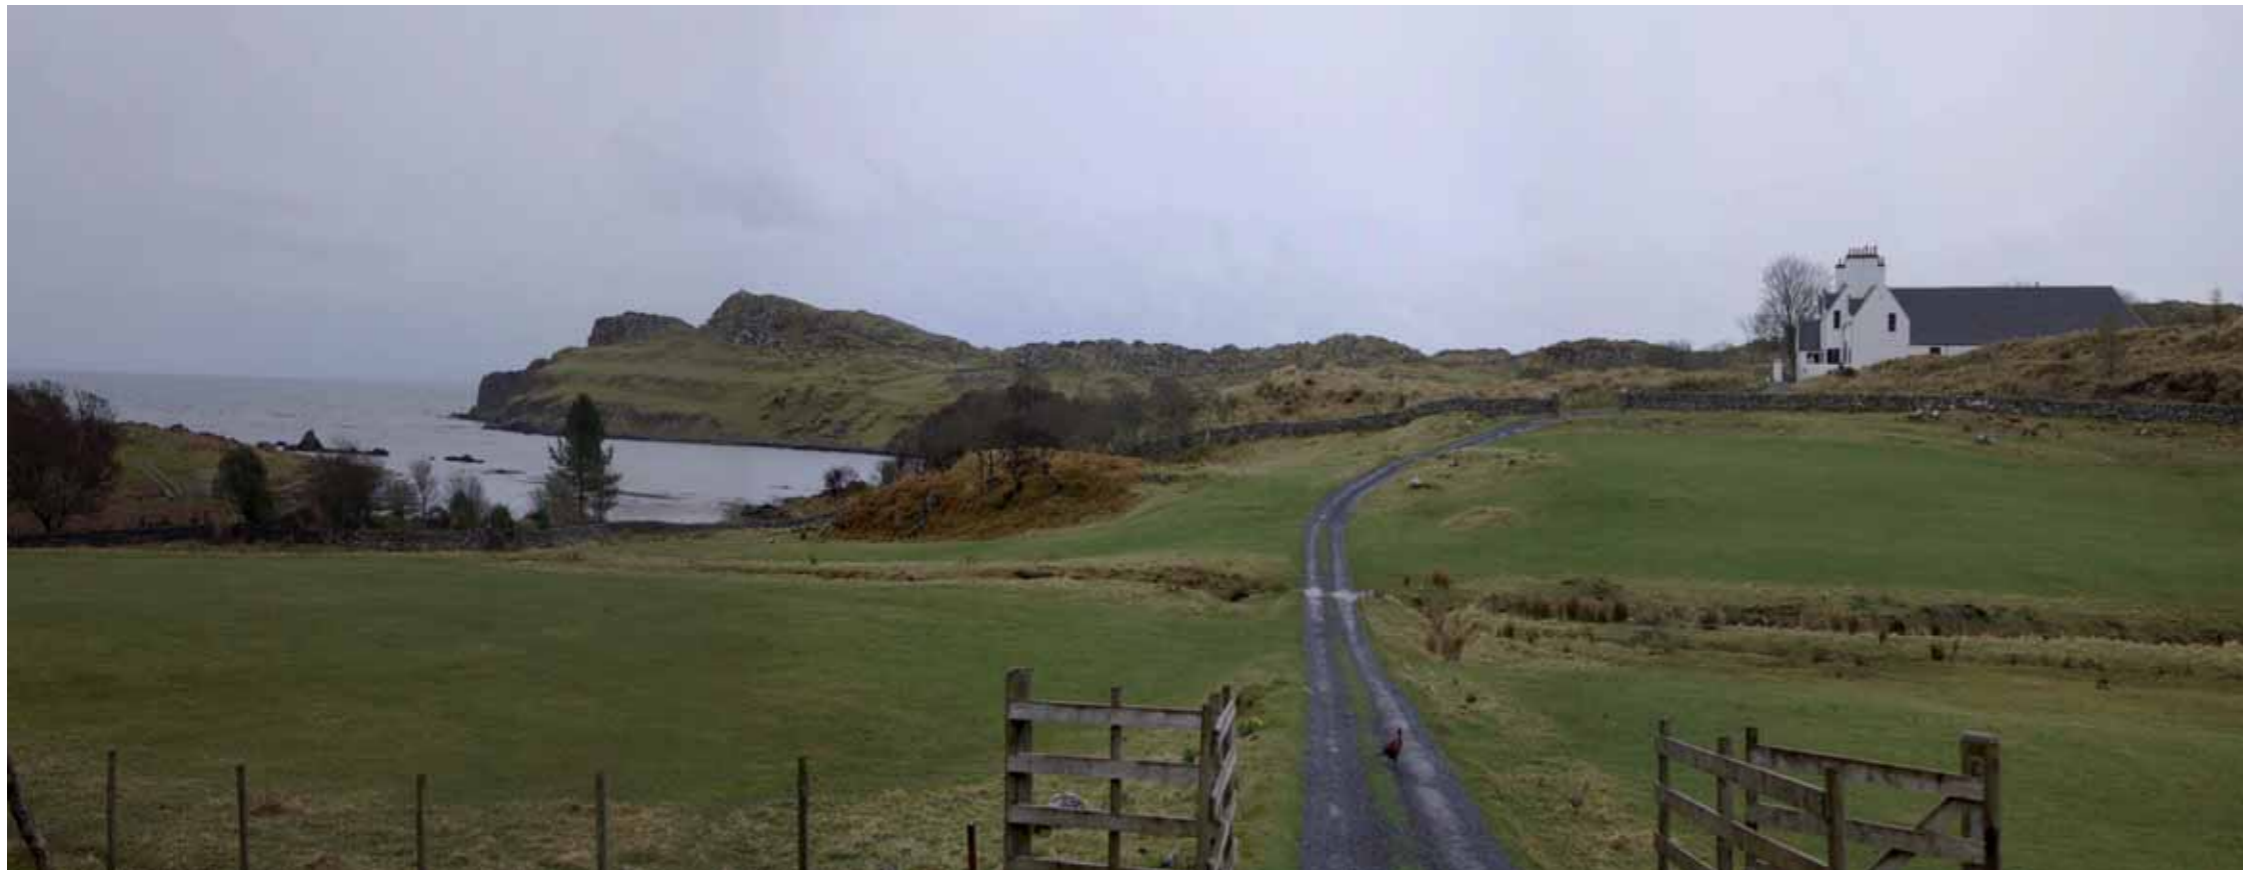
IS5 - Looking east: the approach to the site, which is on the right, with Ardmore house overlooking the site

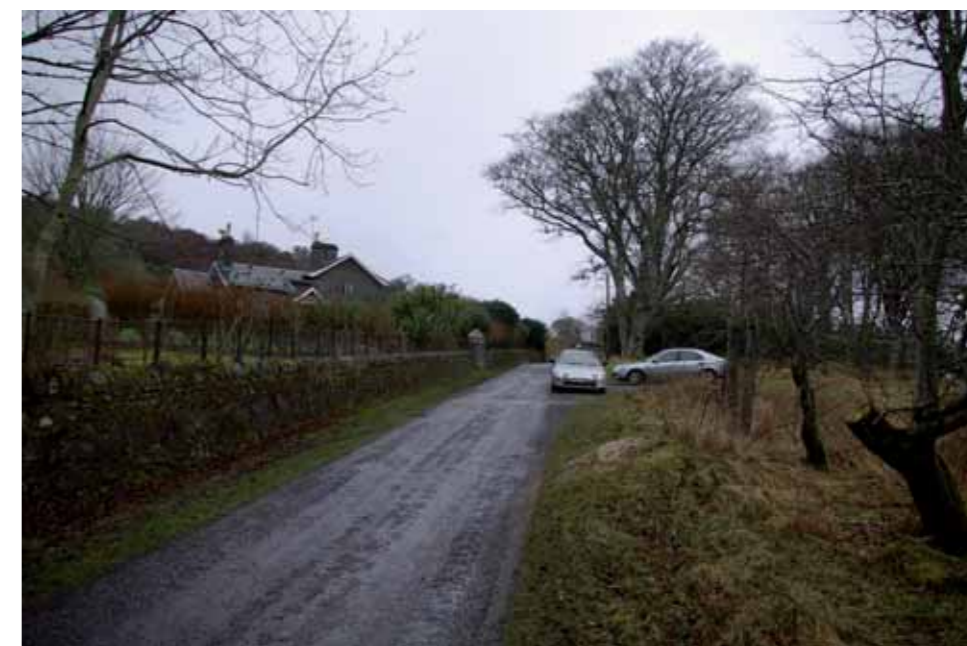
IS8 - view looking north. Tigh Rhaonastil on the left, with potential development site on the right

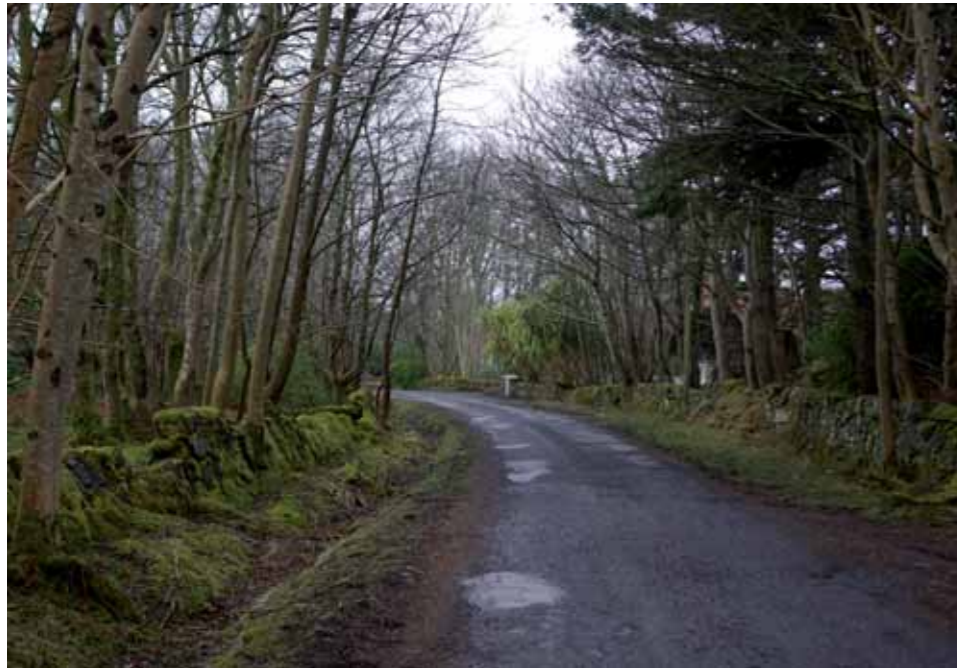
IS10 - looking south with Red Cottage and Tigh-Na-Croitean on the right (site on left hand side of the road)

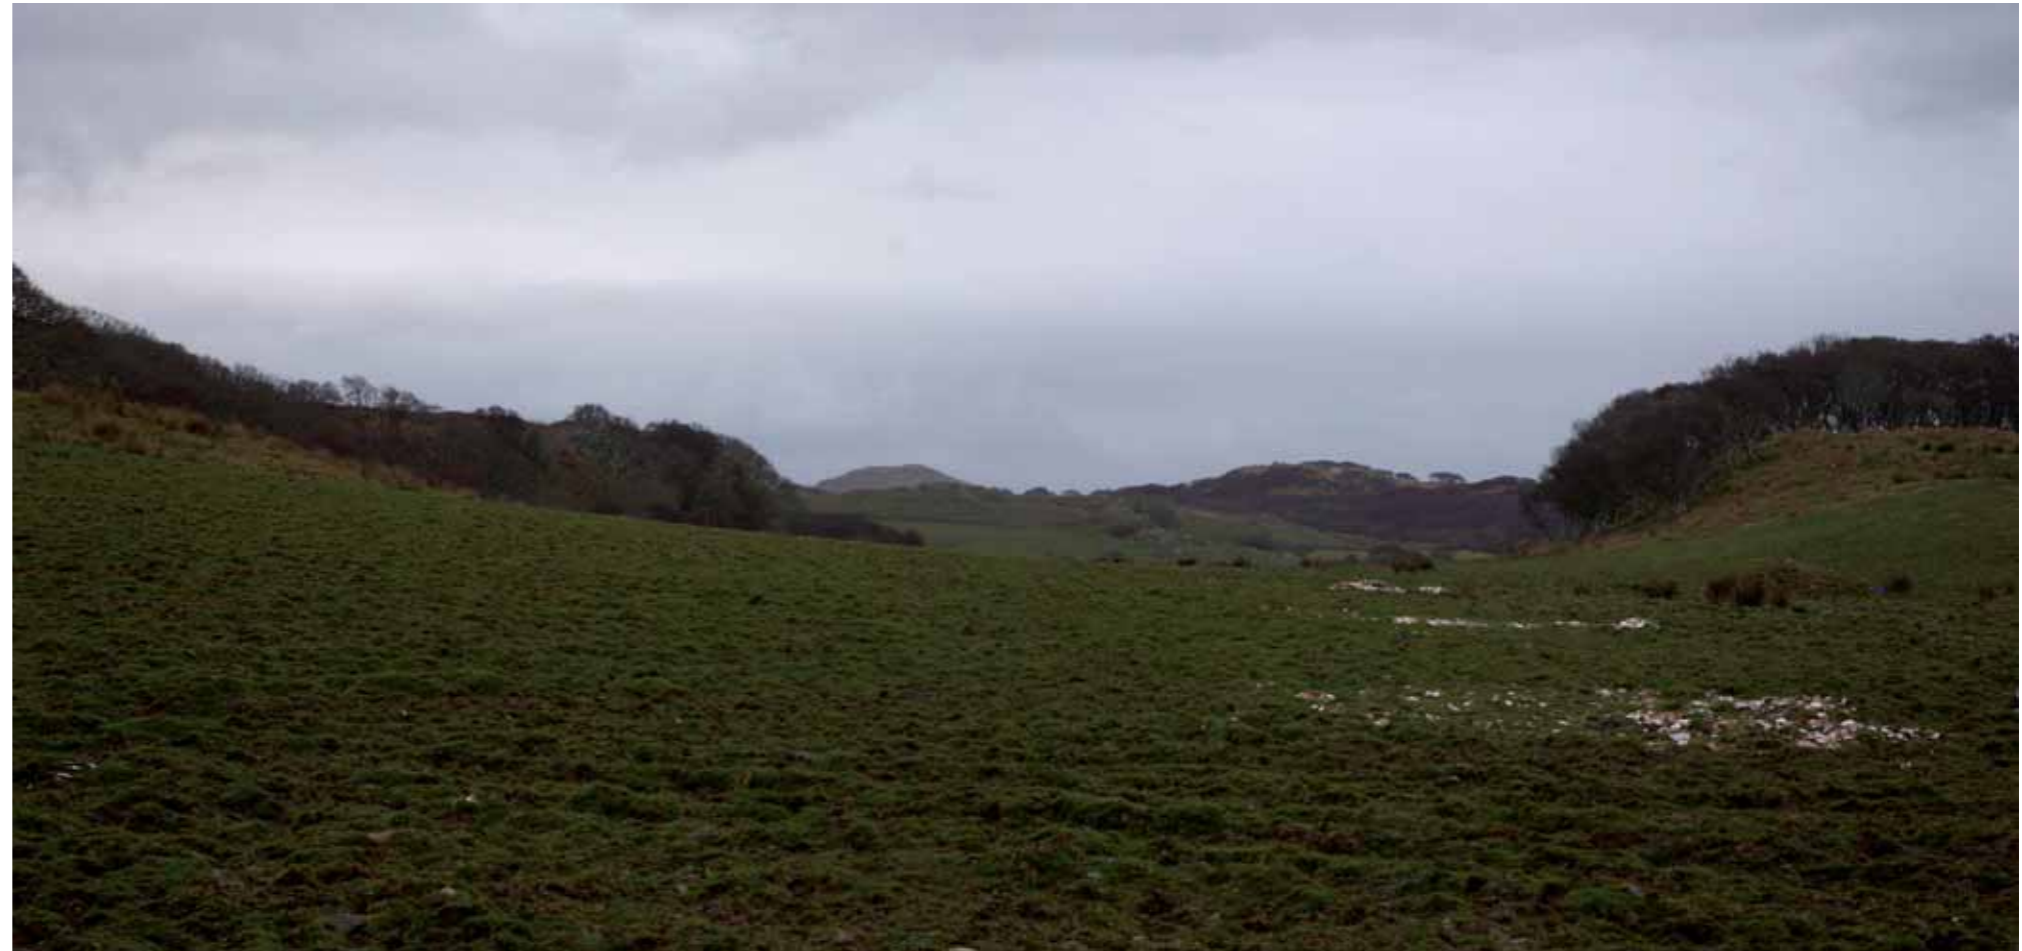
IS11 -View looking north towards the site, providing an indication of the character of the area. The far distant fields are located within the site boundary. The remainder of the site is situated to the left behind the foreground vegetation and landform.

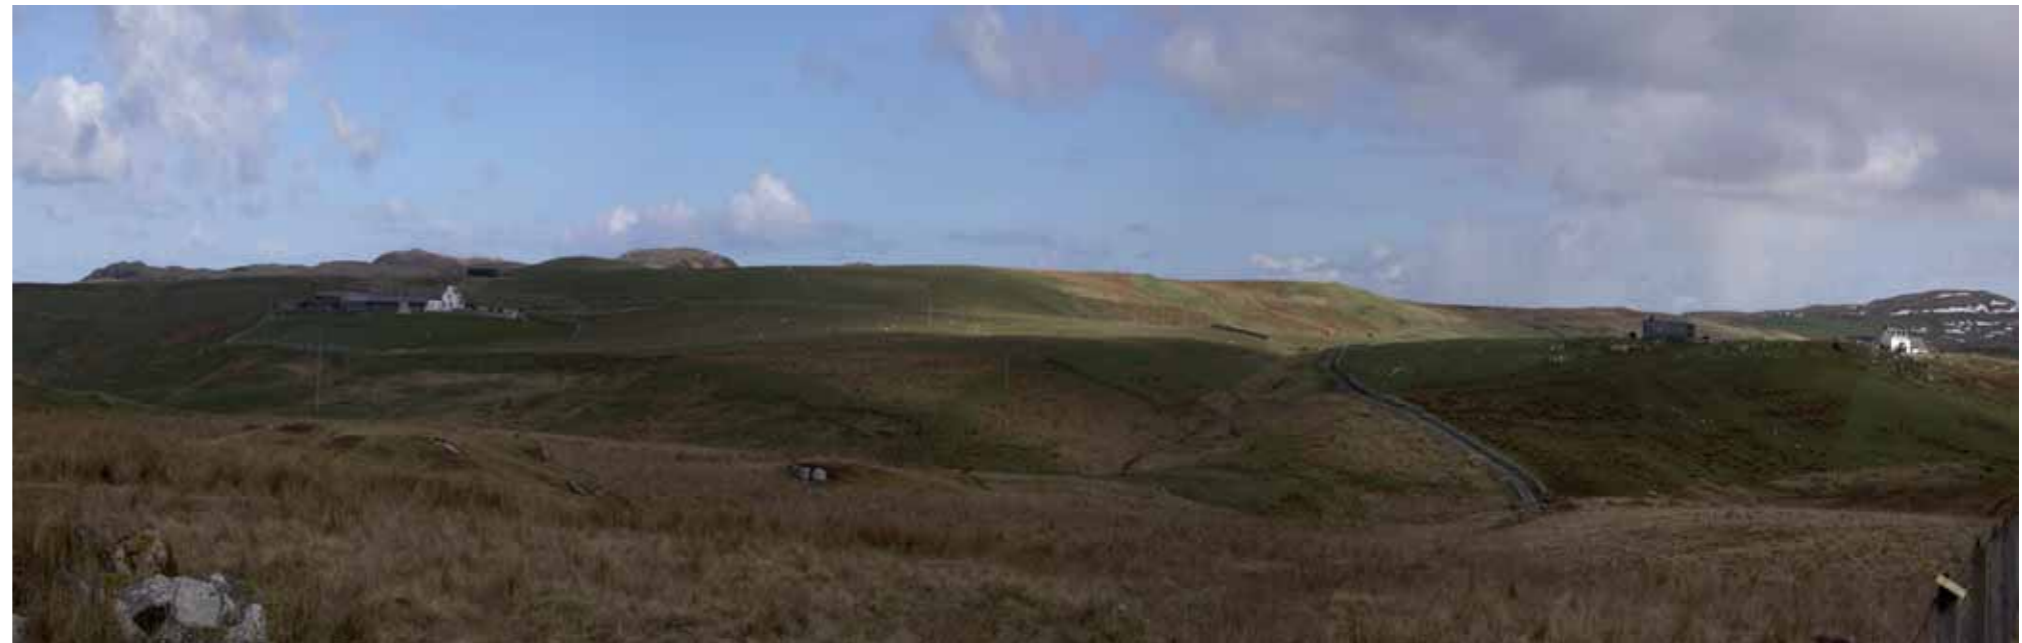
IS12 - View looking north with Lossit on the left and Kelsay on the right
